# **MASTER THESIS**

***“Contribution to Portuguese Urban Fire Investigations  
– Forensic Fire Debris Analysis”***

**STEFANIA OLIVERIO**

**JULY 2016**

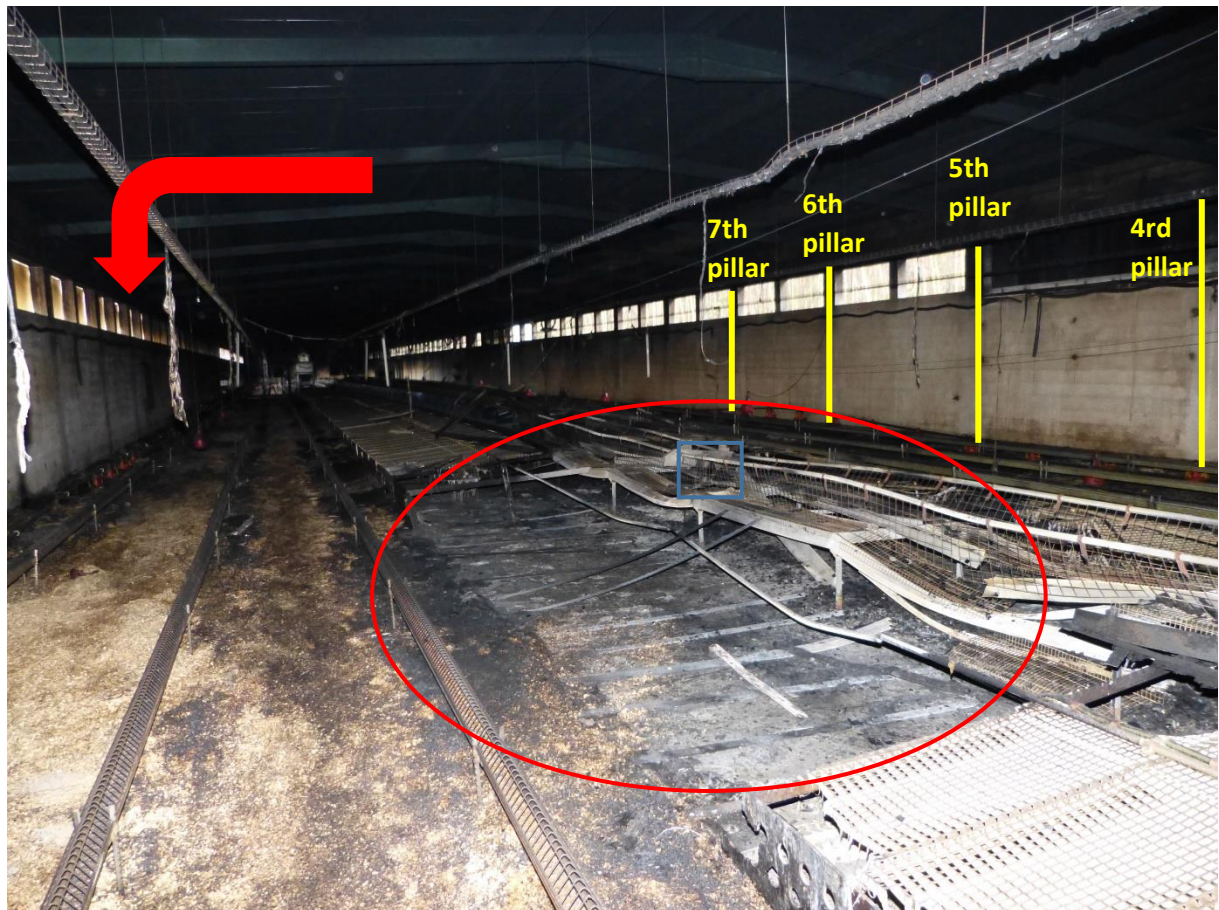
**Picture 04** - First major damage area between pillars 3-7– View from left side (west) of the pavilion; the red circle indicates the area with the highest degree of damage, due to the complete absence of the covering fences, high carbonization level of the material and high soot deposition, also the metal bars are highly bent, which indicates a longer persistence of the flames in that area, which is an indication of a slow developing fire; additionally, major damage and soot deposition can be seen on the ceiling and from there the soot deposition level decreases from the middle to the outer part of the building as well as from the upper part of the walls going down, indicating that the fire propagated from the inside towards the outside and that the flames went up in the middle and then were deviated to the sides once they reached the ceiling, which is a typical phenomenon observed in compartment fires; also, one possible point of origin can be the blue squared engine, where the most damage can be seen.

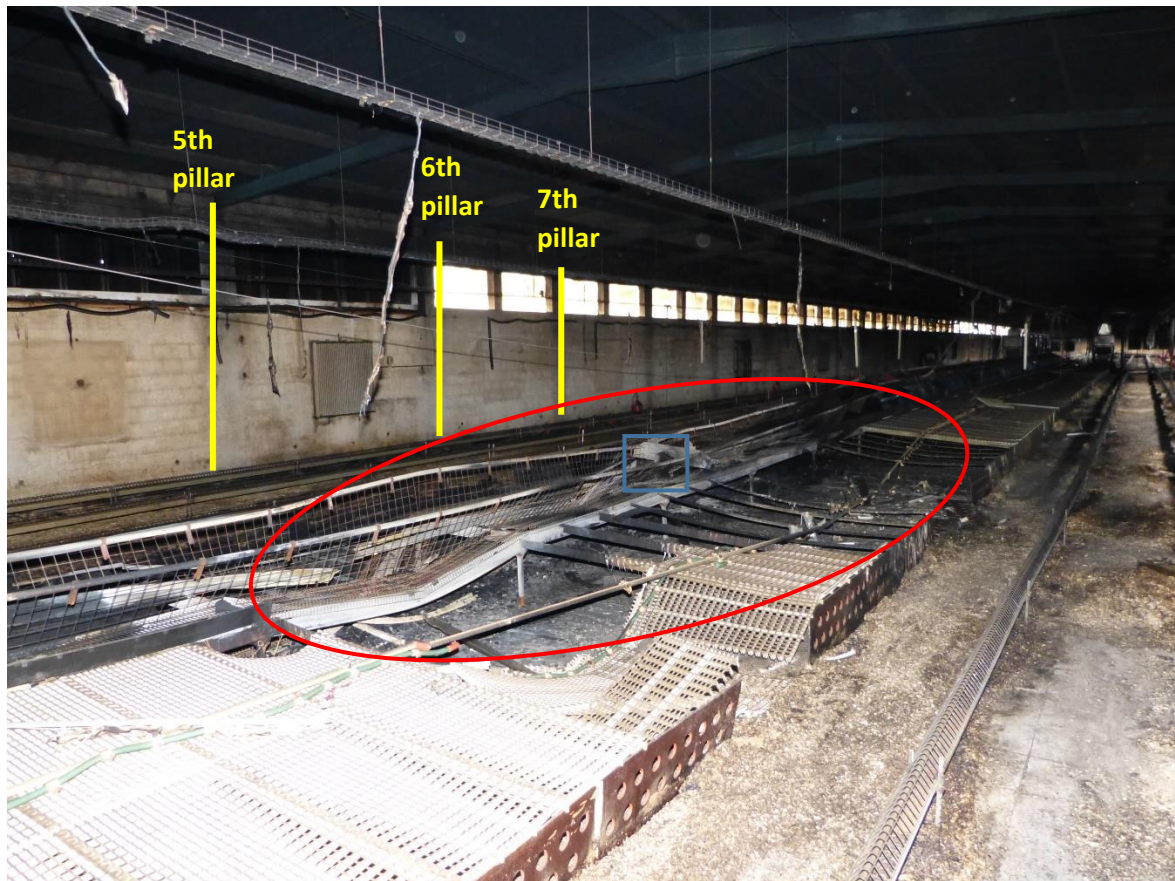
**Picture 05** - First major damage area – View from right side (east) of the pavilion; the first area with major damage that is found in the pavilion is marked by the red ellipse – damage on the right side of the motor (blue square) is less than the one on the left side of the motor (see Picture 10), indicating that the fire started and developed from the motor in direction of the west wall.

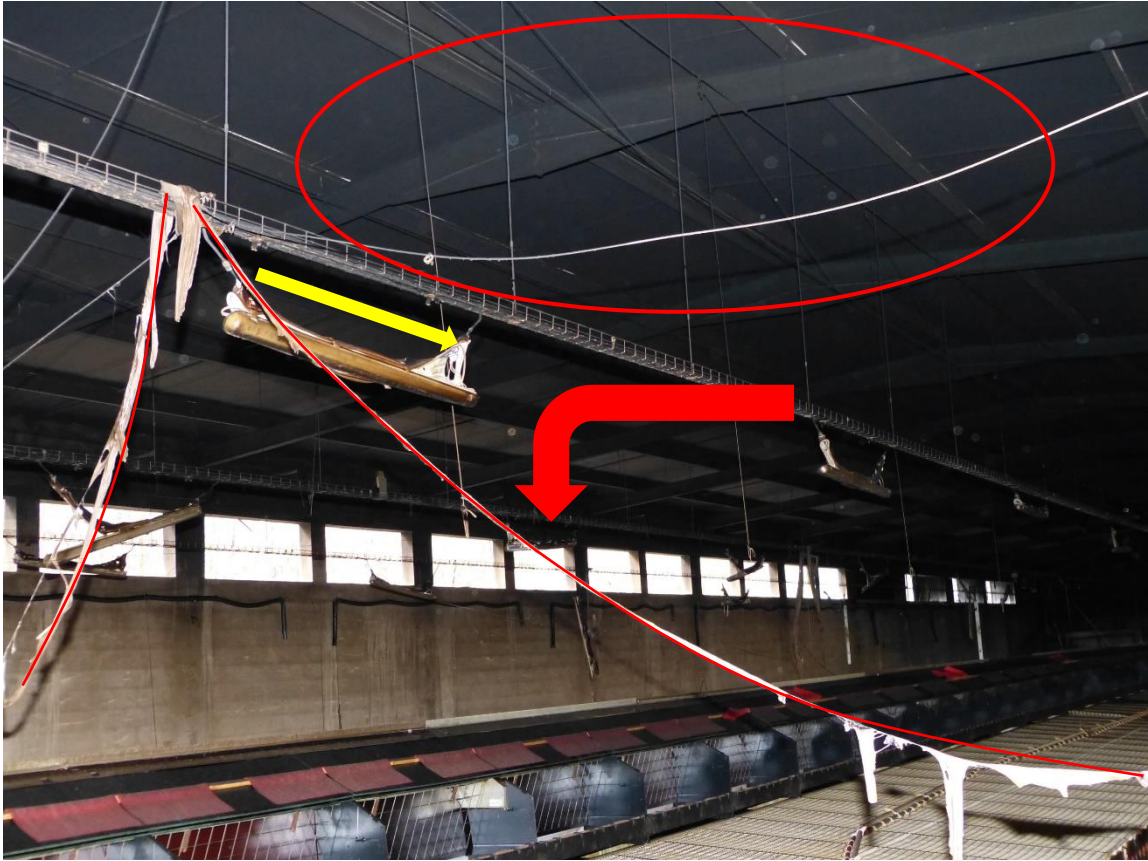
**Picture 06** - Middle area of the pavilion – residues of plastic curtains (red line), lamps increased damage from right to left of the picture (south-north, yellow arrow), convective heat damage can be observed on ceiling (red ellipse), indicating a top-down direction in this part of the pavilion as well as a south to north propagation of the fire.

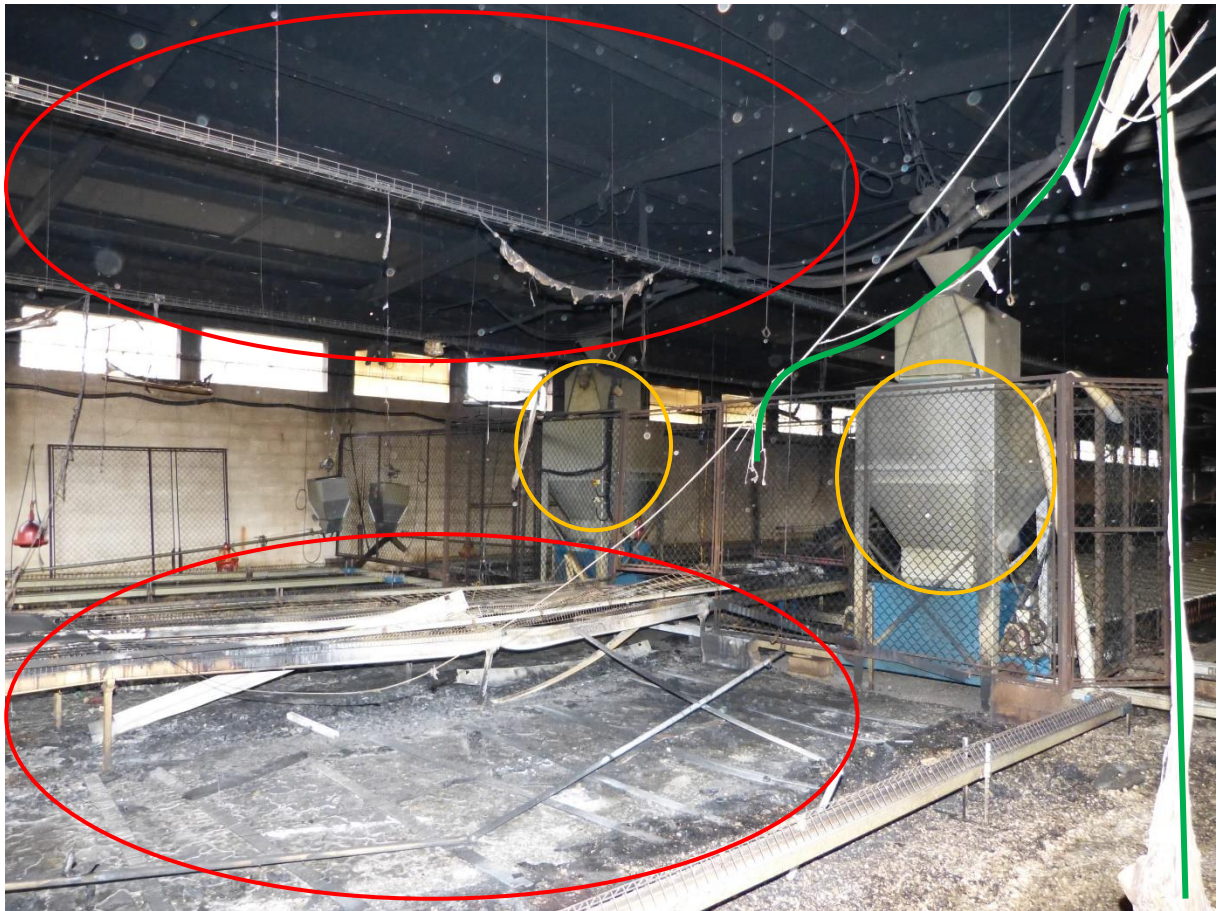
**Picture 08** - Food Supply machines – View from north to south – soot depositions visible (orange circles), more on the right side (west) than left side (east), also major damage on floor (red bottom ellipse) due to completely absent chicken-house covers, metal bars showing high degree of soot deposition and oxidation and deformation, convective heat signs on ceiling (red top ellipse), residues of curtains on right of picture (green line), indicating that the fire was low on that part of the pavilion but had an upgoing trend when it reached the metal fence, directed more towards the right (west) side.

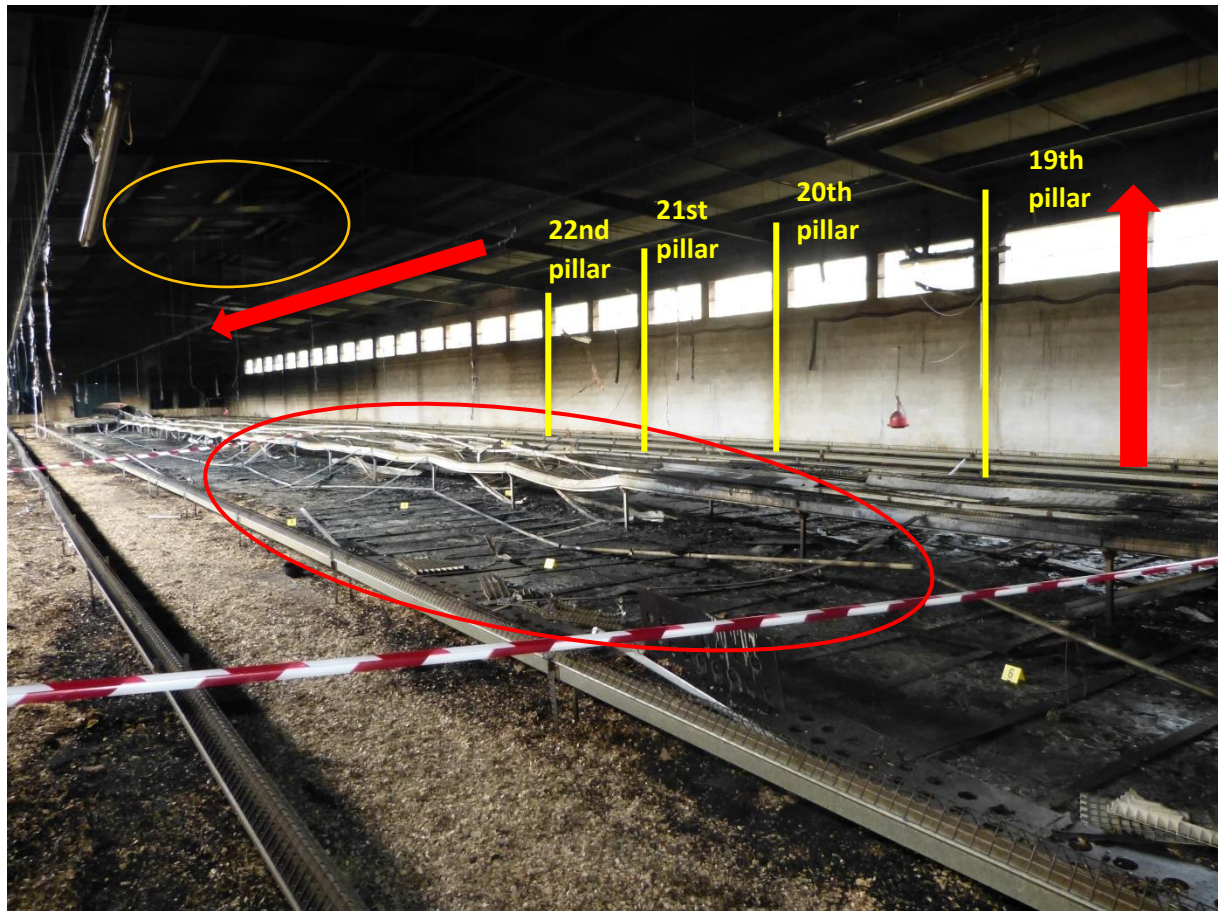
**Picture 09** - Rear part of the pavilion – view from south to north, second area with major damage and possible location of second seat of fire; more extensive damage to the chicken-houses, since most of the roofs are completely destroyed, high level of carbonization; high deformation degree of the metal bars and soot deposition and oxidation signs (red ellipse), signs of a long persisting fire in that area, with the fire going upwards – convective heat signs on ceiling – and then from the middle outwards towards the walls; orange circle shows signs of higher degree of damage on the ceiling, indicating direct flame contact and for a longer period of time in that point; also, the deformation of the light bulbs shows signs of radiant heat.

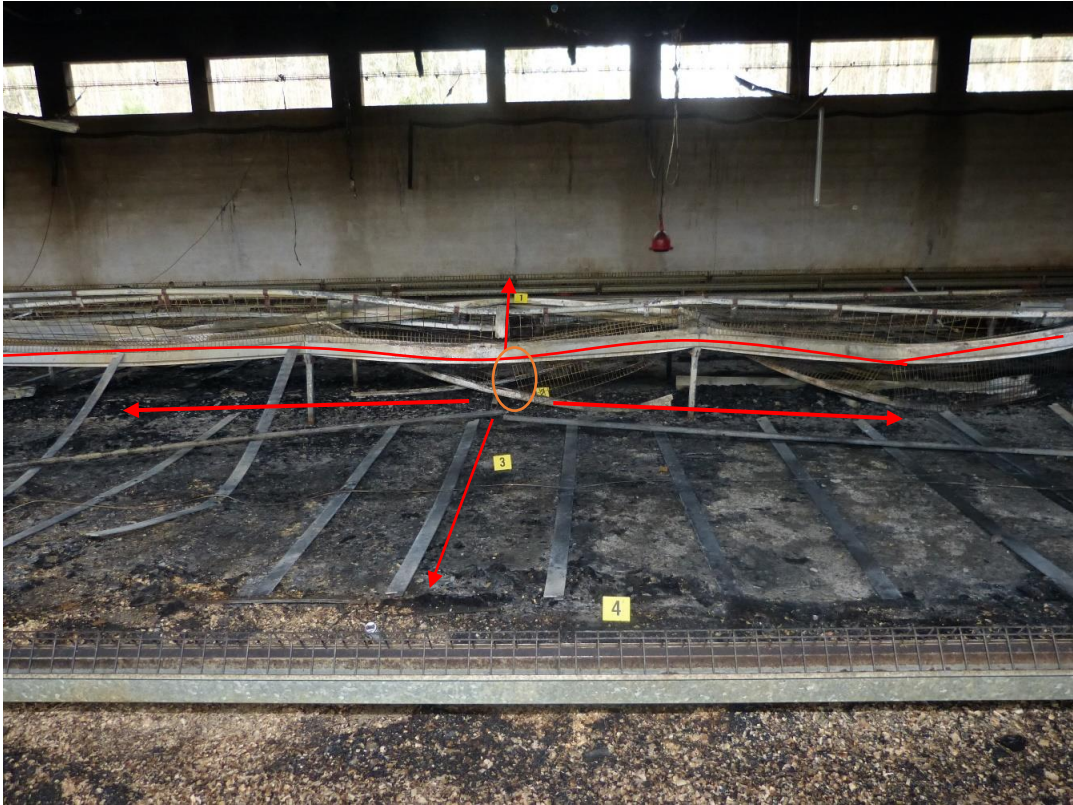
**Picture 12** - Tag # 1-4 – potential seat of fire; high deformation levels of the metal bars can be observed (red lines) and decreasing levels of carbonization in a circular, concentric way (red arrows) from underneath tag #1 (orange circle), giving indication of high probability of that point being the point of origin.

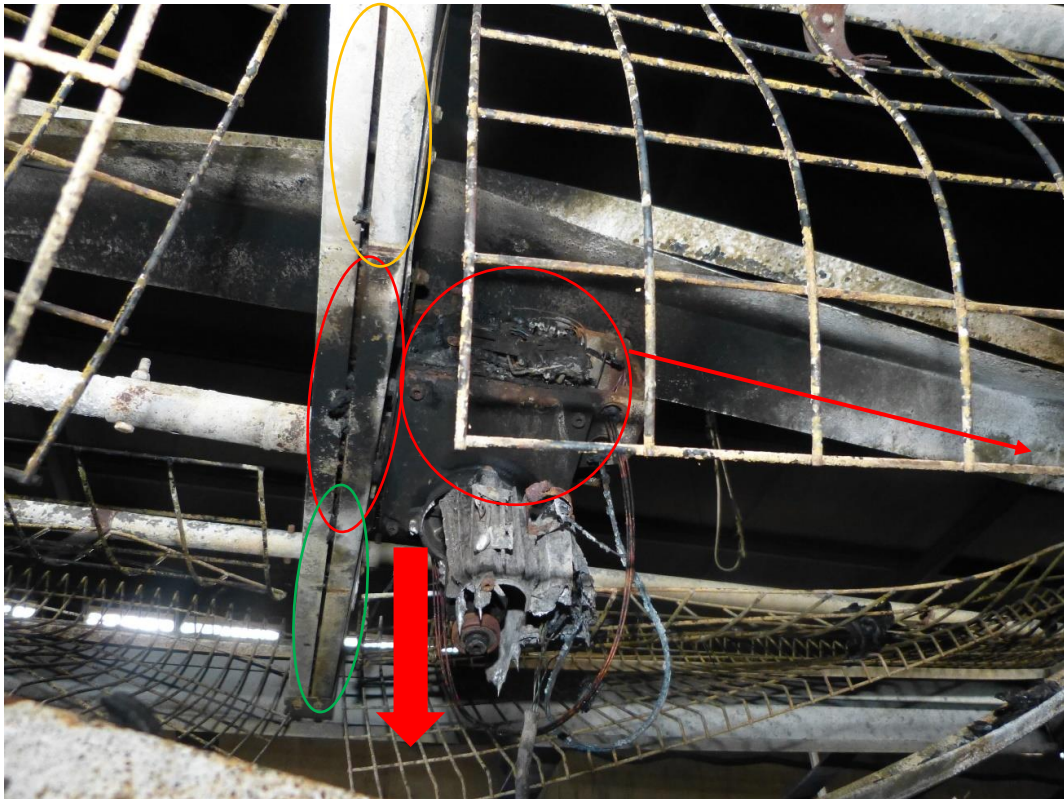
**Picture 14** - Tag #1 and #2 view from underneath; high deformation and drop-down of plastic from underneath the engine; high levels of soot deposition underneath the engine (red ellipses), indicating a possible second seat of fire coming from underneath; clear protection of metal bar behind the engine (green circle), indicating the direction of the fire from the engine towards the top of the picture (west); clear difference in oxidation and damage levels on top (west) of picture (high) compared to bottom (east) of picture (low), confirming direction of propagation facing west.

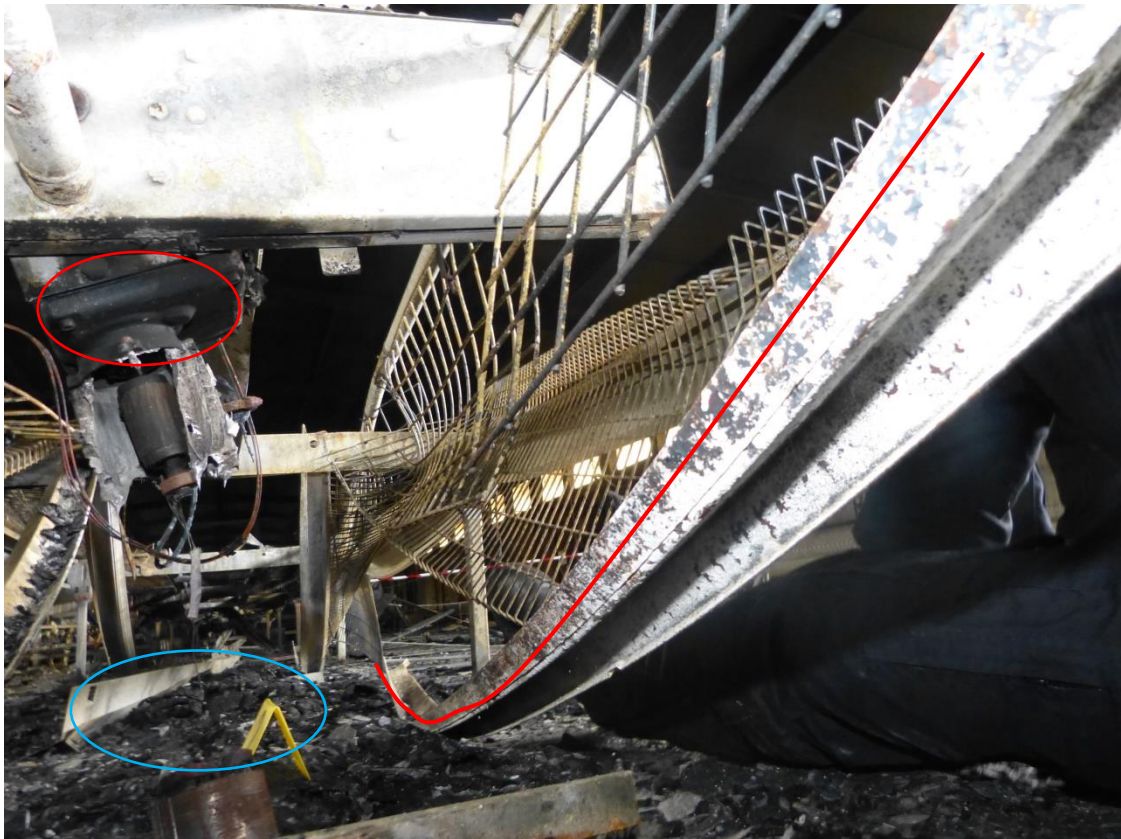
**Picture 17** - Tag #2 – view from the left side (north to south) – metal bar on right of picture shows strong deformation in front of the motor and increasing oxidation from north to south – also, dropdown from melted plastic of bottom motor part – black underneath motor (red ellipse): radiant heat from second fire (blue ellipse).

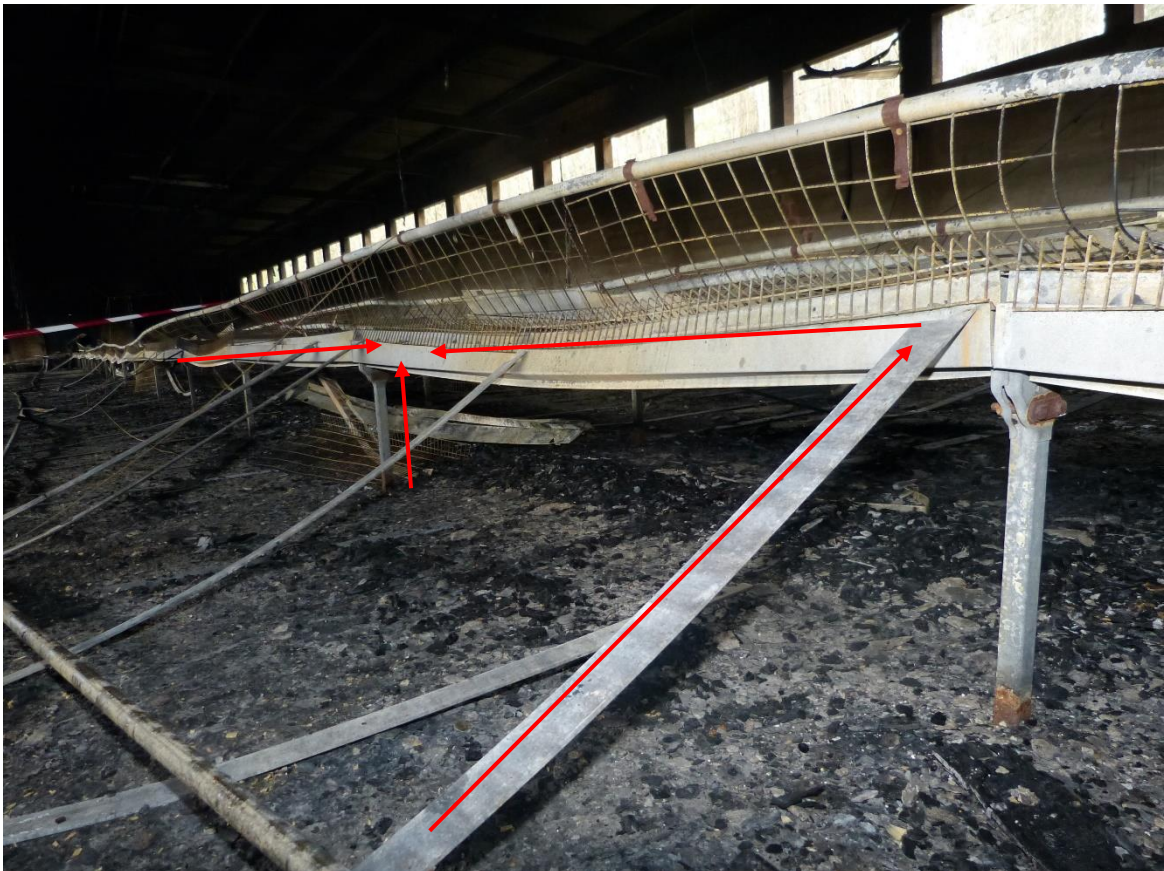
**Picture 19** - View of metal bars on left side of pavilion from potential seat of fire south to north – decreasing levels of oxidation and damage from south to north and from east to west, red arrows indicate the increasing level of damage pointing towards one area of origin.

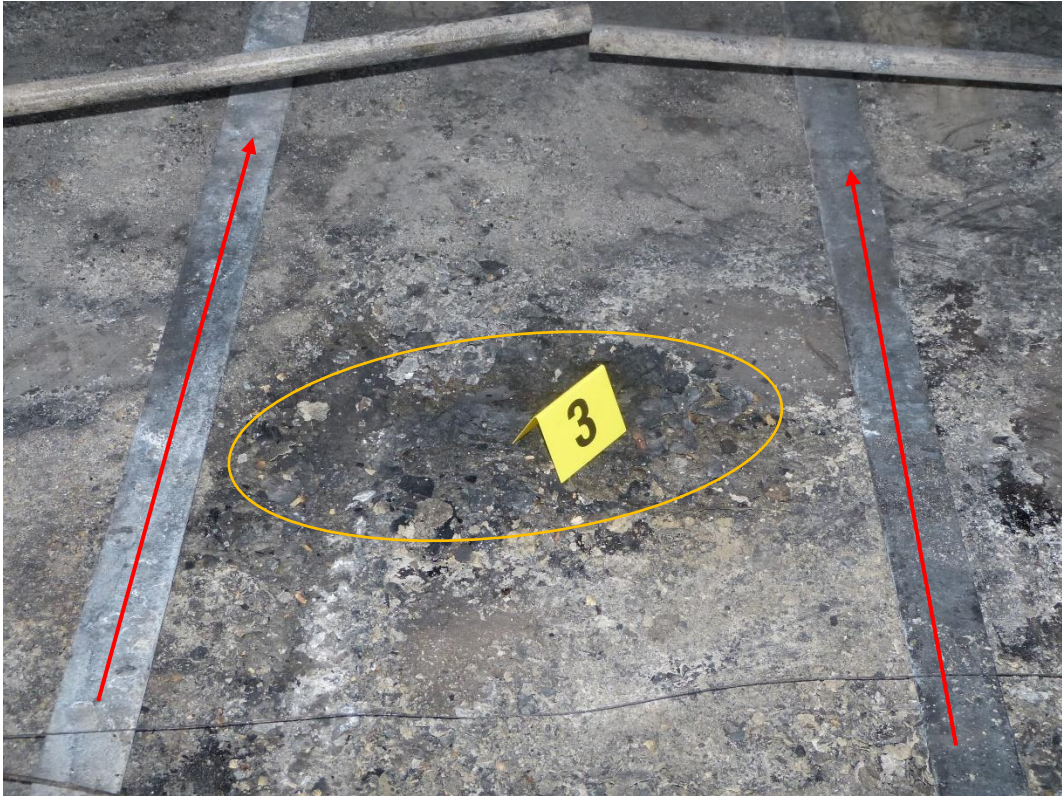
**Picture 22** - Tag #3 – detoxification bloc – damage on bars does not coincide with this point as seat of fire, since the damage should have been pointing to the direction of the bloc in a concentric way, but instead the damage is increasing from bottom (west) to top (east).

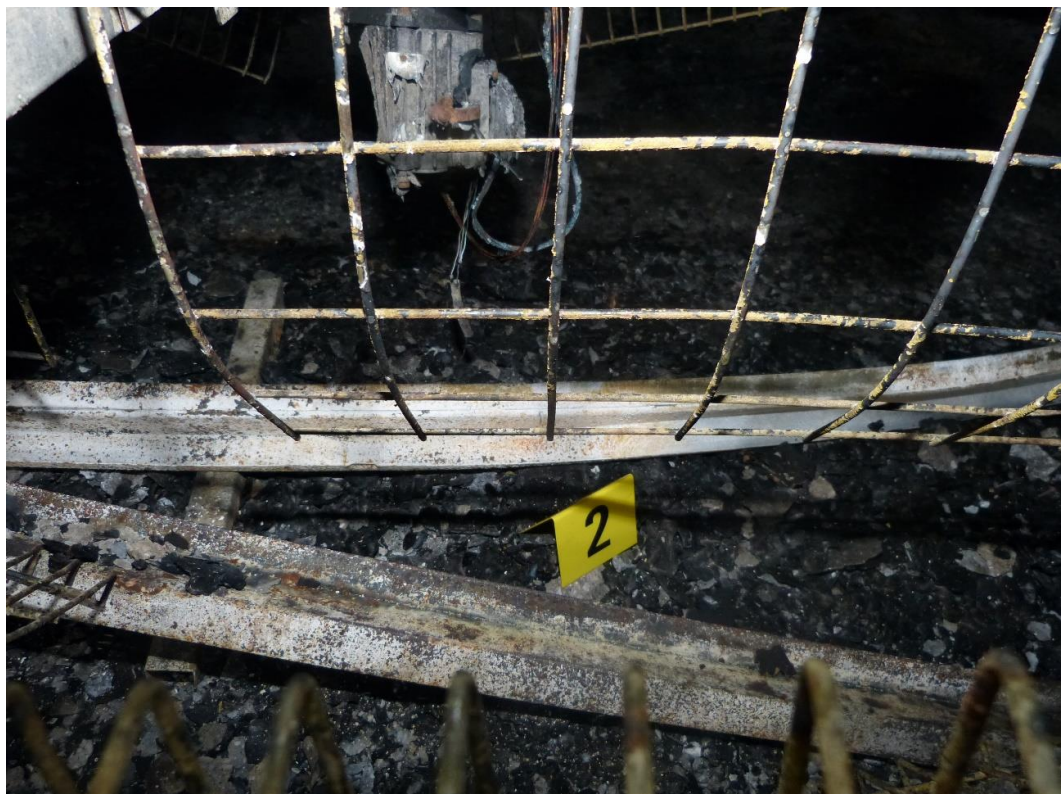
**Picture 23** - Tag #2 view from top, east (top) to west (bottom) – high damage area on floor, signs of low level slow burning.

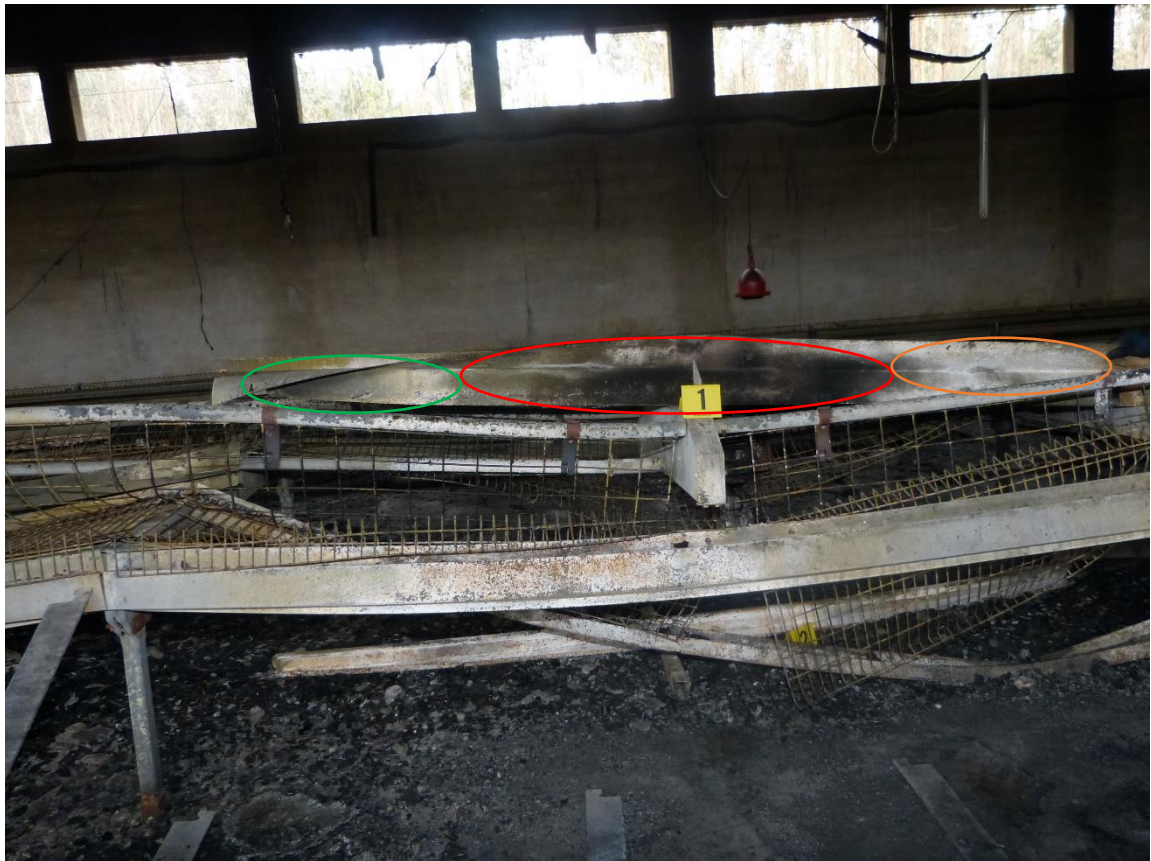
**Picture 24** - View from underneath of central metal bar near tag #1 – direct flame contact in black area (red circle); protection on the left side of the metal bar (green ellipse) and exposition signs on the right (orange ellipse).

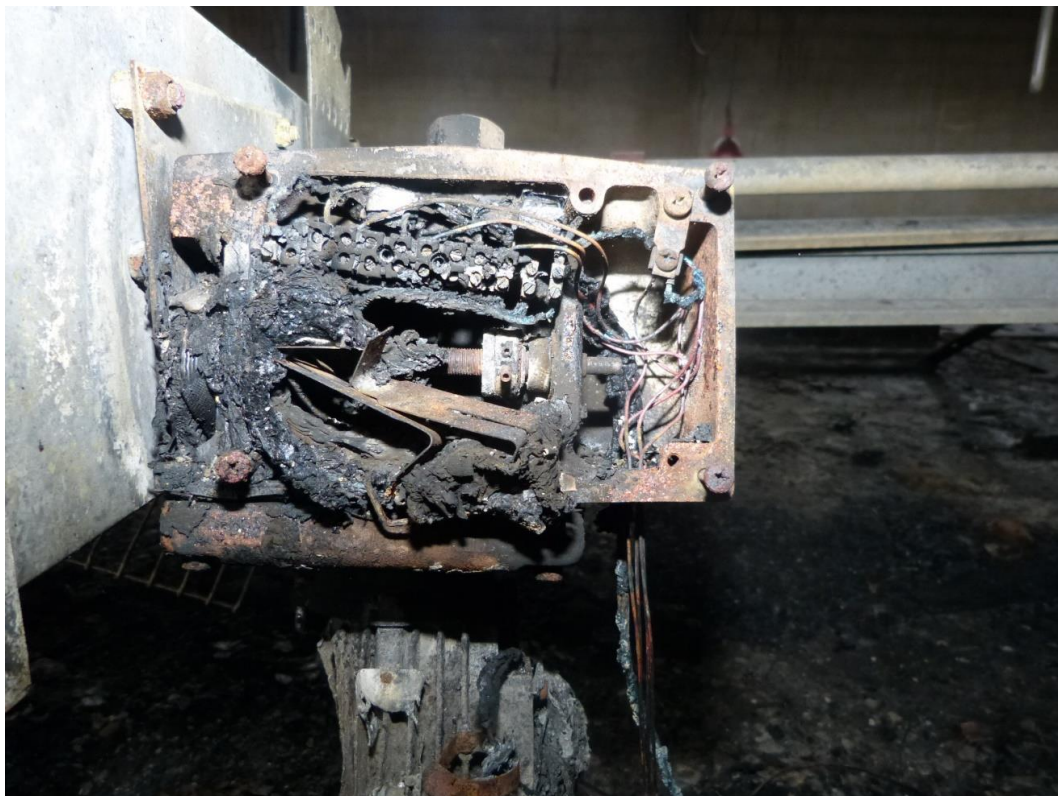
**Picture 25** - Damage of motor (tag #1) from front.

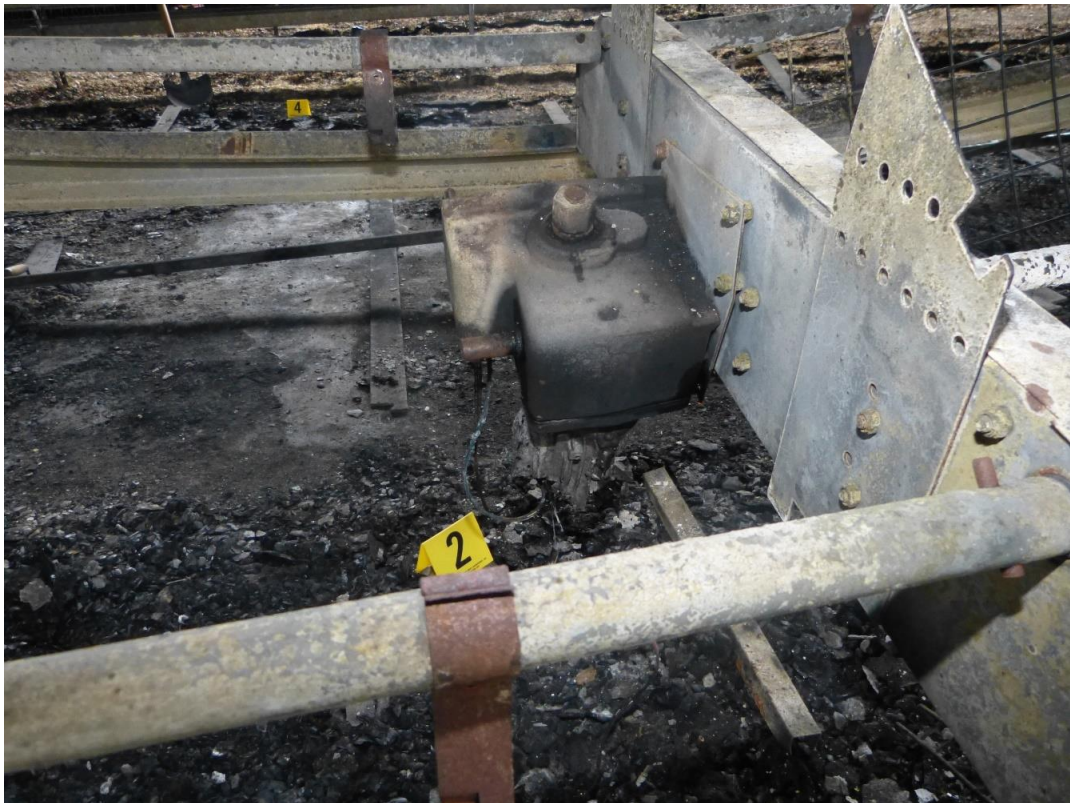
**Picture 26** - View of motor (tag #1) from top, west (top) to east (bottom) – transversal metal bar area behind the motor shows signs of protection, but motor shows signs of heat transfer from underneath (black), indicating heat/fire source from underneath.

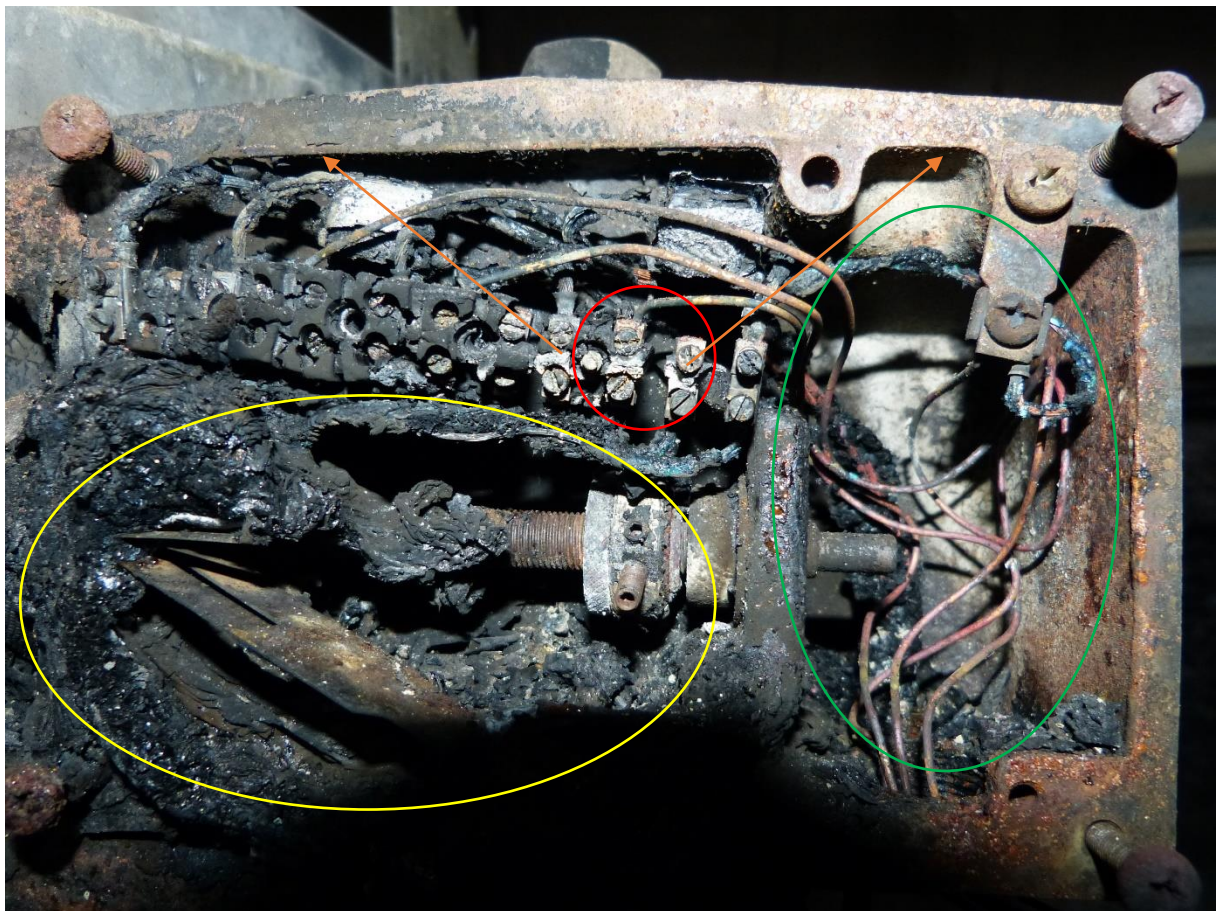
**Picture 29** - Close up view of motor (tag#1) – area with major damage (red circle) between 2<sup>nd</sup> and 3<sup>rd</sup> contact since the plastic of the connections is completely melted away, also from there, V-pattern (orange arrows) can be observed; radiant heat burn area (yellow ellipse); cables on the right of the picture (green area) have the protection completely melted, indication of high temperature impact.

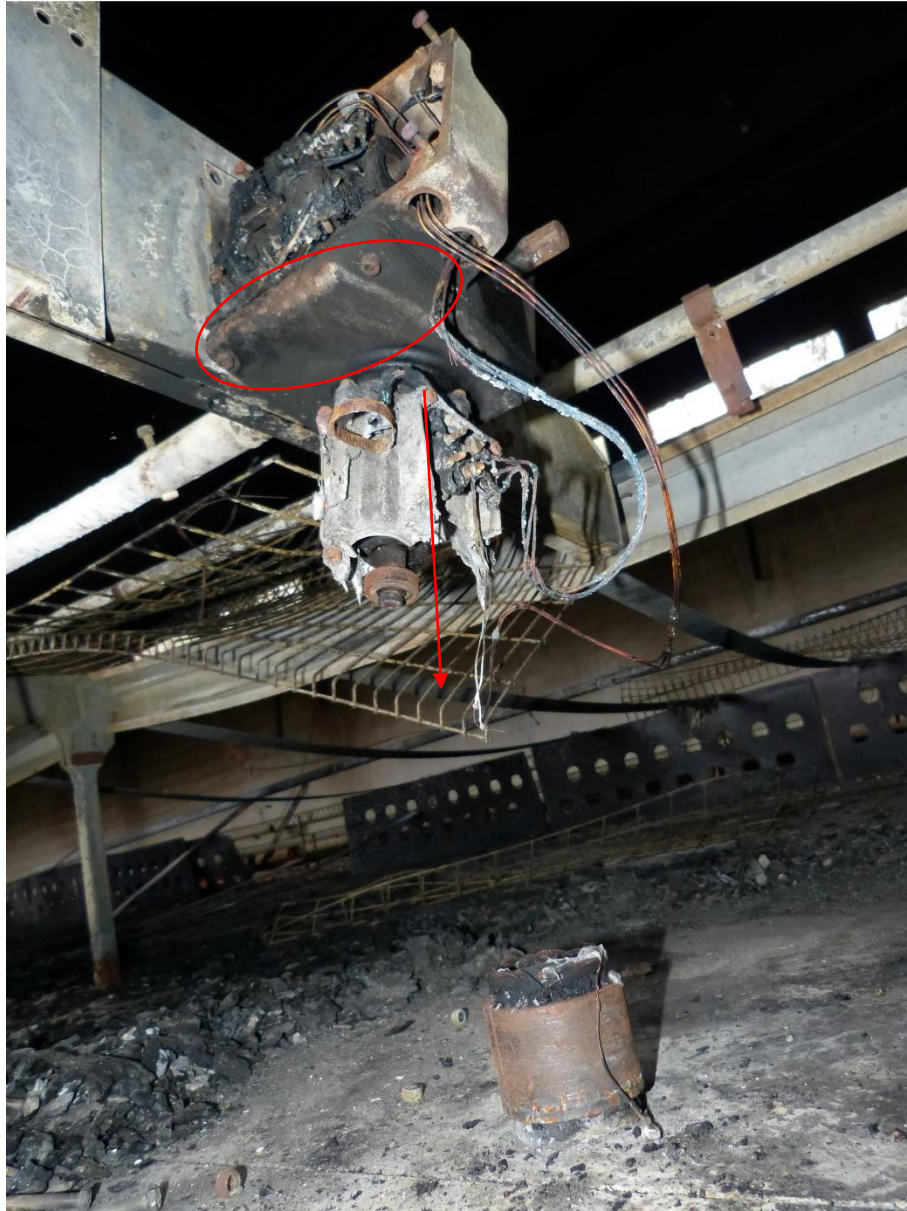
**Picture 30** - View of motor (tag#1) from bottom – black area underneath the motor (red ellipse) indicates heat source from underneath; drop-down of plastic underneath the motor (red arrow).

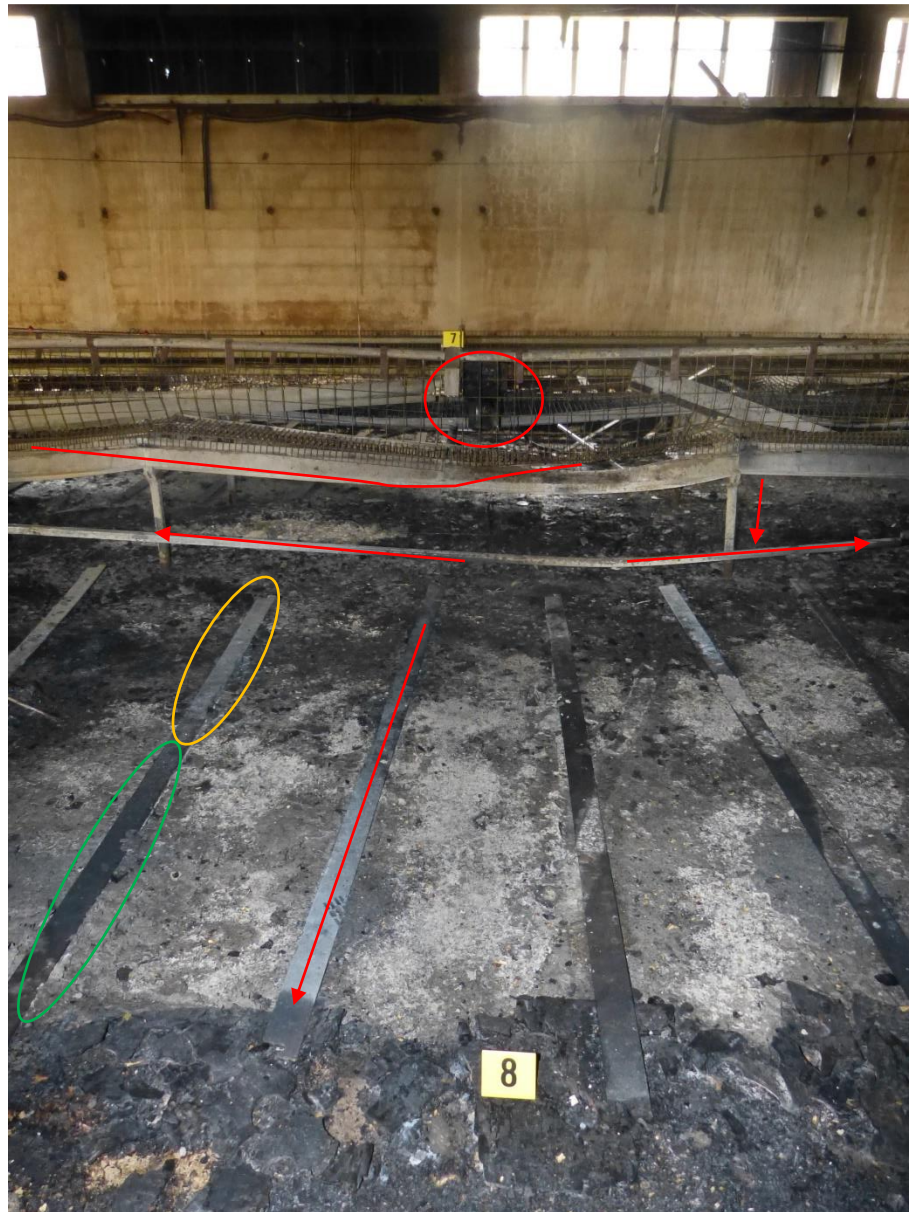
**Picture 33** - Tags #7 and #8, view from west (bottom) to east (top) – second potential seat of fire; red arrows indicate the probable direction of propagation of the fire, due to increasing damage levels in a concentric way towards one point (red circle), highest point of deformation of the metal bars, also signs of prolonged exposition to high temperatures, exposition signs are strong; metal bars on the floor show decreasing damage signs from top (east) to bottom (west).

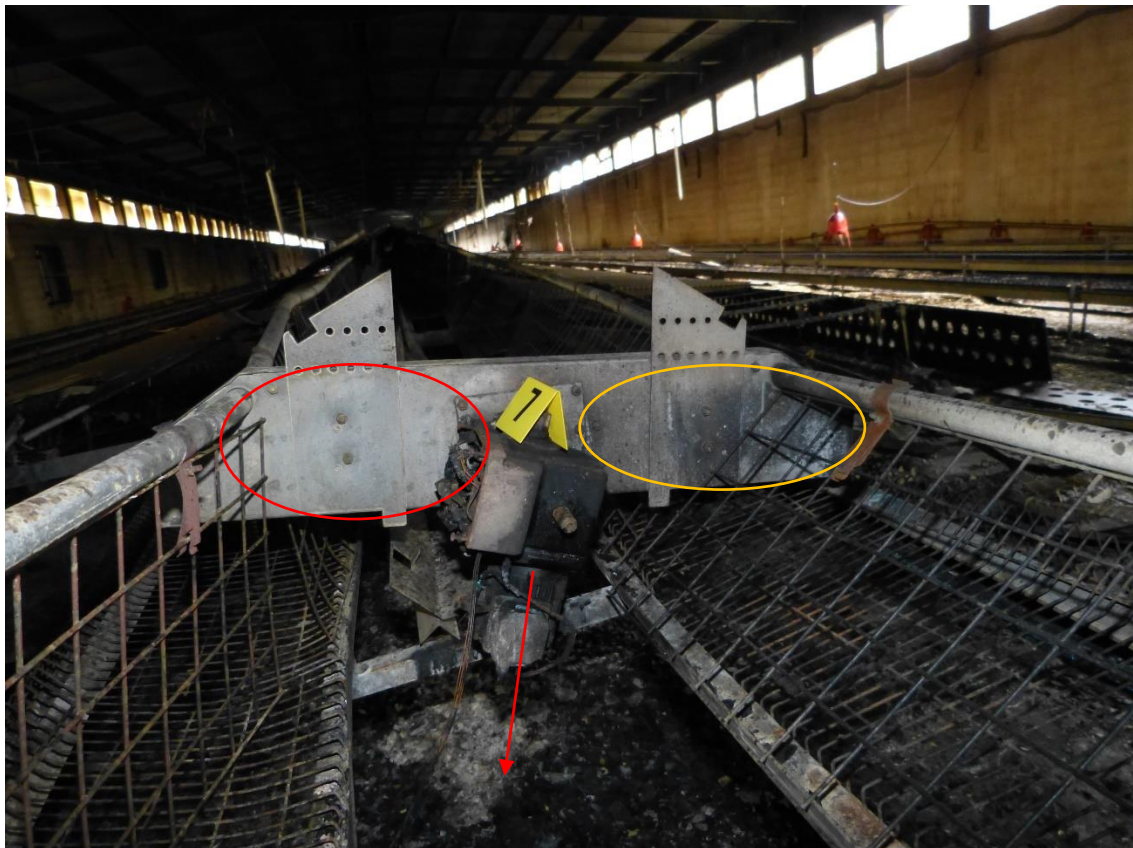
**Picture 35** - Tag #7, view from right side (south to north) – horizontal metal bar in middle shows clean burn pattern on left side (red circle), soot deposition of right side (orange ellipse), indicating direct flame contact on left side and radiant/convective heat damage on right.

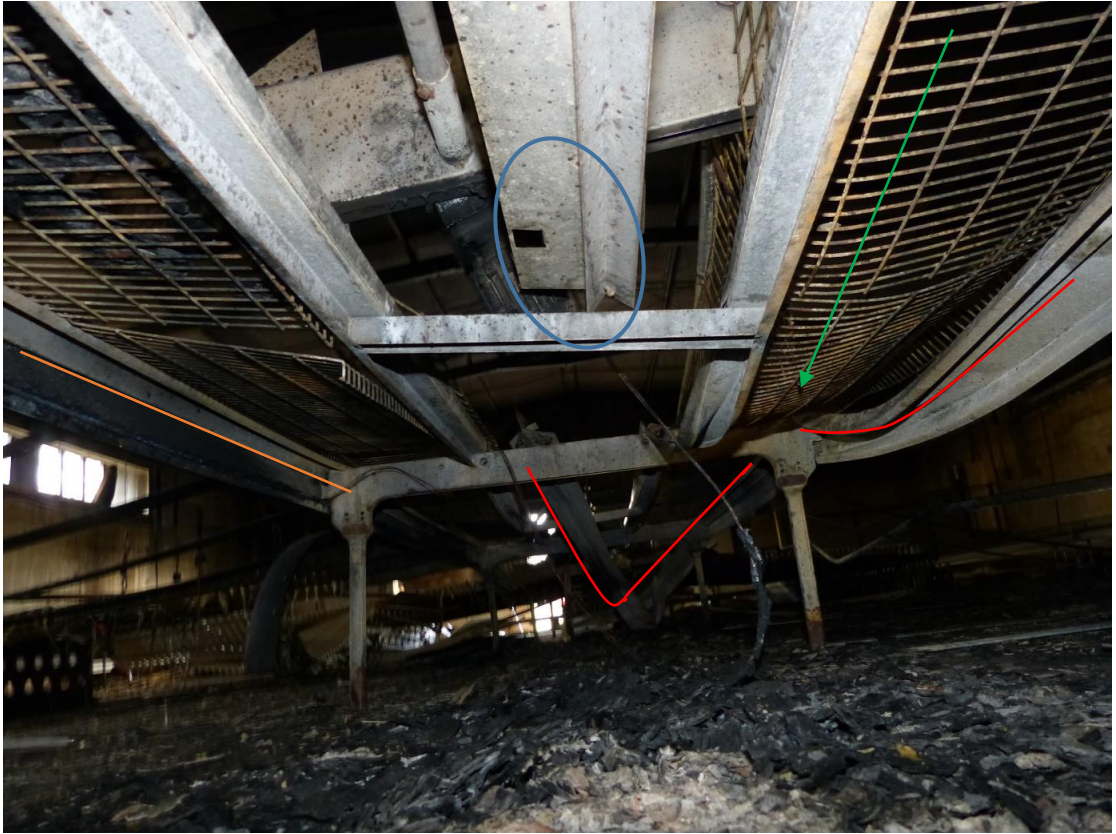
**Picture 36** -View of left side of tag #7 from bottom – high deformation of metal bars (red lines) on the right side (west) of the picture compared to the left side (east), indicating propagation direction towards west and not east from the motor (blue ellipse); increased oxidation levels of metal fence towards the motor (green arrow), pointing to the point of origin.

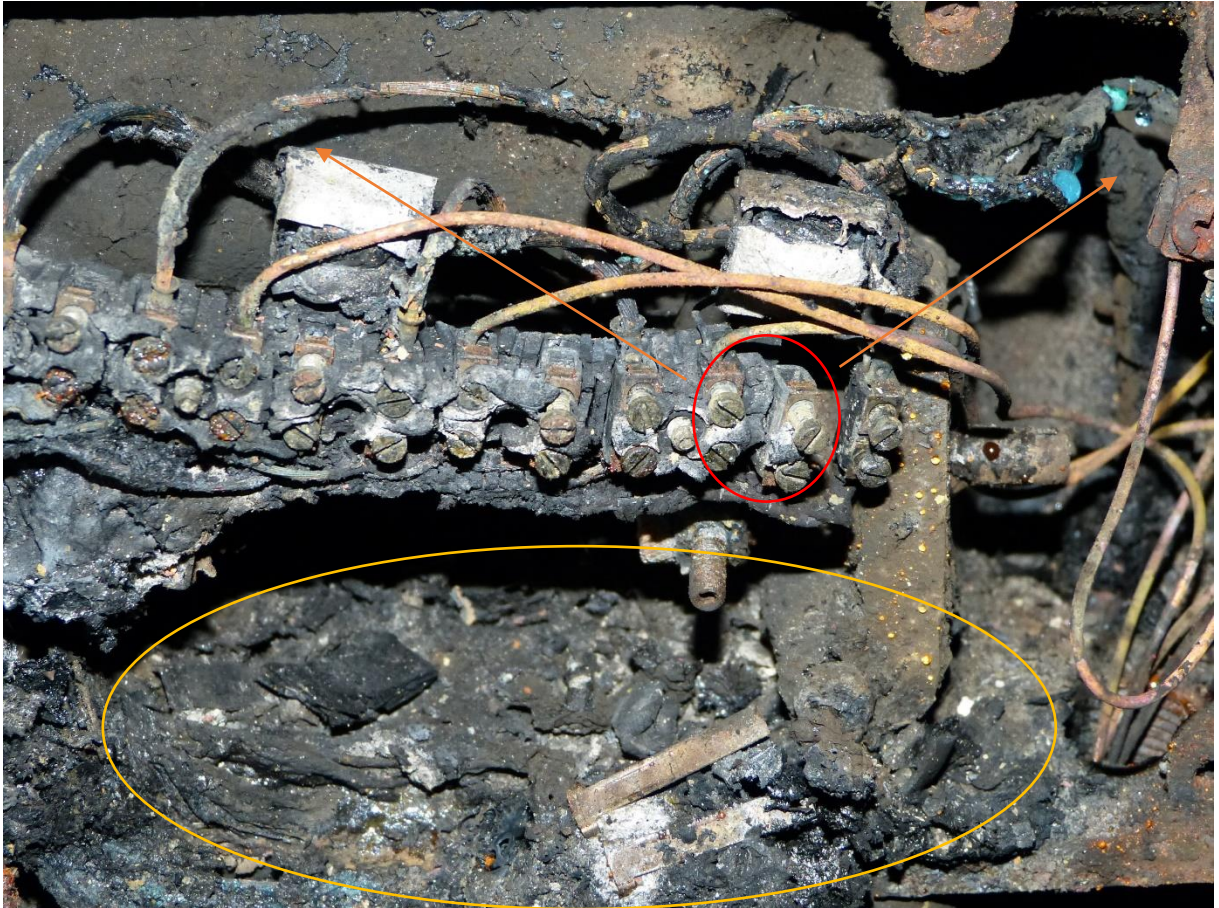
**Picture 38** - Close up view of motor (tag#7) – highest degree of damage between 2<sup>nd</sup> and 3<sup>rd</sup> contact (red circle), from there V-pattern can be observed on the levels of damage; radiant heat damage on the part below the contacts (orange ellipse).

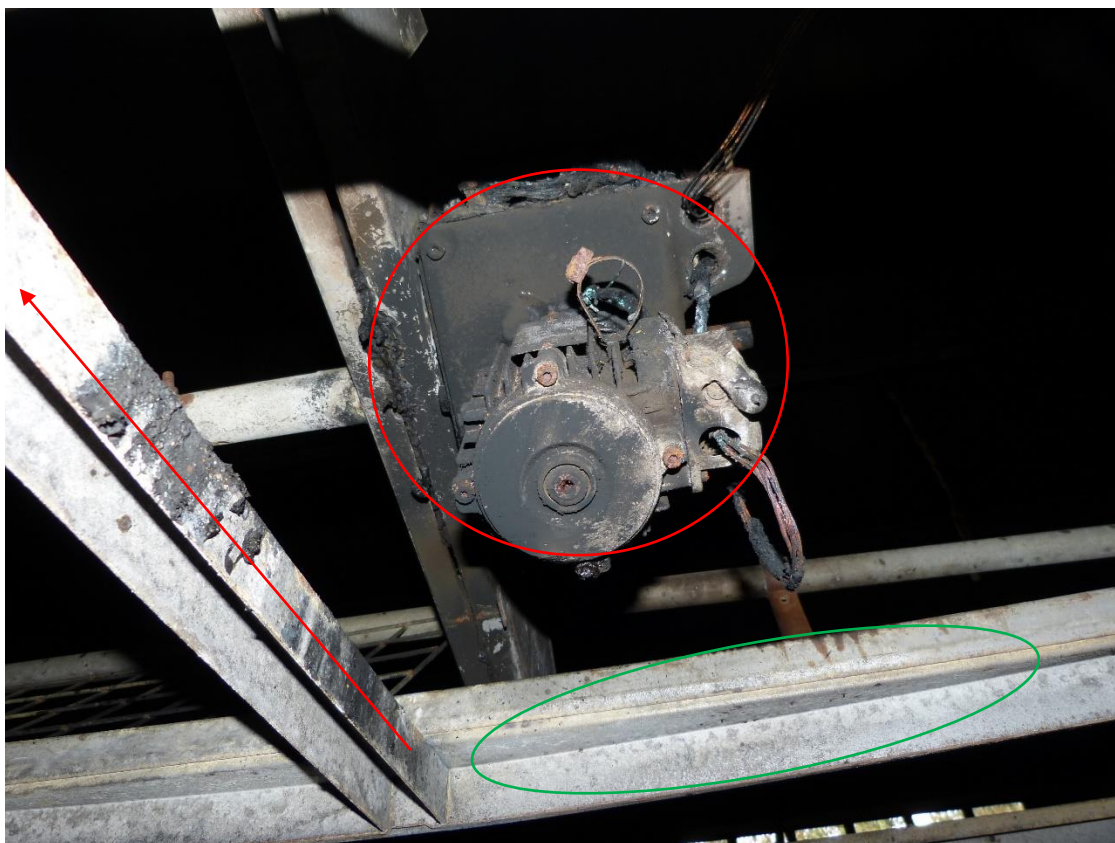
**Picture 40** -View from underneath of motor (tag#7) – high soot deposition levels underneath the engine, showing convective heat damage (red circle); decreasing damage from there outwards (red arrow); protected area behind the motor (green ellipse).
