# **MASTER THESIS**

***“Contribution to Portuguese Urban Fire Investigations  
– Forensic Fire Debris Analysis”***

**STEFANIA OLIVERIO**

**JULY 2016**

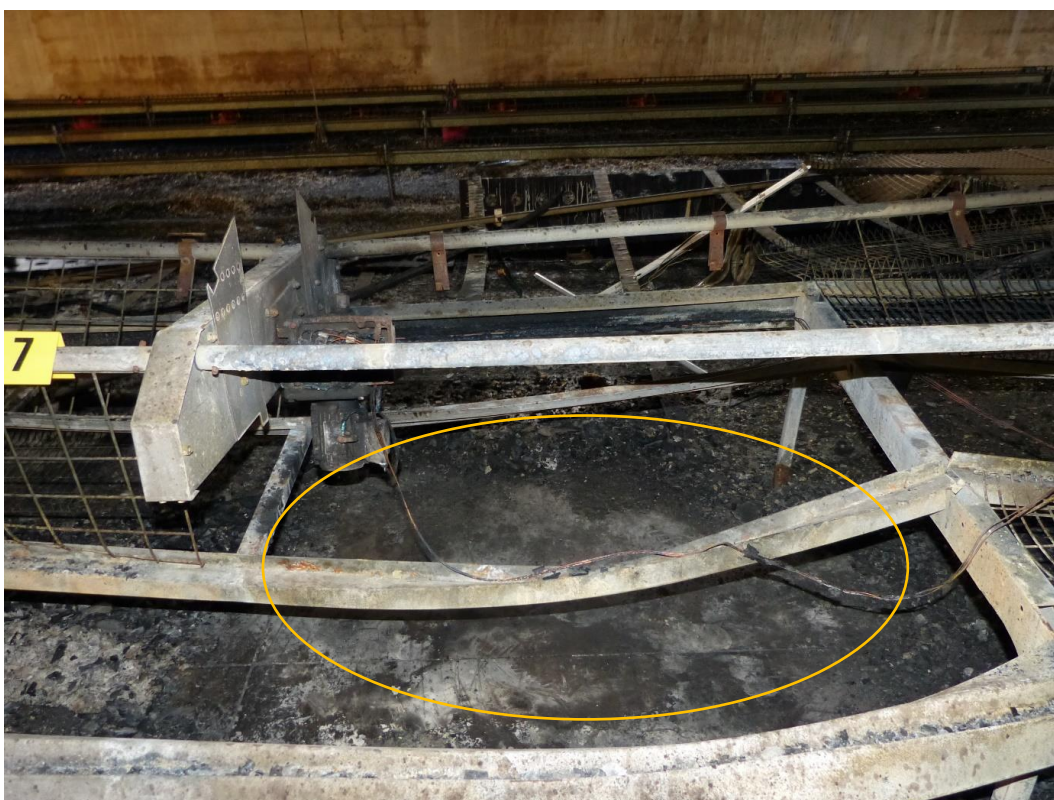
**Picture 41** -View of floor underneath motor (tag#7) – no visible signs of presence of ignitable liquids (orange ellipse).

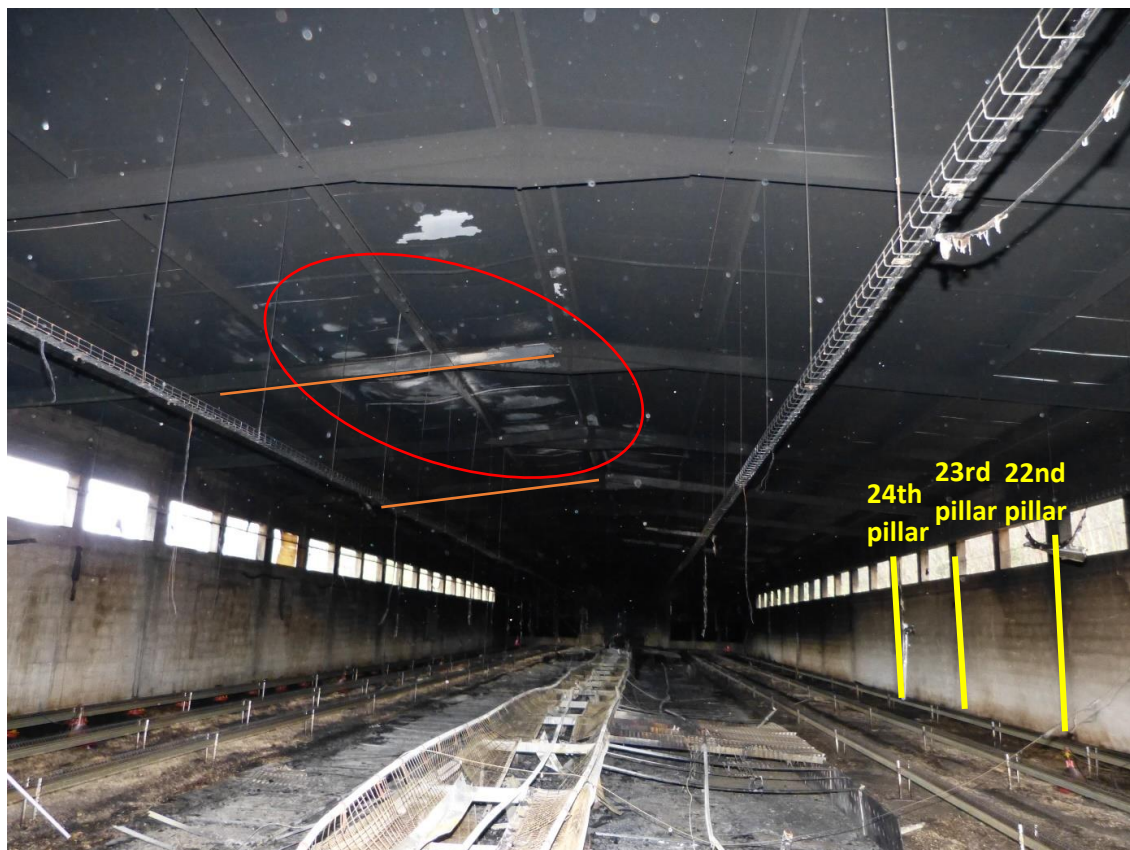
**Picture 43** - View of rear part of pavilion – damage on ceiling (red circle) coincides with a direct flame contact for a longer period of time, which is due to the presence of curtains in those points (orange lines), which worked as a barrier for the fire, until the curtain was melted and the fire could 'carry on'.

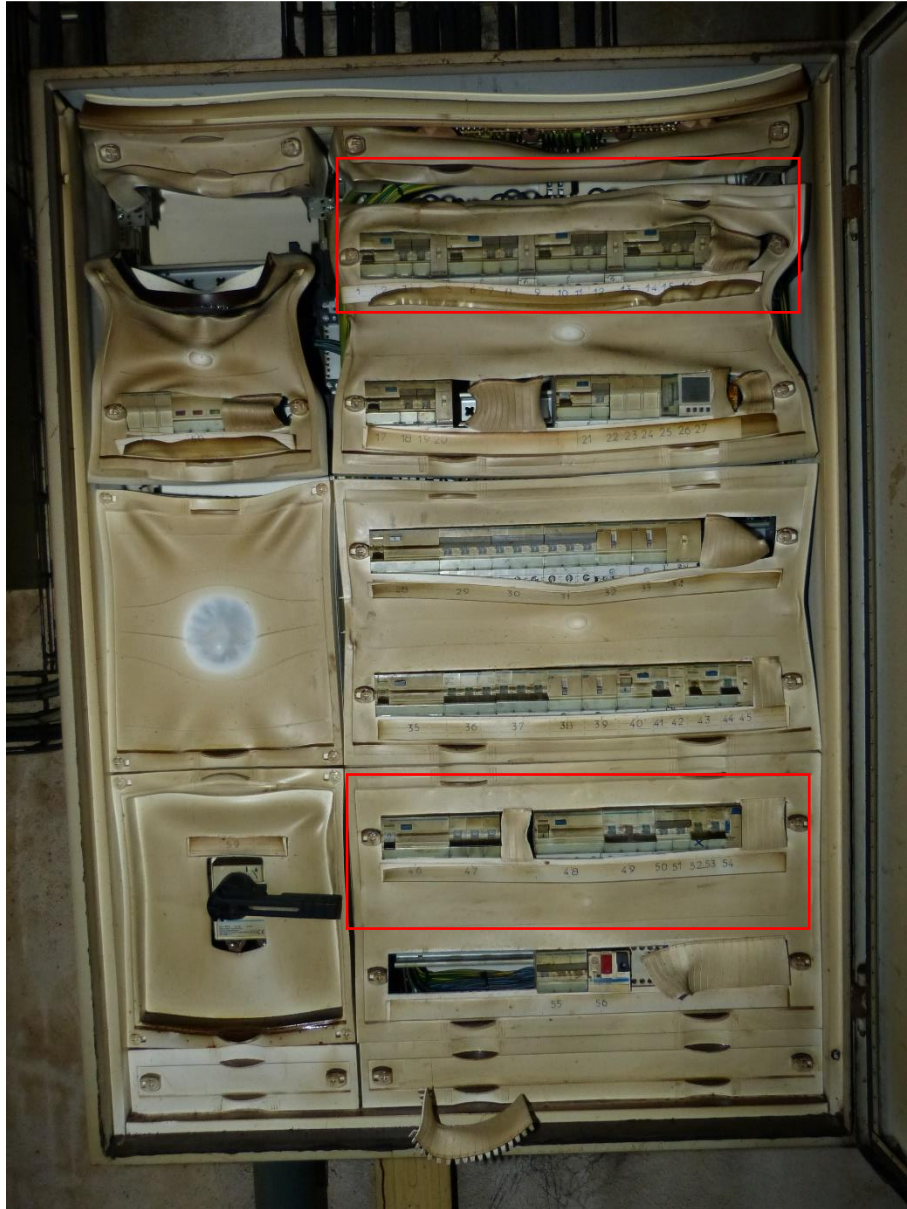
**Picture 46** - Electrical box – red rectangles mark the areas repaired by the electrician.

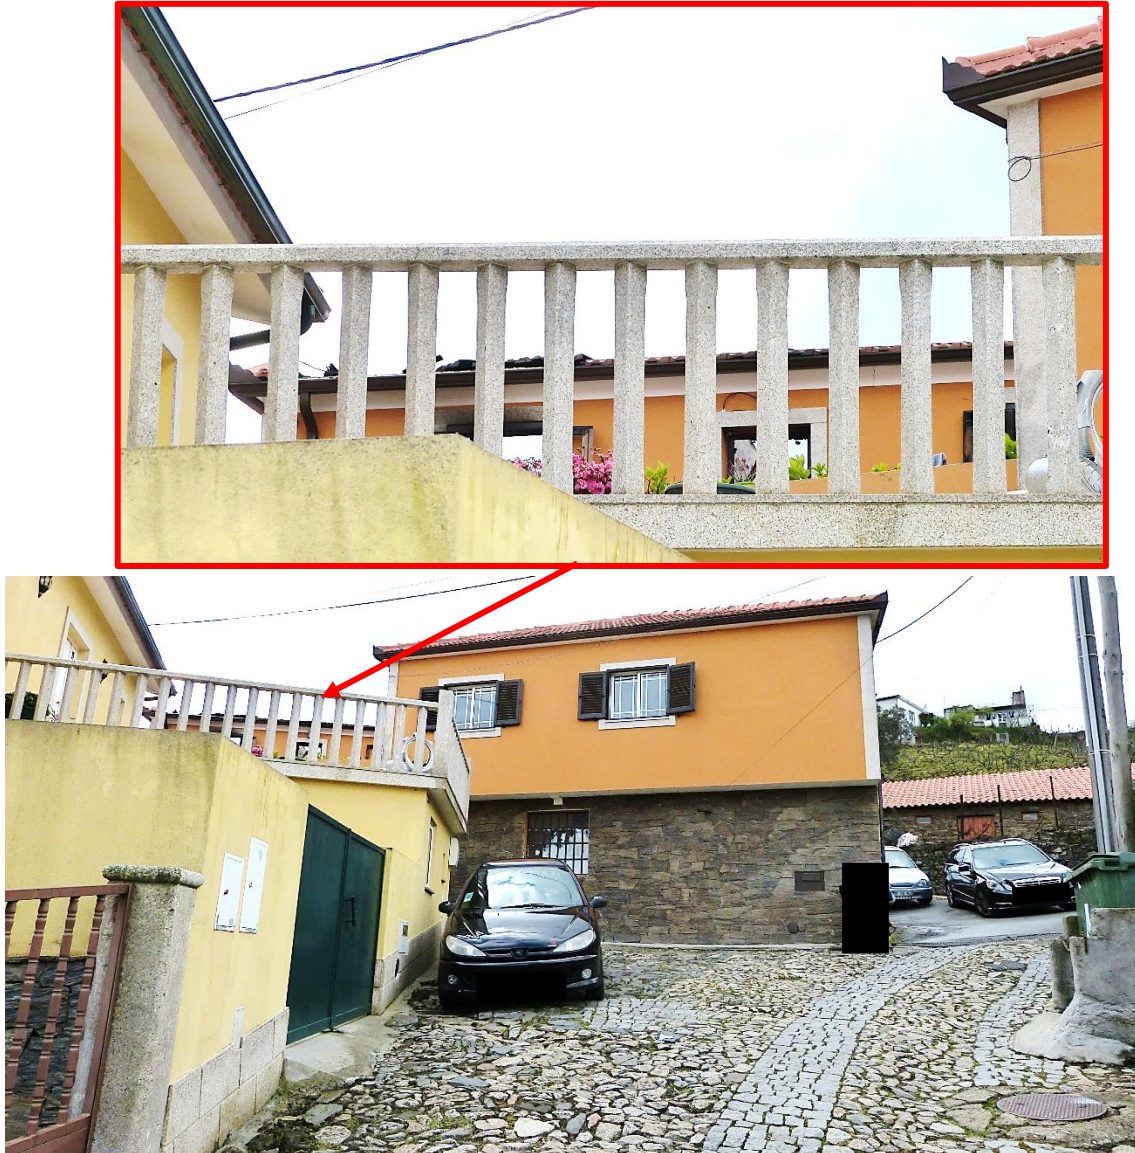
**Picture 01** – Outer view of the house where the fire occurred: damages were only recorded in the area where the bedrooms were located.

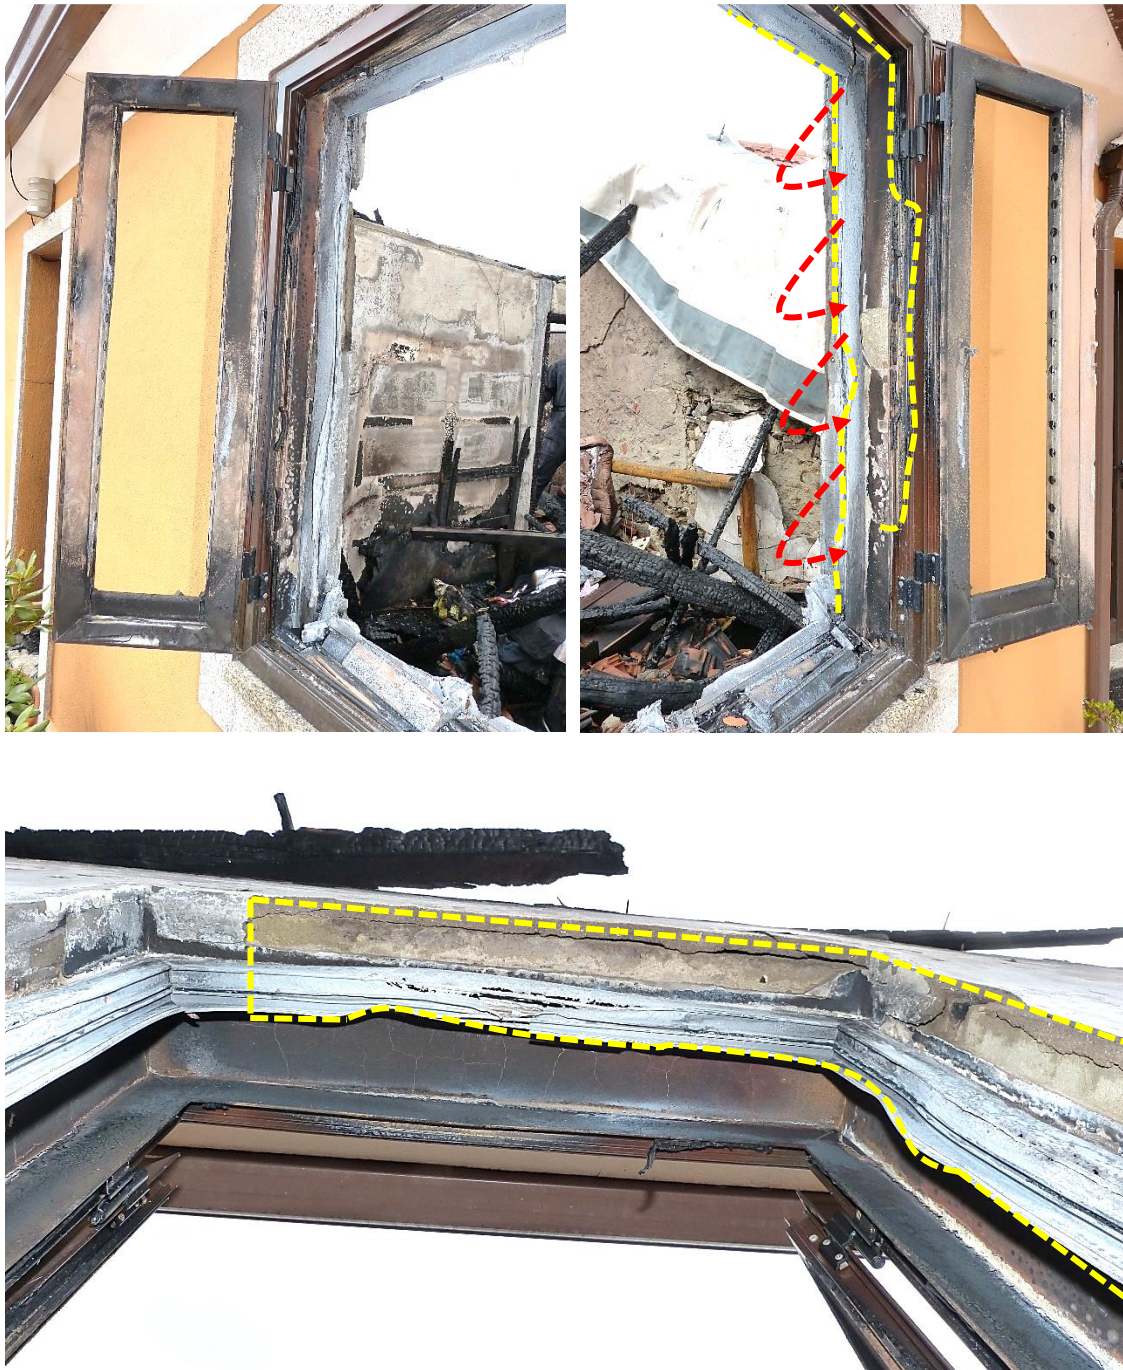
**Picture 06** – The master bedroom window shows, albeit to a lesser extent, a higher concentration of the damage on the right side of the aluminum frames –yellow frame-, in line with the incidence of a low heat source with intensity but slowly – red arrows - from a point below and located on that side.

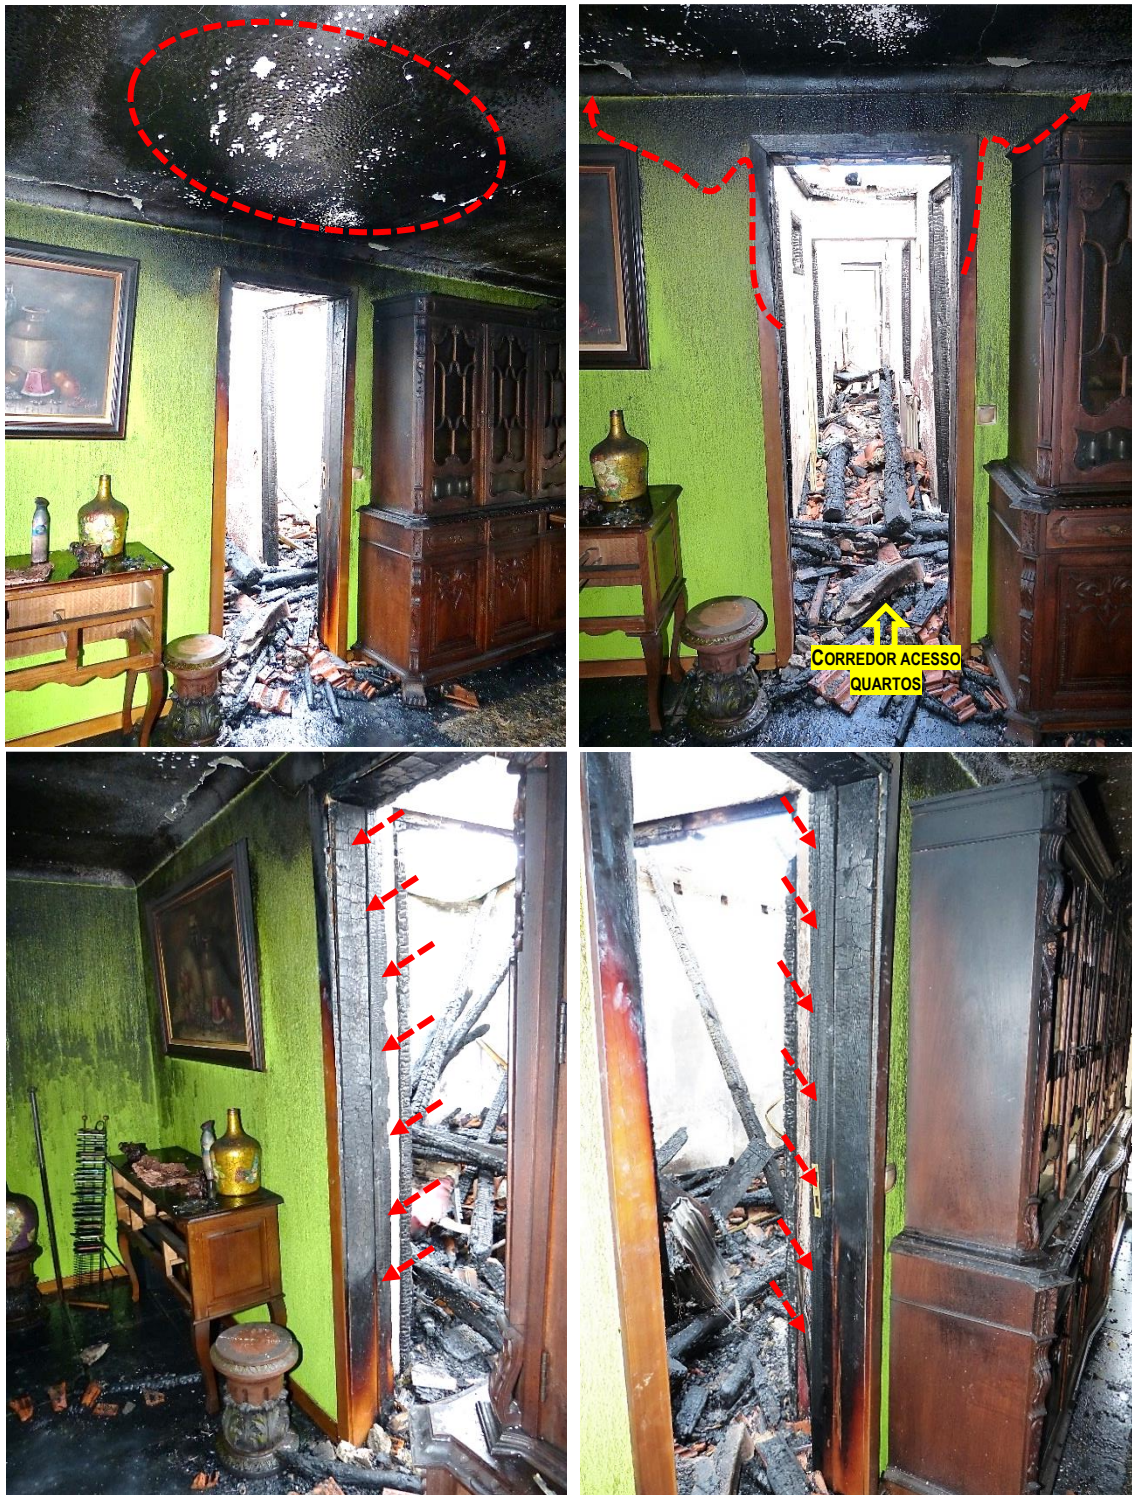
**Picture 09** – In detail the damage to the ceiling –red circle - and the door frame of the access door to the corridor to the rooms -which was closed- showing the carbonization of the material downwards in the course of propagation of combustion –red arrows - in consequence of the convection currents.

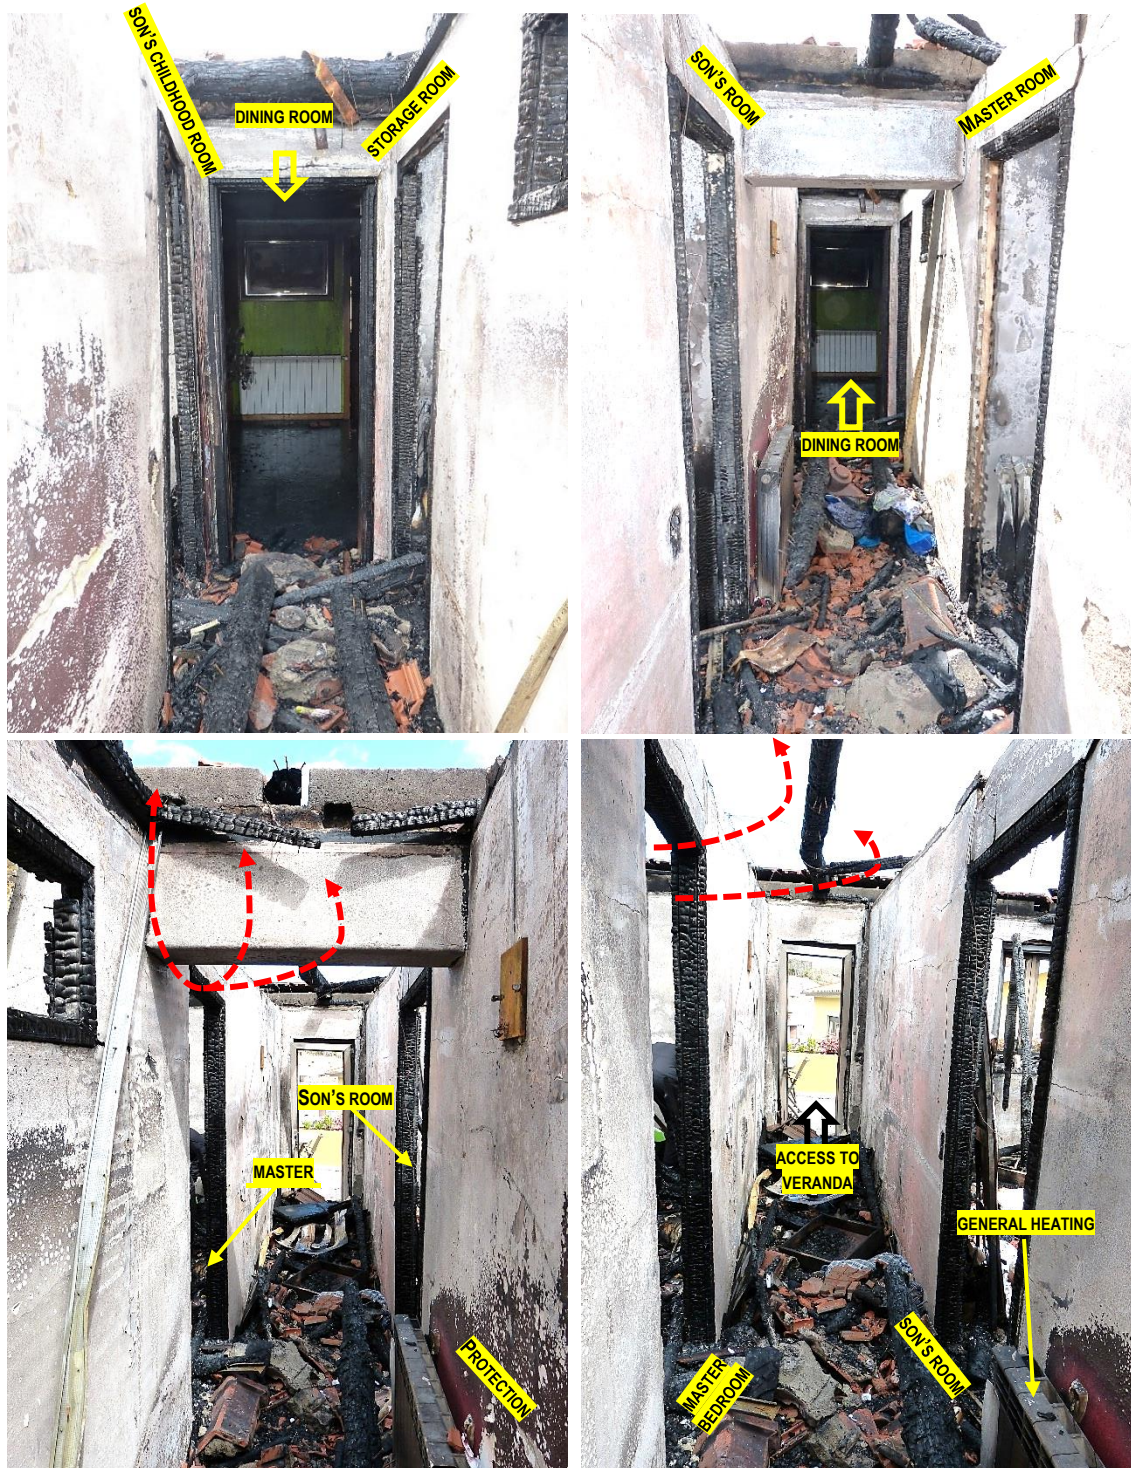
**Picture 10** – In the corridor uniformity in the degree of damage is observable, confirming that the heat transfer occurs mainly by the upper area - full destruction of the false ceiling and cover- it is possible to see greater protection areas at a low level with the presence of the original paint on the walls and the preservation of the central heating.

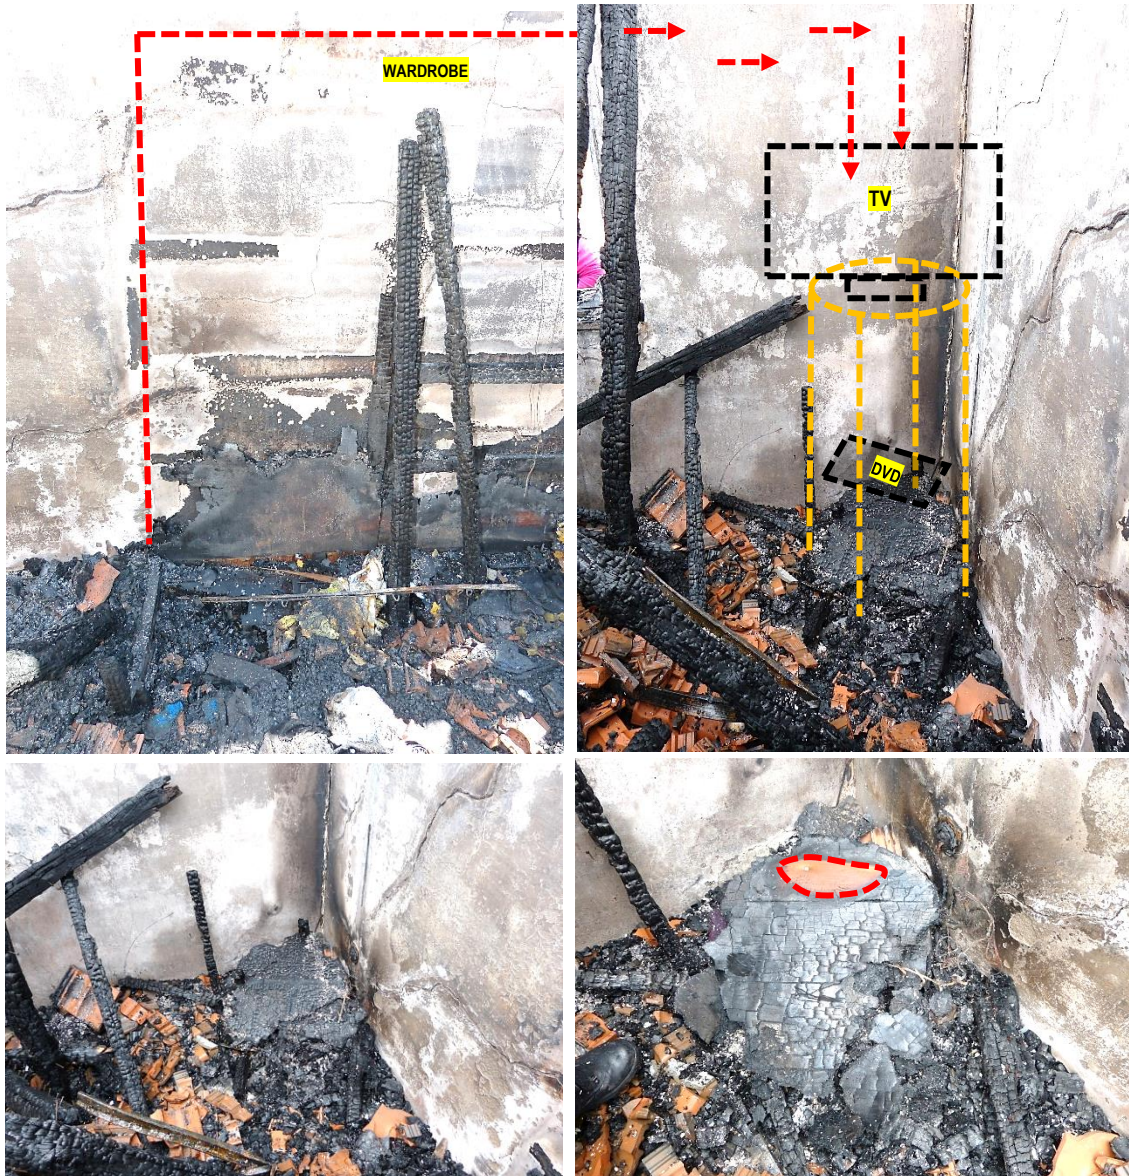
**Picture 14** – Corner of the area, where remains of the table are found (orange lines to simulate the location), that show on the top a protected zone, coinciding with the position of the "foot" of the TV –red circle- which indicates a consumption of the structures in a downward direction red arrows.

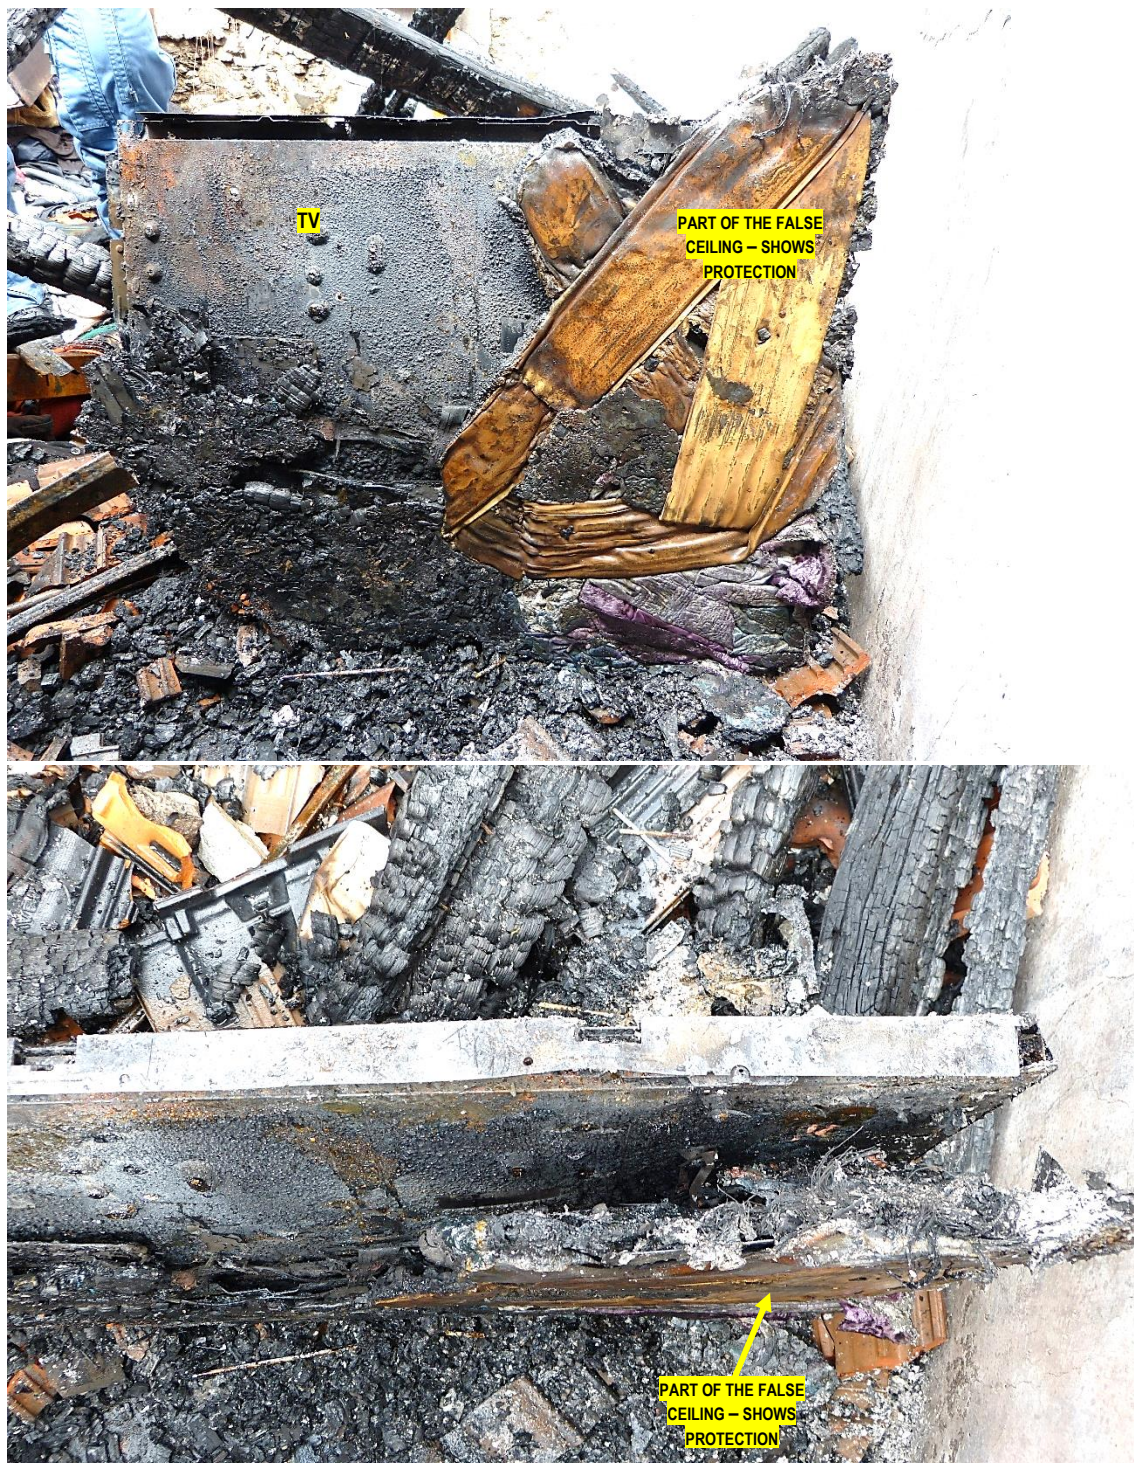
**Picture 16** – TV recovered in the debris, which had fallen in front of the table. Underneath the device -due to melting- a section of the false ceiling was identified, which fell on the floor due to the heat received by the spread of the fire before the fall of the TV.

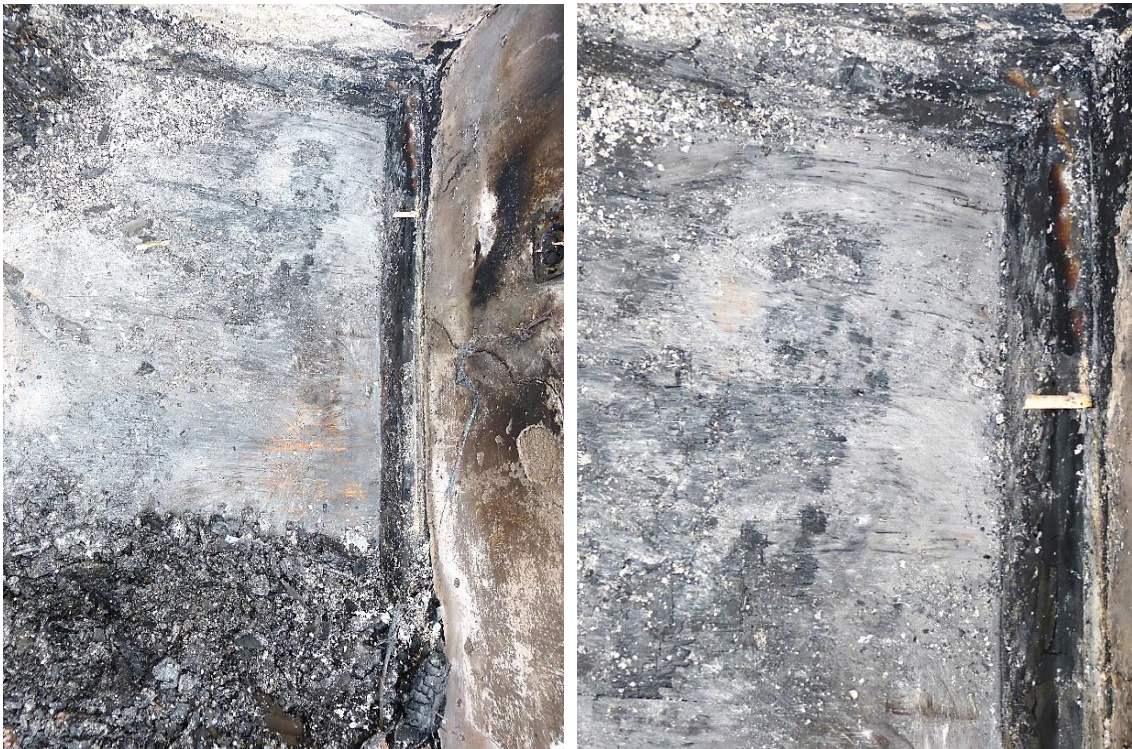
**Picture 18** – Detailed view of the floor where the table was located (see previous photos). After removing the debris, there was the absence of any damage to the floor level, which allows us to exclude that a fire started at that point, especially with the use of an ignitable liquid as a fire accelerant.

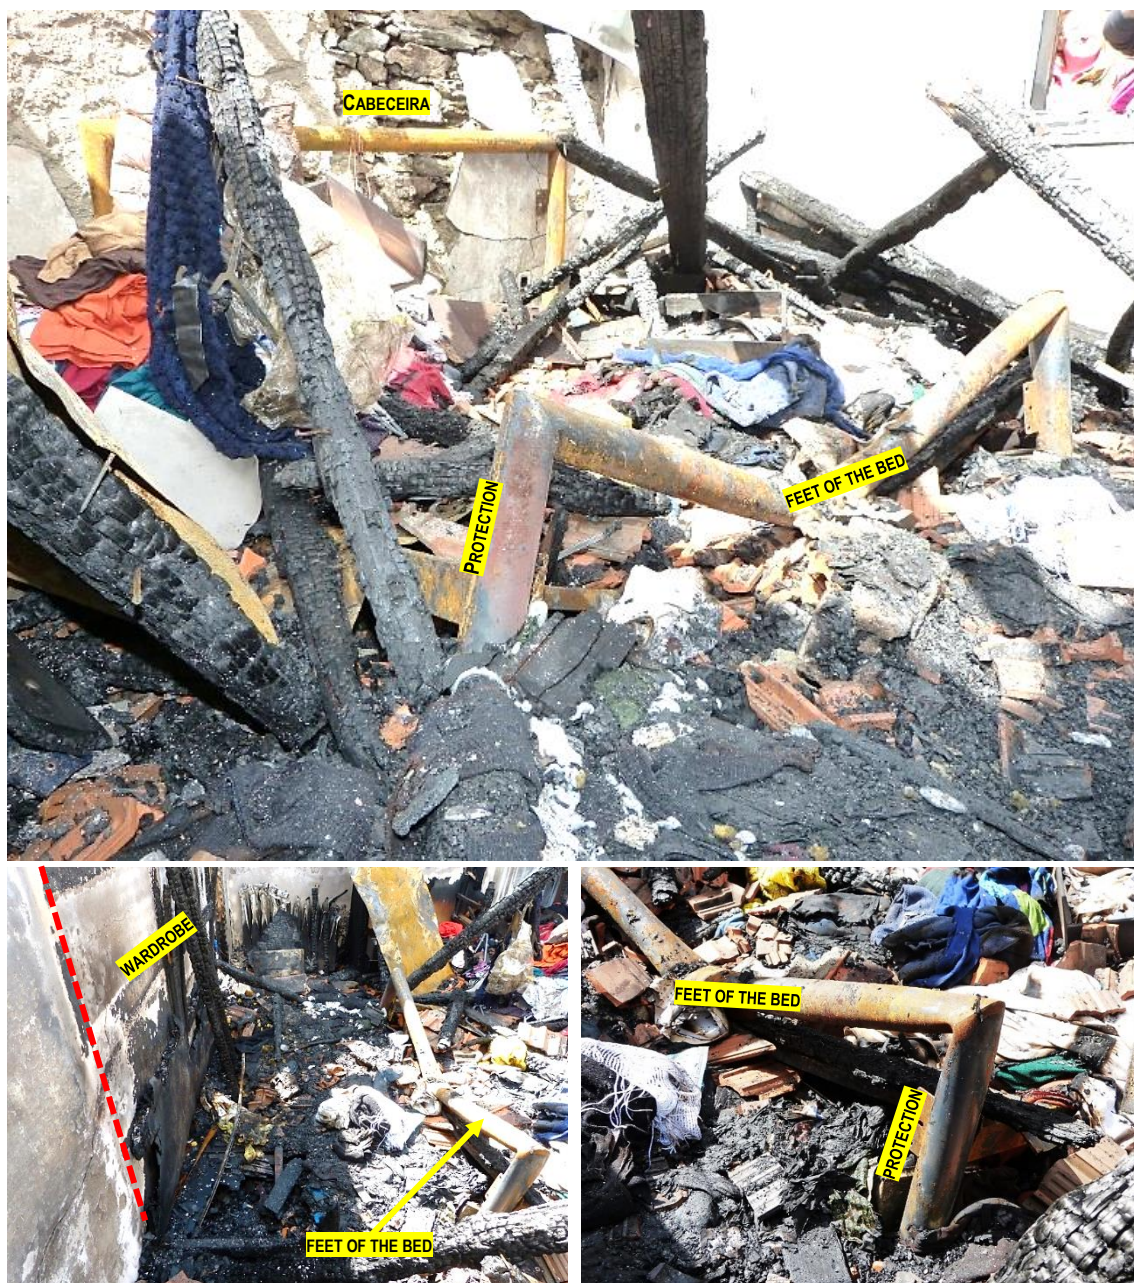
**Picture 19** – Perspective of the couple's bed, metal frame, identifying different degrees of damage. In the horizontal bar and the support feet a low degree of oxidation on the face exposed to the wardrobe and the table is observable, confirming their remoteness from the initial point of combustion on the head, where a higher degree of damage is visible.

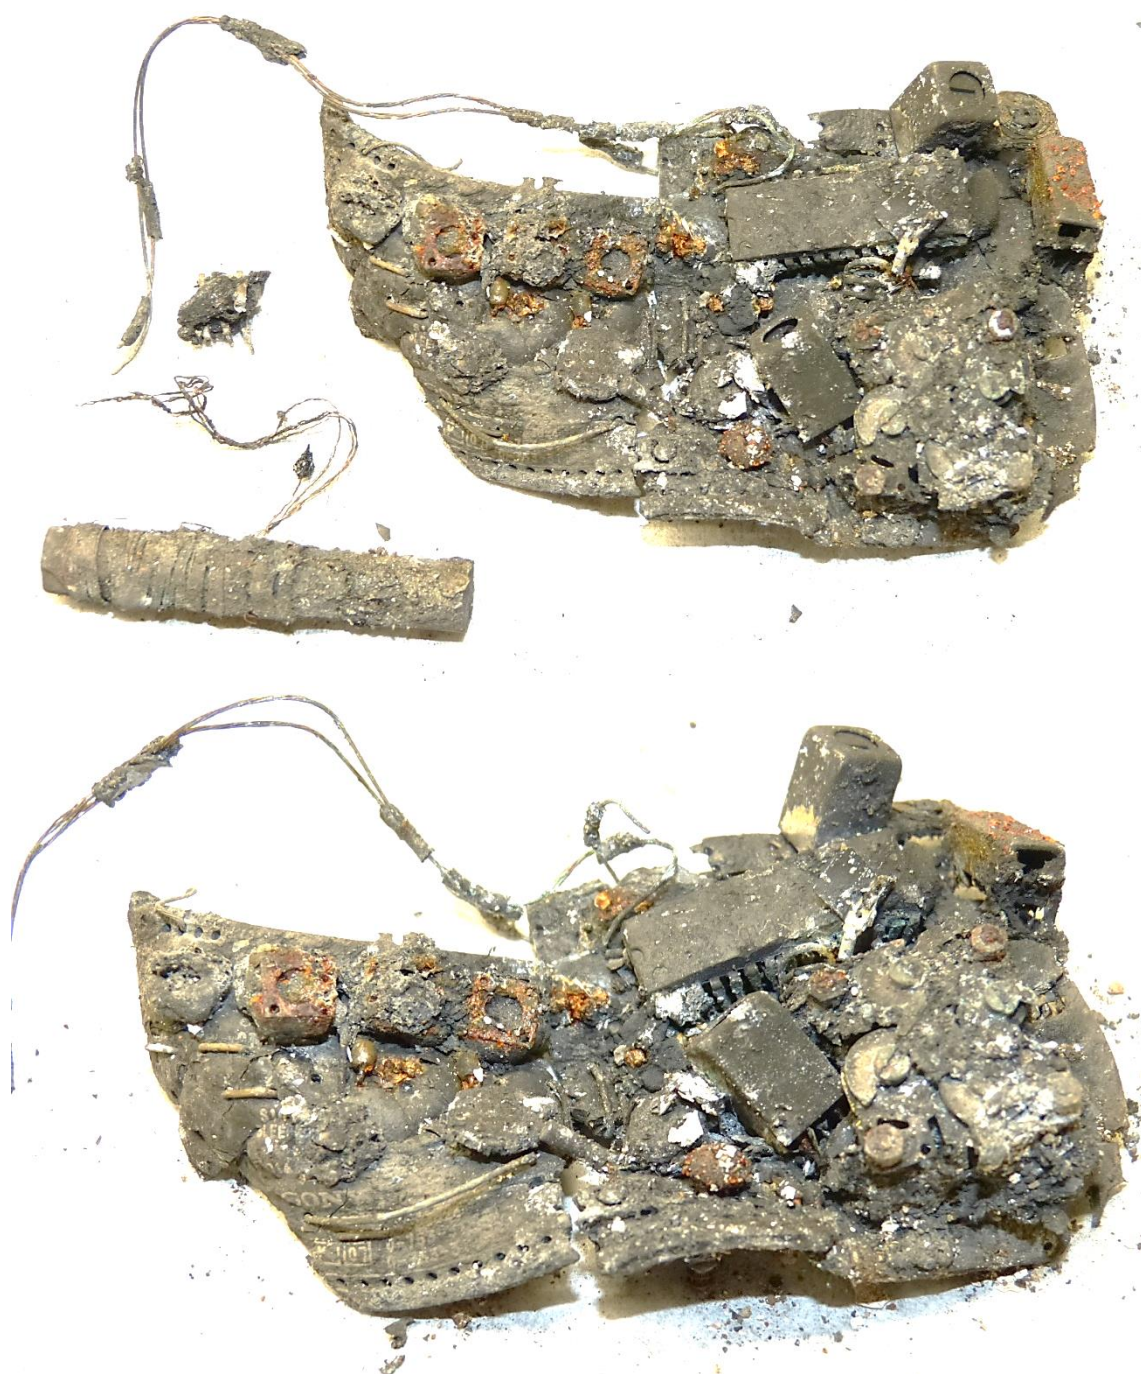
**Picture 24** – Detailed view of the remains of the electrical components belonging to the alarm clock after cleaning of the fire debris. Homogeneous damages can be observed, which result from the reception of an external heat source.

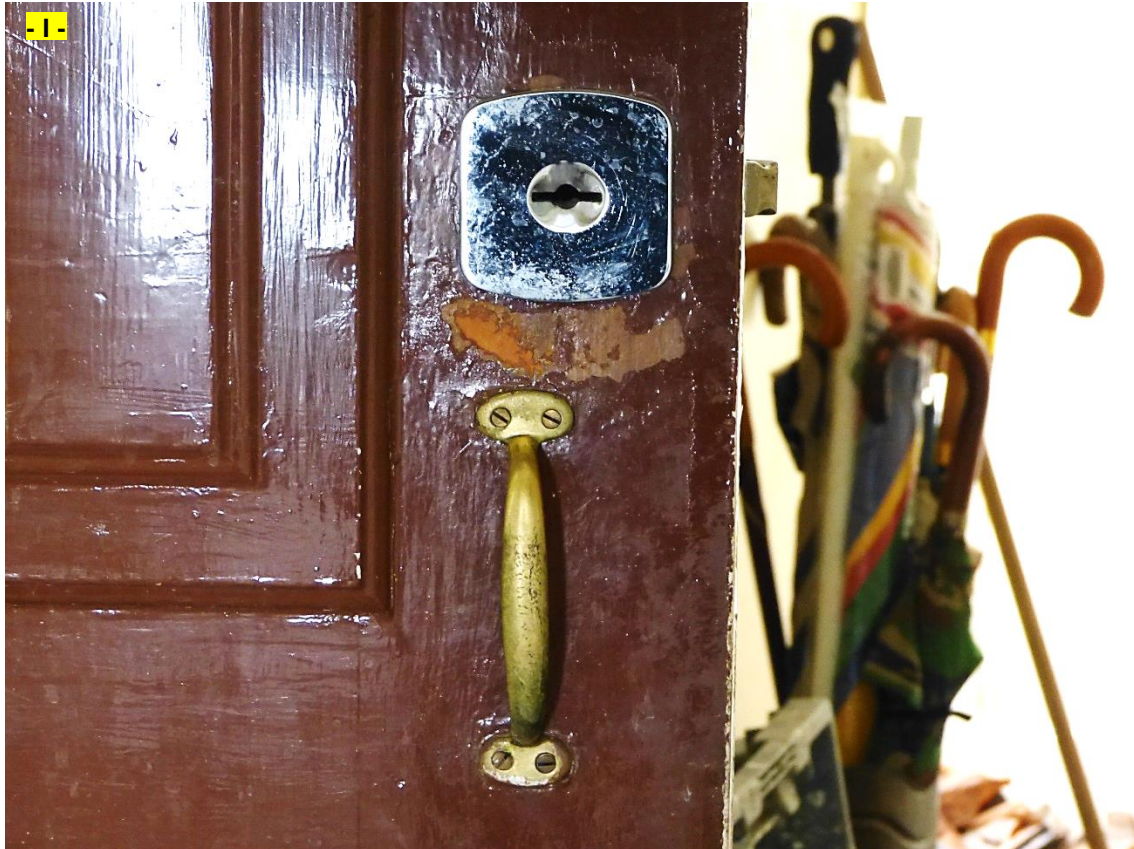
**Picture 03** – Detailed view of the lock from the outside (I), the main frame (II) and the connecting part on the other side of the door (III) – no signs of forced entry.

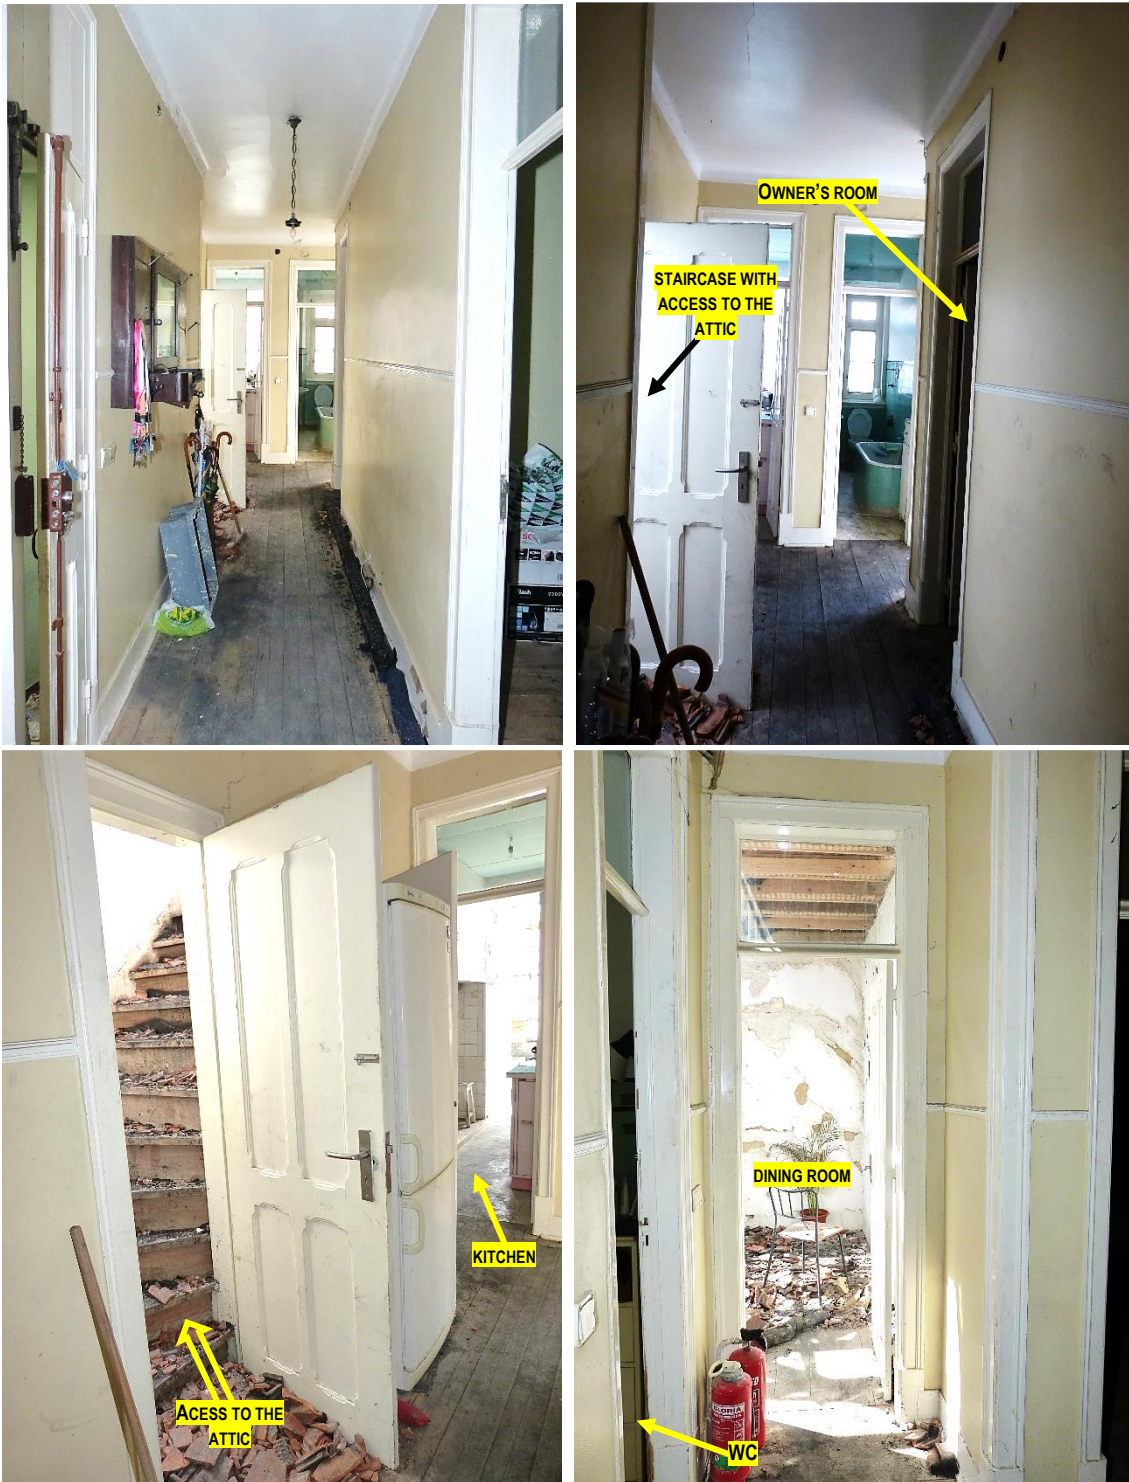
**Picture 04** – View of the apartment’s entrance hall, where it is observed that there is no damage from the spread of fire, except at the level of the area in the living room corresponding to the damaged area in the attic, which resulted from collapse of the false ceiling, indicating the development of the fire from the top floor -attic-.

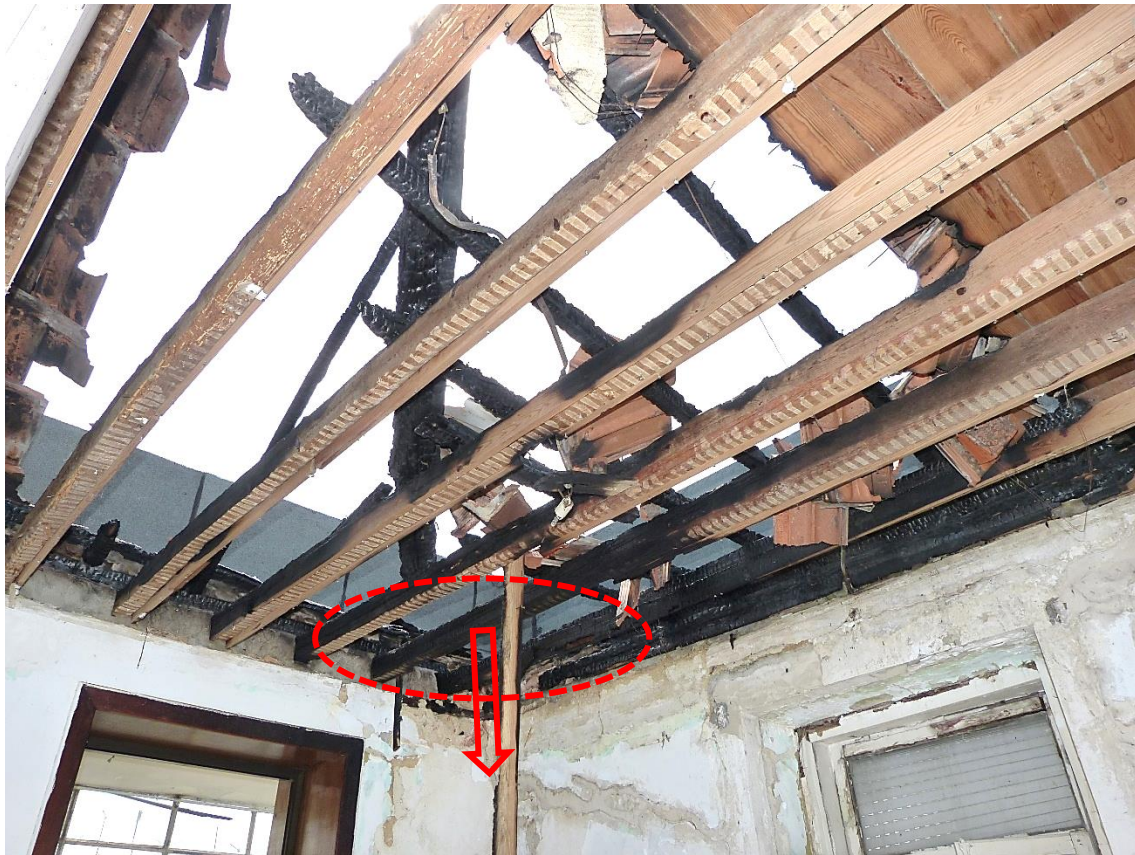
**Picture 05** – Inside of the dining room, observing a degree of complete destruction of the ceiling and the main wooden structure between the floors. Accordingly, it appears that the lower face is protected, consistent with heat acting downwards from an upper level, the attic. This damage is particularly visible at the corner, where it is limited and the degree of carbonization of the structures is higher, resulting from its proximity to a circular point of origin – red circle. Yellow circle indicates tag#3, where a sample was collected for laboratory analysis.

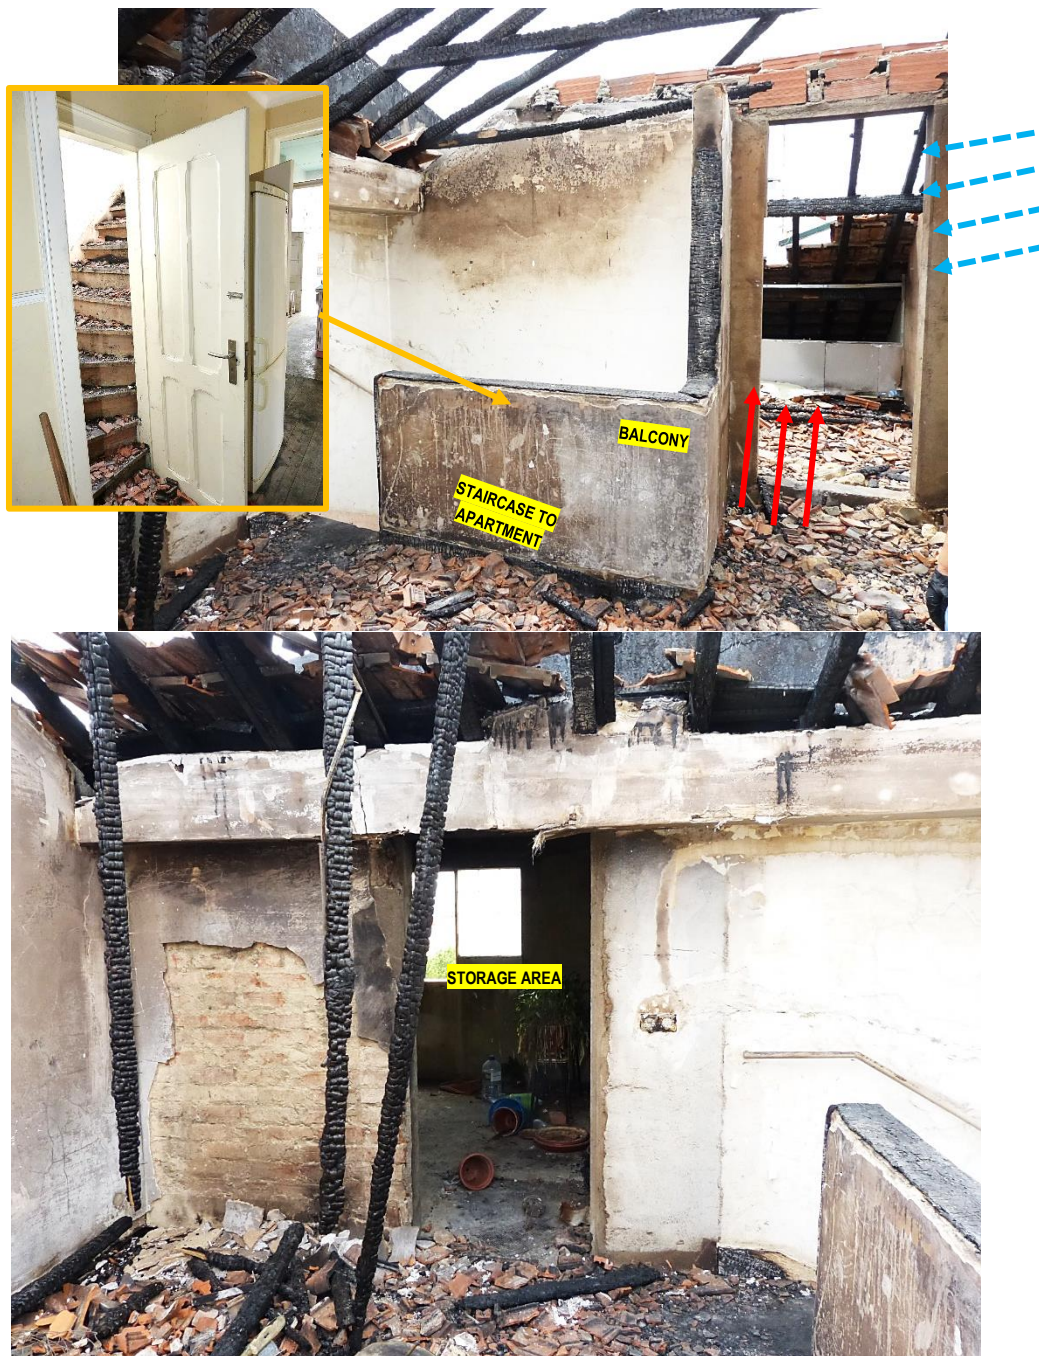
**Picture 07** – Area of the attic with access to the stairs to the apartment. Especially on the balcony damage indicators of both directions of propagation are visible, meaning they originate from opposite points.
