# **MASTER THESIS**

***“Contribution to Portuguese Urban Fire Investigations  
– Forensic Fire Debris Analysis”***

**STEFANIA OLIVERIO**

**JULY 2016**

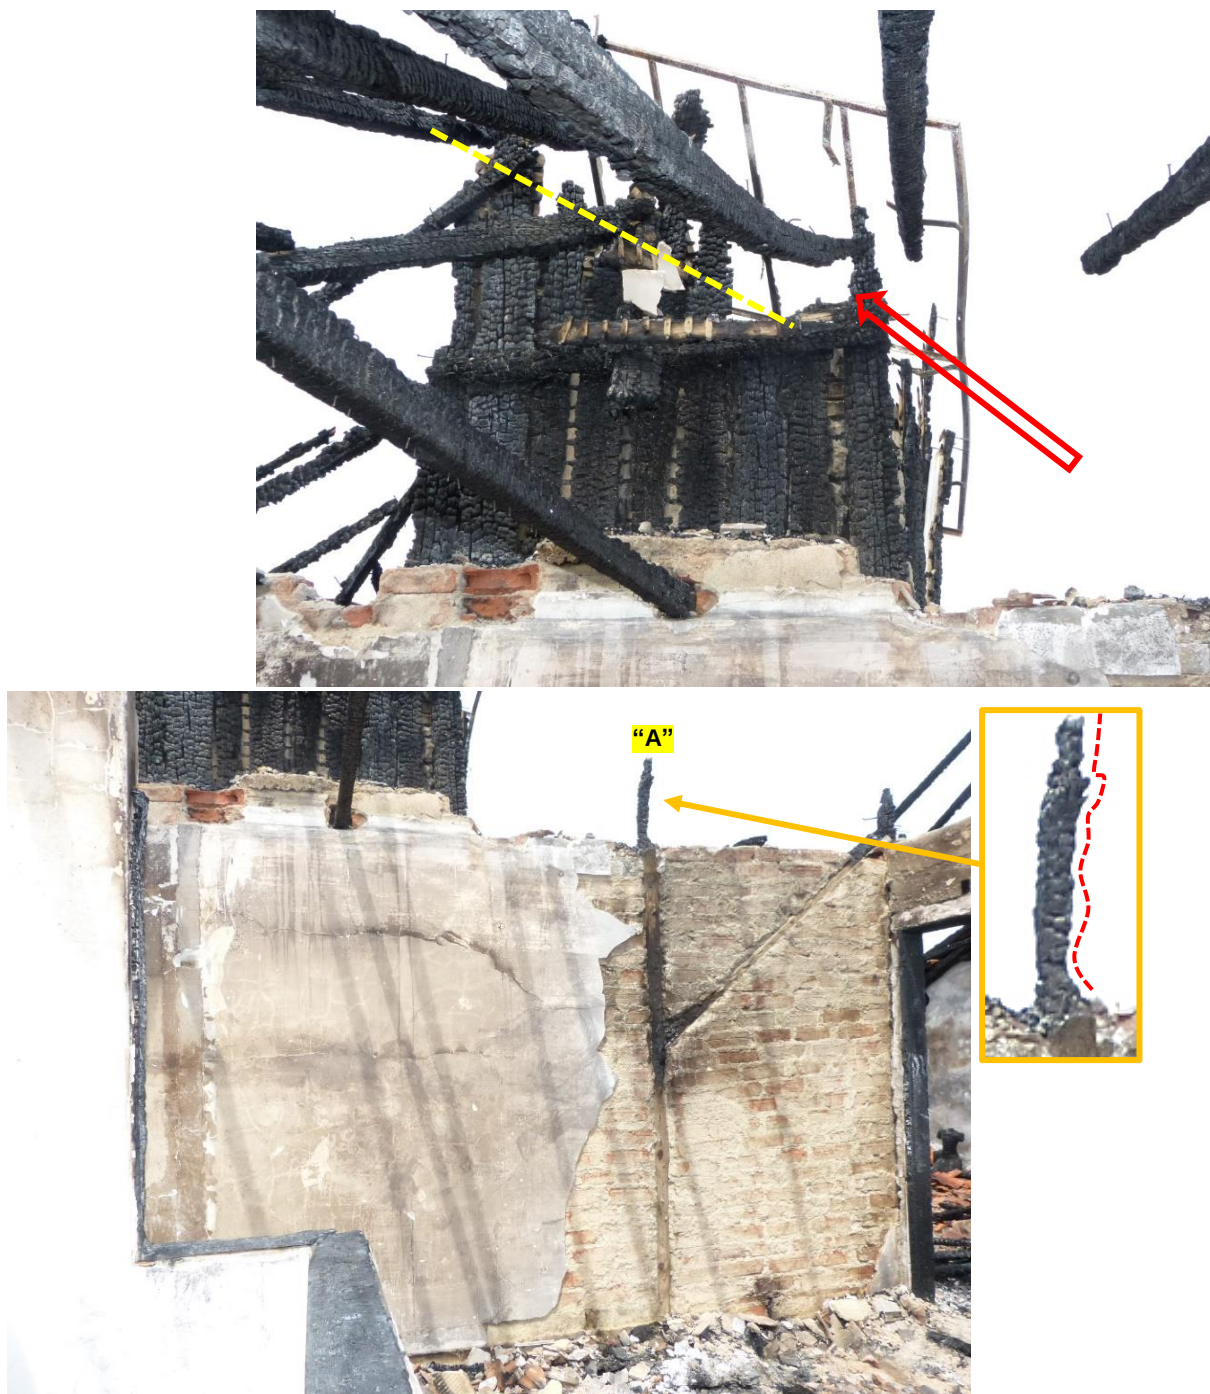
**Picture 09** – Appearance of the level of carbonization on the structure of the ladder-box supporting the skylight, which identifies a higher consumption of the right side (side facing the front right side) - relative to the left sense of observation- with a damage in "V"-pattern , due to transmission of heat by radiation and by direct action of the flames upwards, with the direction of propagation being shown by the red arrow, from the front side of the right side. Concomitantly the "A" pillar presents a similarity in the degree of damage reported –red line-, due to the same direction of propagation.

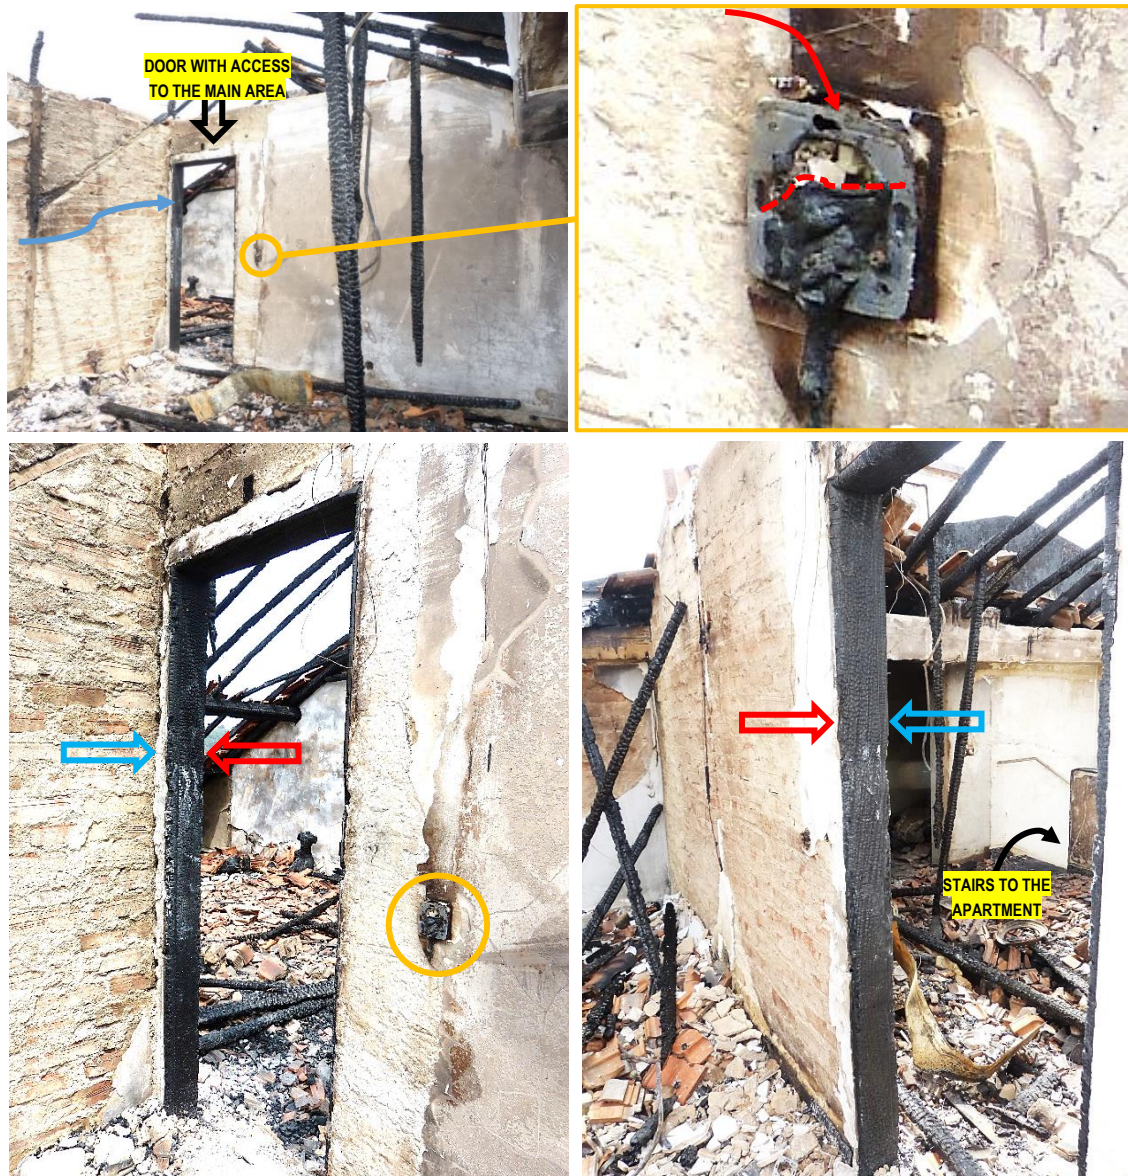
**Picture 10** – Door delimiting the hall at the top of the stairs to the lower floor and the large attic area. On both sides of the door-jamb a homogeneous morphology of the damages is observed, identifying a symmetrical carbonization level on the trim structure, indicative of two directions of propagation of fire from two separate sides -red and blue vectors. On the switch next to the face of the exposed door to the room / hall with access to the stairs a higher consumption of its components is visible downwards, consistent with the transmission of heat by convection, showing their distance from one of the points of origin –red line-.

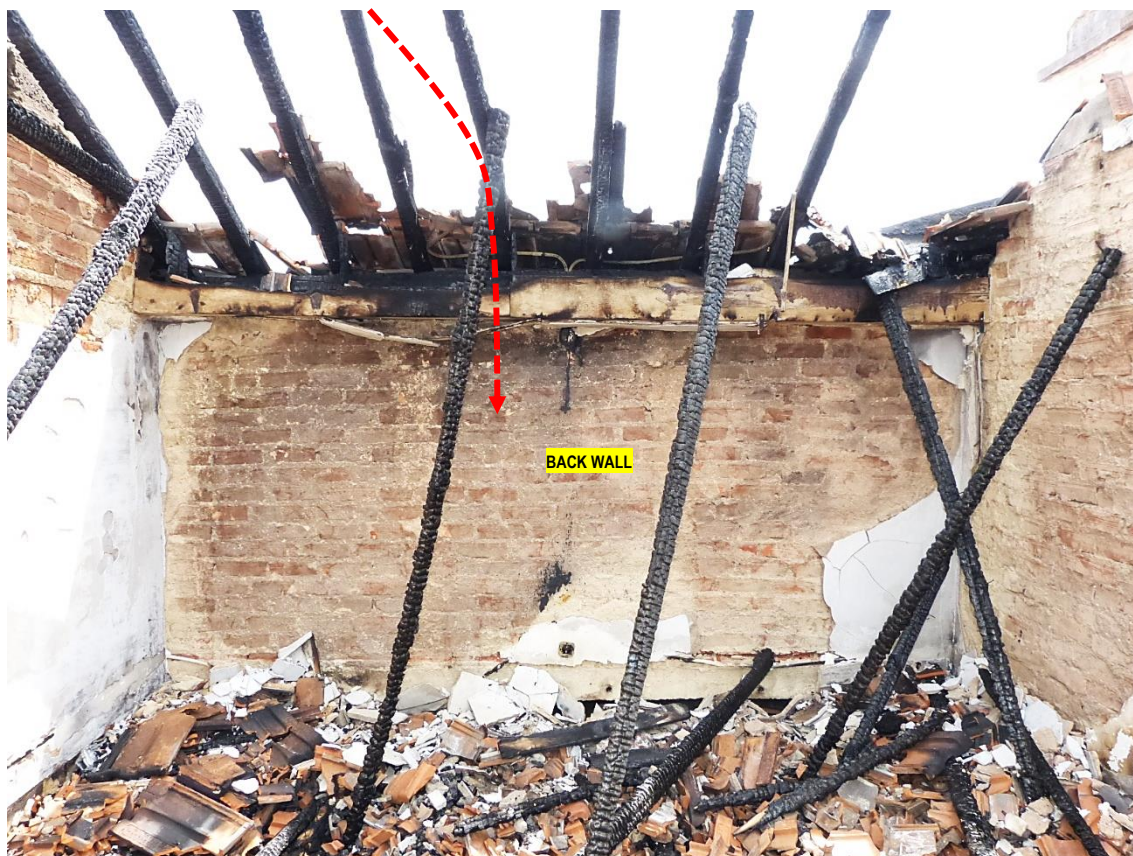
**Picture 11** – View of the back wall showing damages in amplitude starting from a higher level, consistent with the reception of heat during an advanced stage of the combustion, in which the fire was already in propagation – red arrows – resulting from the development of a fire originating on the opposite side – main facade.

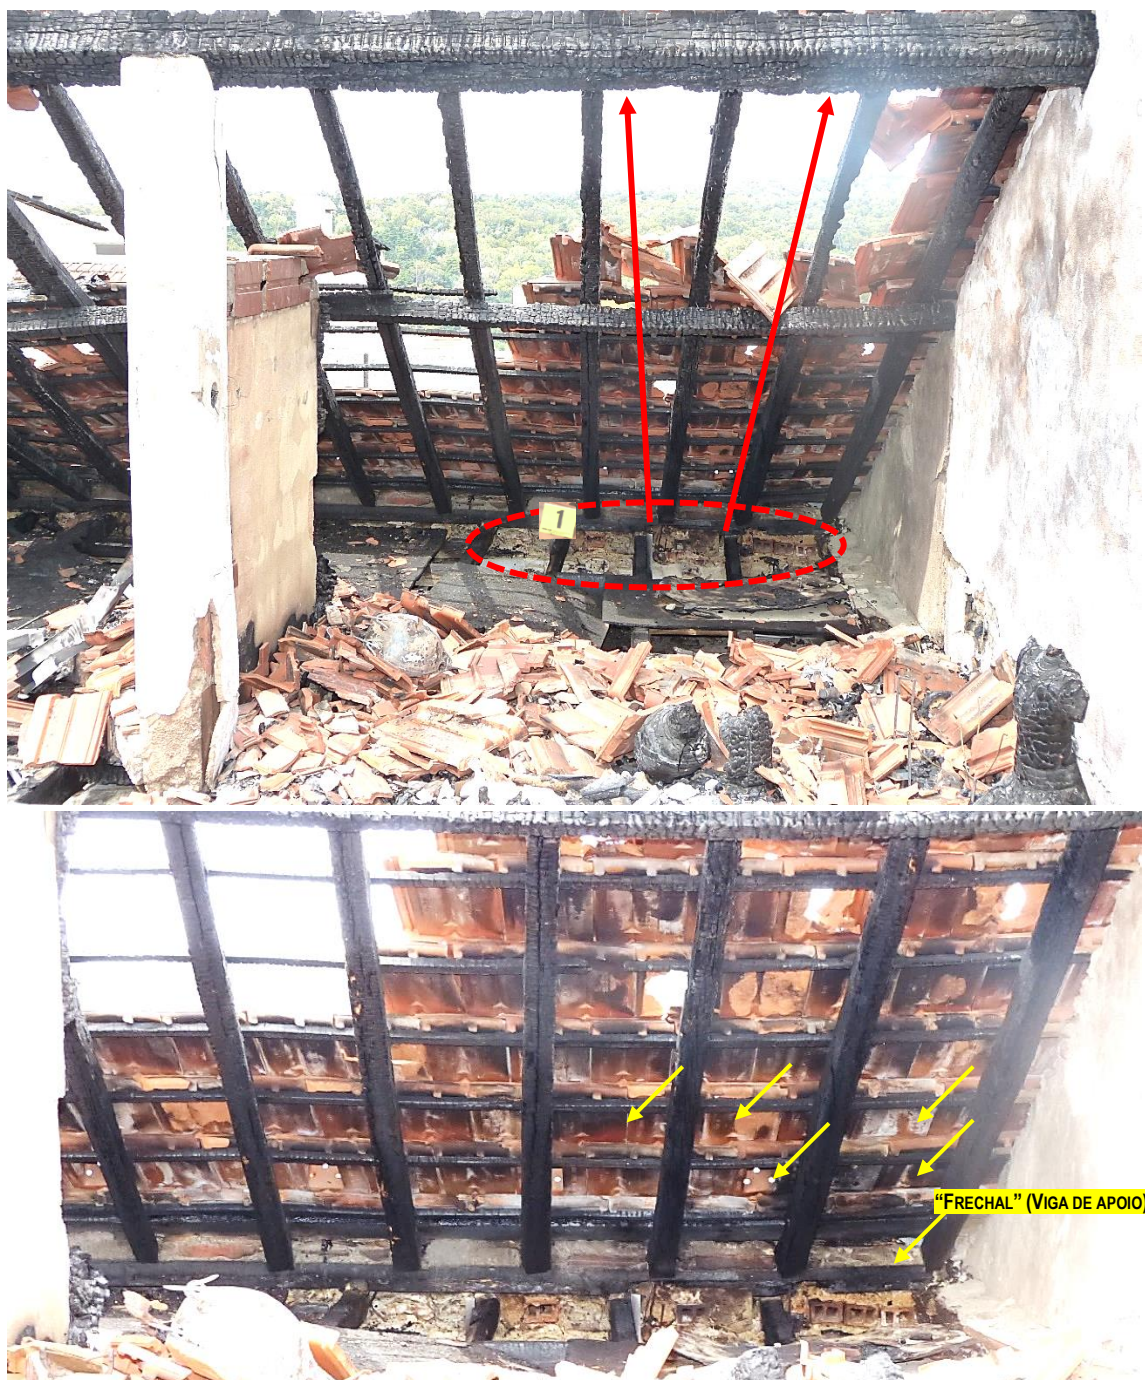
**Picture 14** – By observation of the tiles, protected areas at the top can be observed –yellow arrows, compared to the side (surface) facing the floor, which has soot depositions from direct contact with the flames, confirming the upward direction of propagation of the fire as well as the development of combustion, with an increasing amplitude of the damage directly proportional to a point of origin on the bottom of the beam located on the main facade of the building – tag #1.

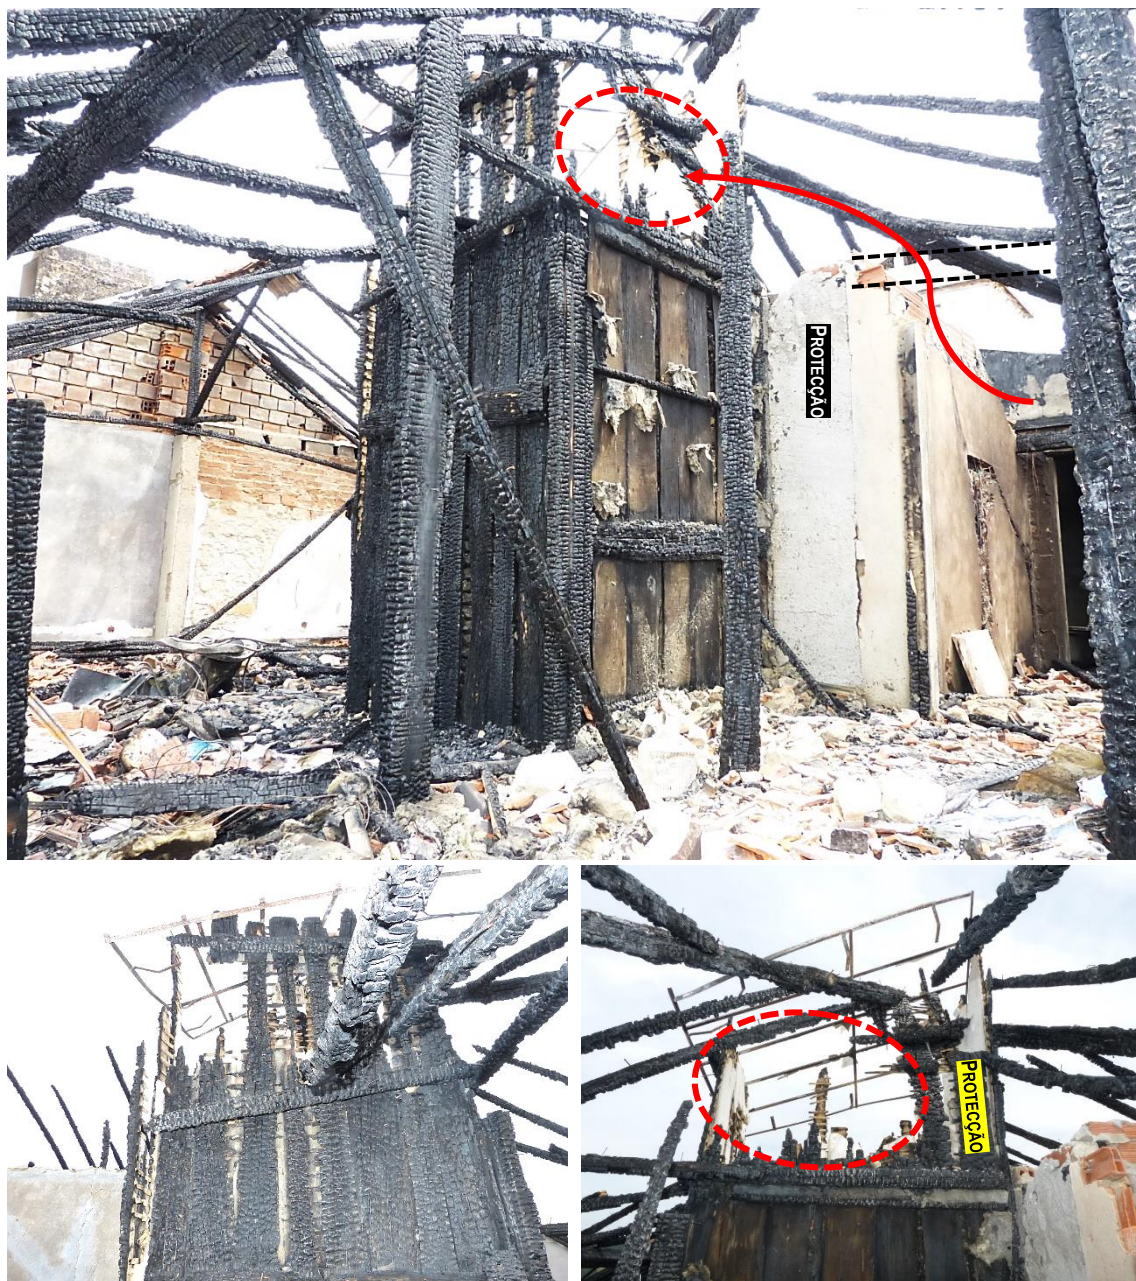
**Picture 17** – Na estrutura da caixa de escada onde assentava a clarabóia, contrariamente ao verificado nas faces expostas ao primeiro e segundo pontos de início (vide Fotos 11 e 22) foi identificado numa das faces um dano pontual -círculo a tracejado vermelho- resultante da acção do calor de uma propagação proveniente de um terceiro foco de incêndio -vector a vermelho-, razão pela qual o movimento dos fluídos de ar quente protegeram a zona de canto da parede e da estrutura da caixa de escada. Esse localizava-se do lado oposto dos anteriores na zona entre as fachadas lateral esquerda e a de tardoz.

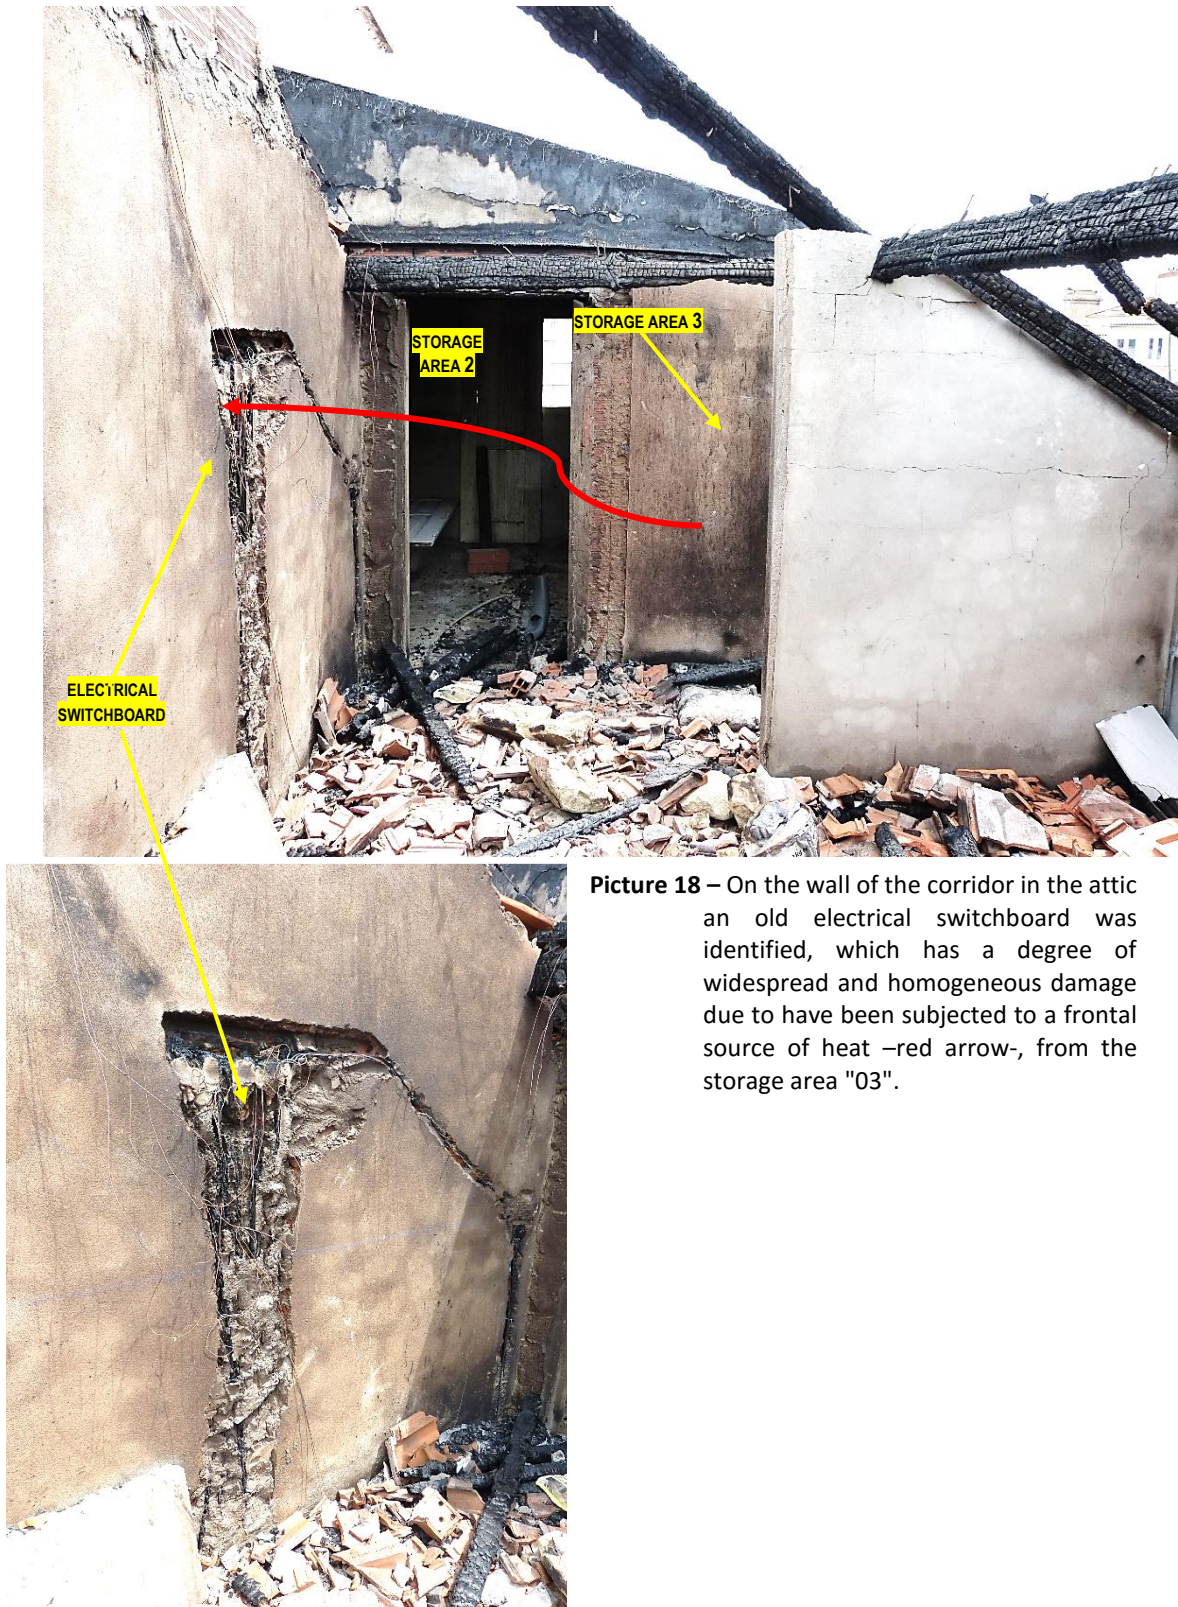
**Picture 18** – On the wall of the corridor in the attic an old electrical switchboard was identified, which has a degree of widespread and homogeneous damage due to have been subjected to a frontal source of heat –red arrow-, from the storage area "03".
