# **ANALYSIS OF THE SEISMIC VULNERABILITY OF A MASONRY BUILDING**

**Mestrado em Engenharia Civil  
Área de Especialização: Estruturas  
Dissertação**

## **Analysis of seismic vulnerability of a masonry building**

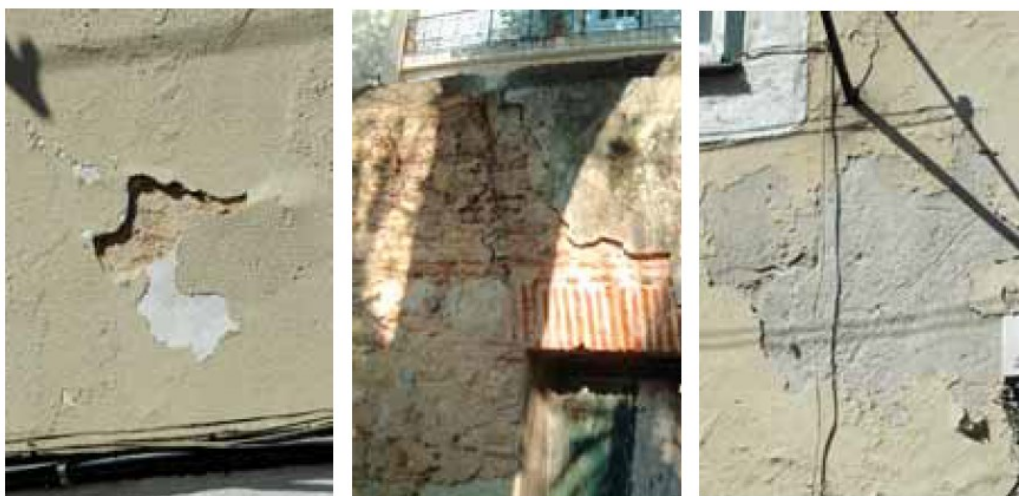
Figure 25 – Bad examples of rehabilitation with cementitious solutions which did not last long (Lisboa, 2005)

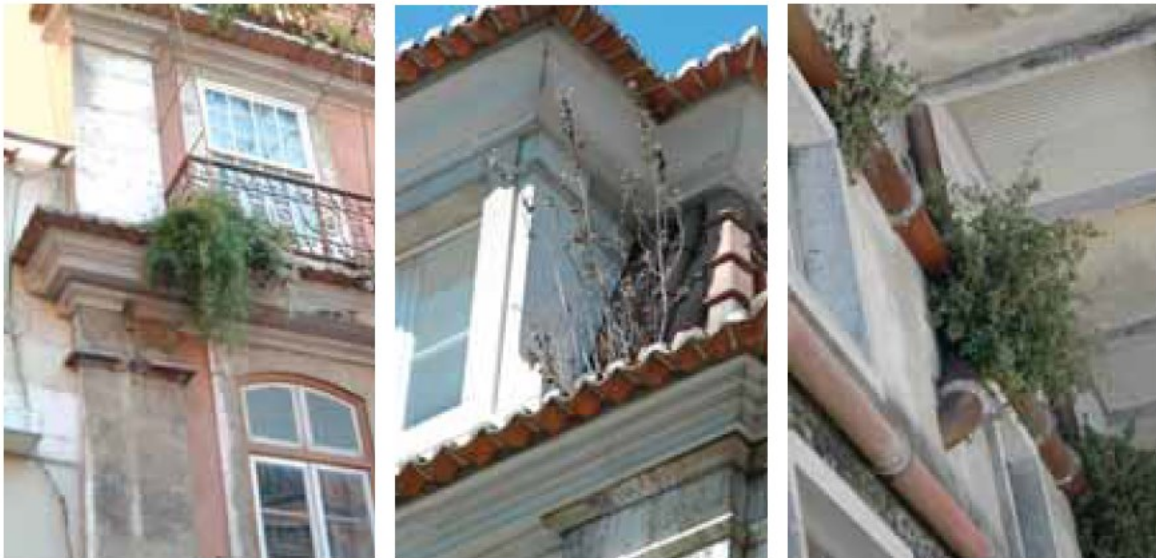
Figure 26 – Vegetation on facades which will cause cracking and detaching of elements (Lisboa, 2005)

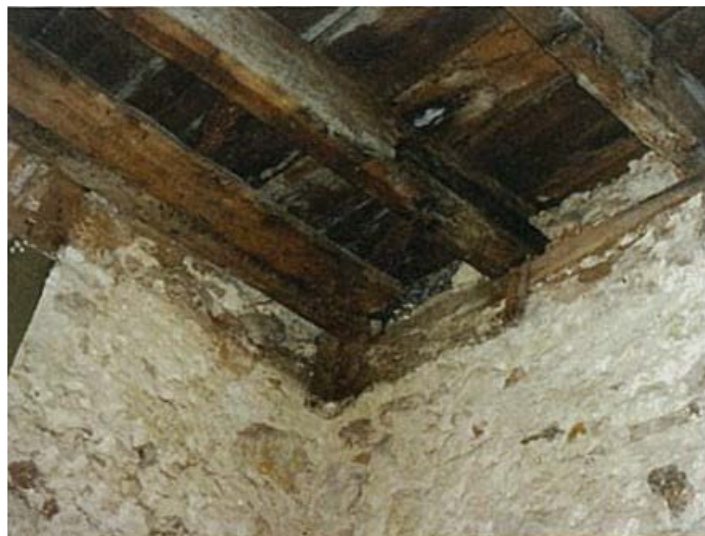
Figure 27 – Timber joists decay on its edges due to water ingress (Lisboa, 2005)

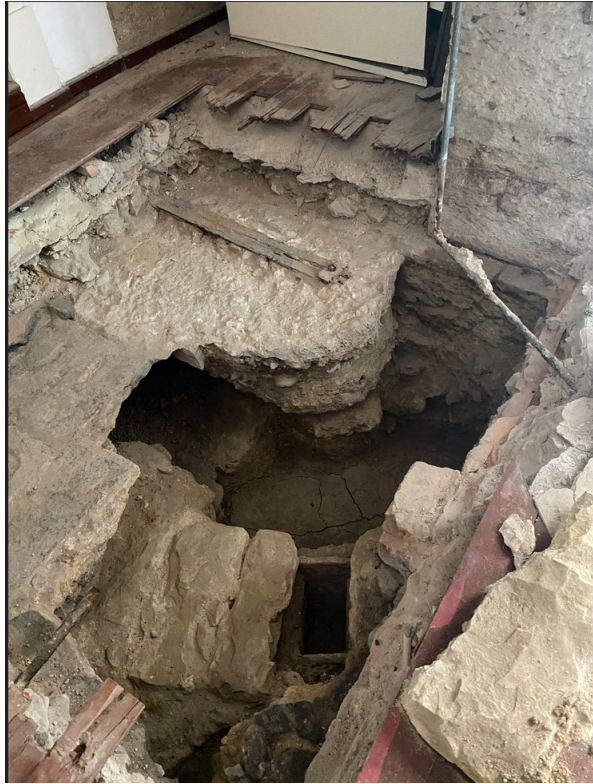
Figure 31 – Trial pit to the existing foundations at lower ground floor (Picture taken on site)

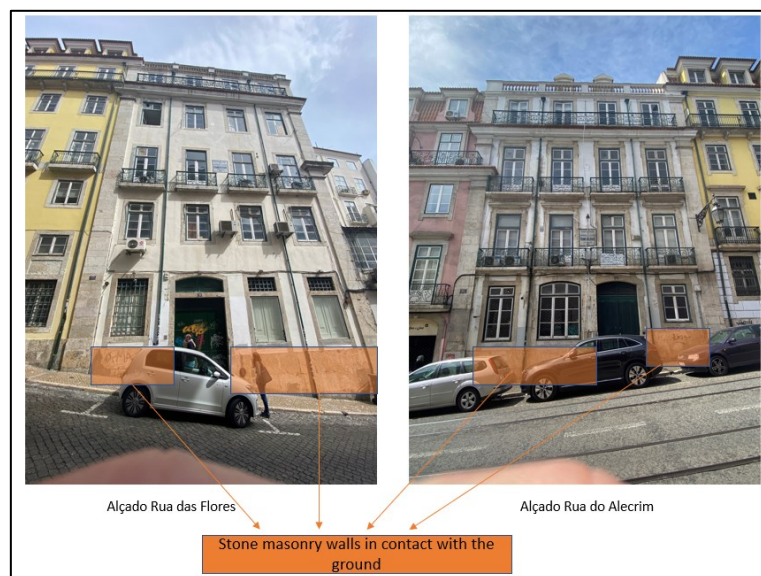
Figure 35 – Façade elevations showing stone masonry in contact with the ground to avoid ascending water (on site pictures adapted to explain the stone masonry in contact with the ground)

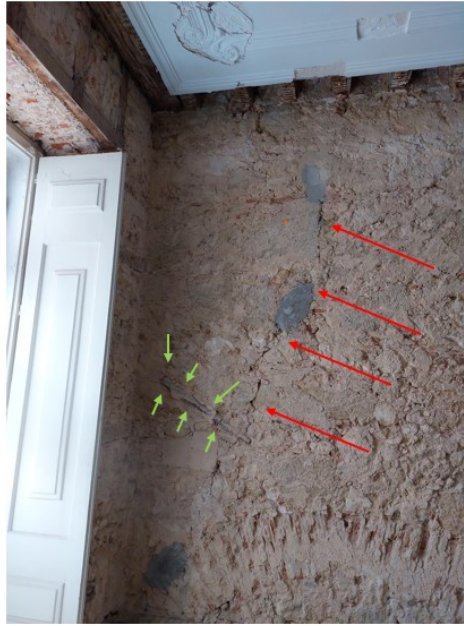
Figure 36 – Party wall showing a “Gato metálico” indicated by the green arrows and crack indicated by the red arrows. (picture taken on site and adapted for the case study)

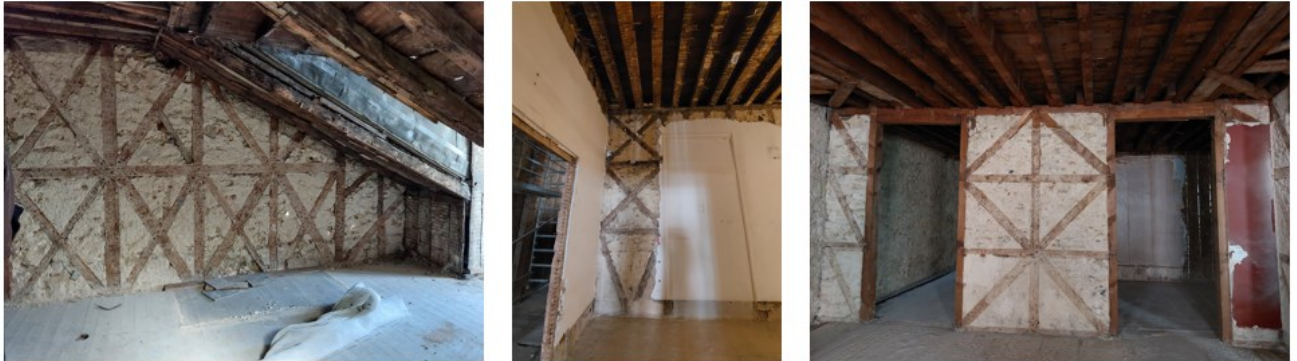
Figure 38 –From left to right , frontal walls at roof level; front walls on levels below (Pictures taken on site)

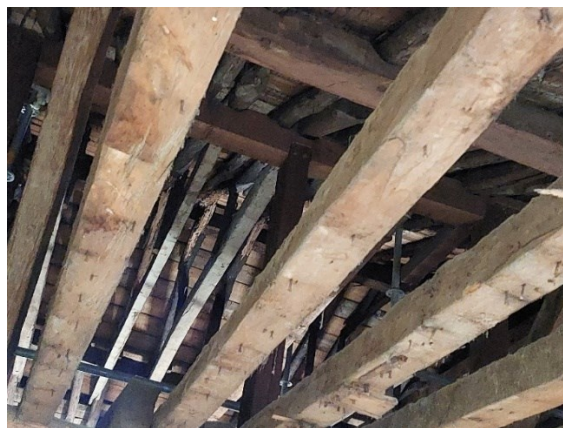
Figure 39 – Roof trusses, clearing showing burnt timbers that have been left in position ( Picture taken on site)
