**American Rock Art Research Association Occasional Paper No. 5**

# Conservation Efforts on the Engravings of the Côa Valley Archaeological Park, Portugal

Jennifer K. K. Huang

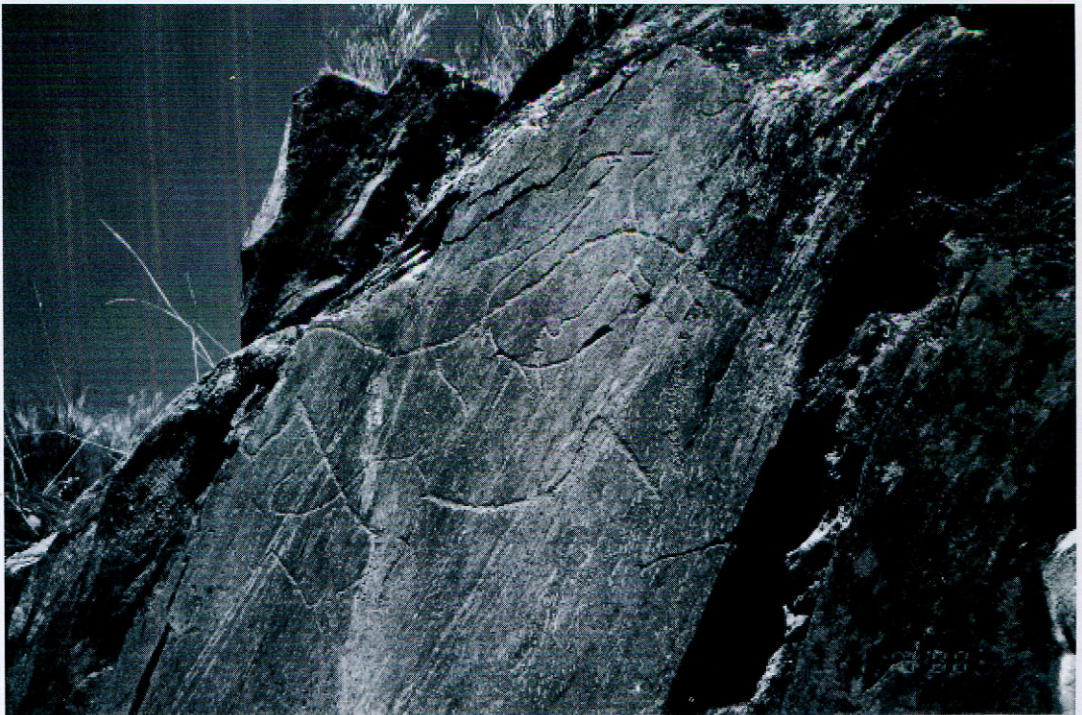
*Figure 2. Example of the engravings that appear to be stylistically of the Paleolithic era.*

Studies concentrated on resolving the question of the age of particular engravings. According to some prehistorians, the style of these petroglyphs suggested a Paleolithic origin (Figure 2). Experts in Paleolithic art felt certain just upon seeing the engravings that they certainly did date to the Solutrean and Magdalenian eras of the Upper Paleolithic (Clottes 1998). Comparisons between the Côa engravings and the cave paintings in other parts of Iberia and throughout France showed great similarity of both form and content (Gay 2000). Yet the placement of the engravings on rocks in the open air was less common in art of known Paleolithic age.

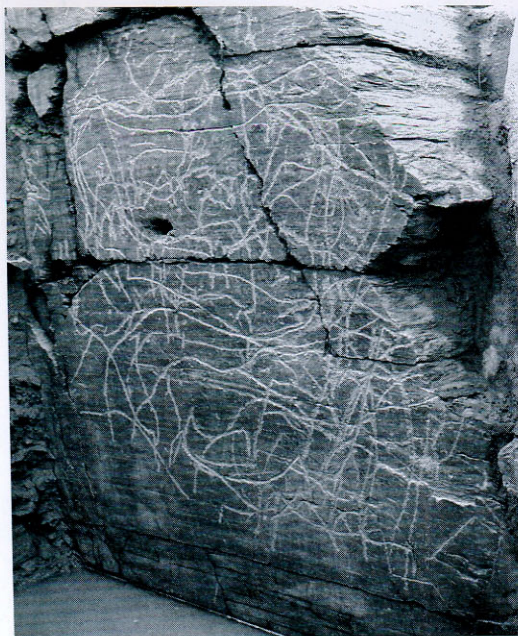
**Figure 3.** Excavated panel at Fariseu that shows engravings of similar style and content to others along the Côa River valley. Photo courtesy of the Instituto Português de Arqueologia Website, anonymous photographer.

According to these reports, several human occupation layers constituted the sediment and soil excavated from in front of the engraved slab. Artifacts recovered from that stratigraphy, such as chipped stone tools and hearthstones, have been positively dated by thermoluminescence to the Upper Paleolithic (Mercier et al. 2001). The rock face itself is almost entirely covered with multiple layers of engravings; the 82 superimposed motifs share the same Paleolithic style as other engravings found throughout the park (Figure 3). Further studies will certainly be done in the hopes of strengthening the argument, which is still receiving challenges from a staunch group of rock art researchers (see Abreu and Bednarik 2000; Bednarik 2003; and Watchman 2003 for examples). But as it stands, the Côa Valley seems to be the largest open-air Paleolithic rock art site in Eurasia, if not the world. It has changed

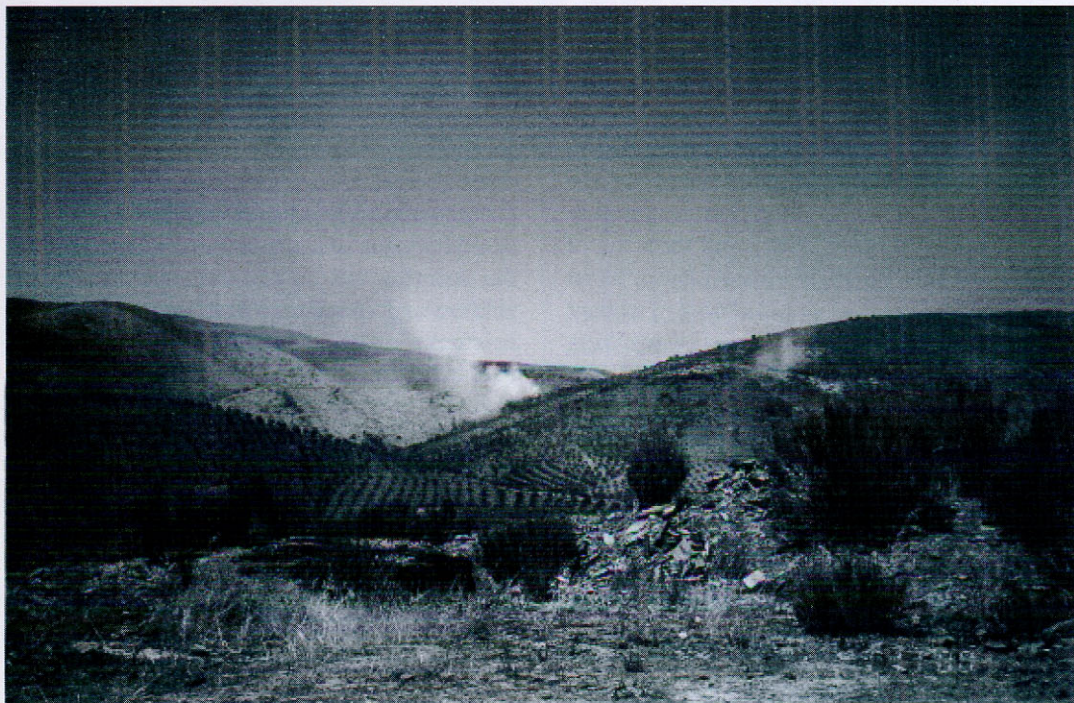
**Figure 7.** *Smoke rises from several small wild fires in the hills of the Côa Valley, potentially threatening engraved rock sites.*

In addition, each summer in northeastern Portugal small fires erupt in the grassy hills (Figure 7), many of which are set by sheepherders hoping to burn dried vegetation and revitalize the hills with new fodder for their herds. In 2000, one such fire roared through part of the public site of Ribeira de Piscos. The engravings seemed unaffected, but the impact of fire on rock art can be fatal over time. Inspection of rock art within the vicinity of a fire performed at a macro-, or visual, level can indicate problems such as spalling
