# **MASTER THESIS**

***“Contribution to Portuguese Urban Fire Investigations  
– Forensic Fire Debris Analysis”***

**STEFANIA OLIVERIO**

**JULY 2016**

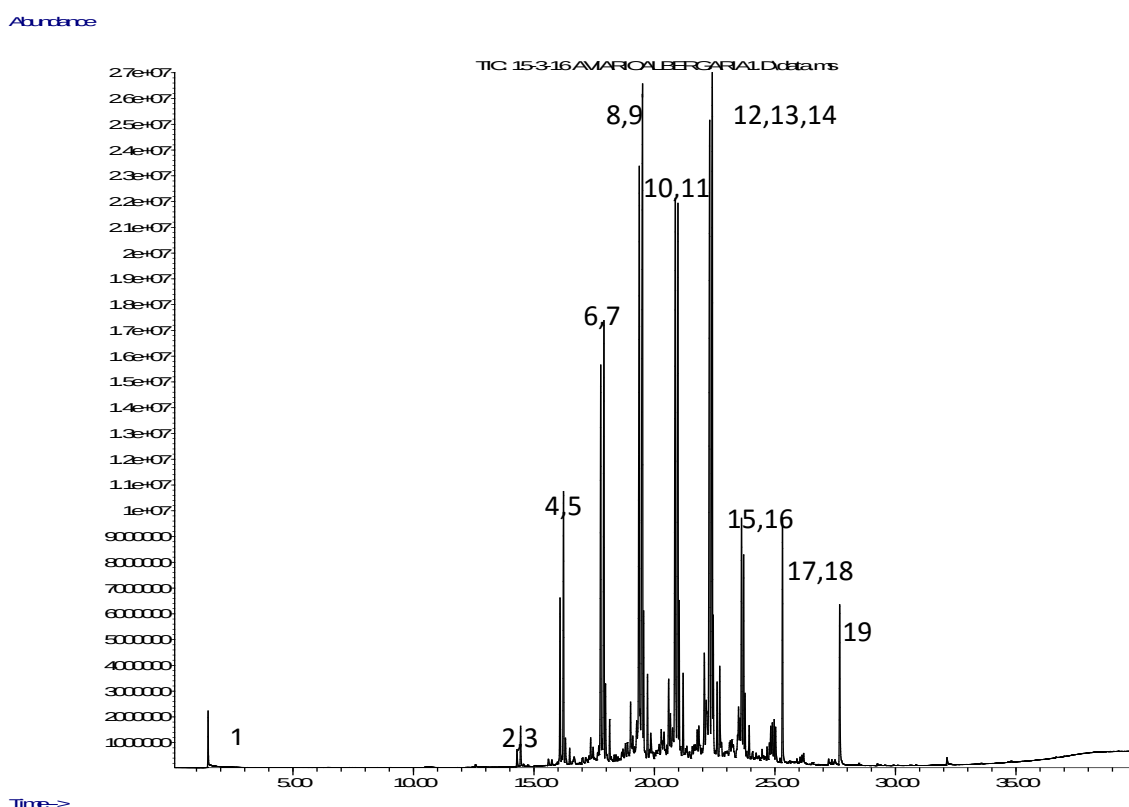
**Figure 3:** TIC of products produced from the sample 1 collected at *Fire Scene 1*. Peak identities: (1) Carbon dioxide; (2) Dodecene; (3) Dodecane; (4) Tridecene; (5) Tridecane; (6) Tetradecene; (7) Tetradecane; (8) Pentadecene; (9) Pentadecane; (10) Hexadecene; (11) Hexadecane; (12) Decylbenzene; (13) Heptadecene; (14) Heptadecane; (15) Octadecene; (16) Octadecane; (17) Dodecylbenzene; (18) Nonadecane; (19) Octadecanoic acid methylester.

Both samples 1 and 2 show a series of consecutive alkene-alkanes ranging from C<sub>12</sub> to C<sub>19</sub>, which constitute the main pattern of the TICs and highly resemble the profile of a HPD, according to ASTM standards. Additionally, octadecanoic acid methylester was found in both samples, hexadecanoic acid methylester only in sample 2.

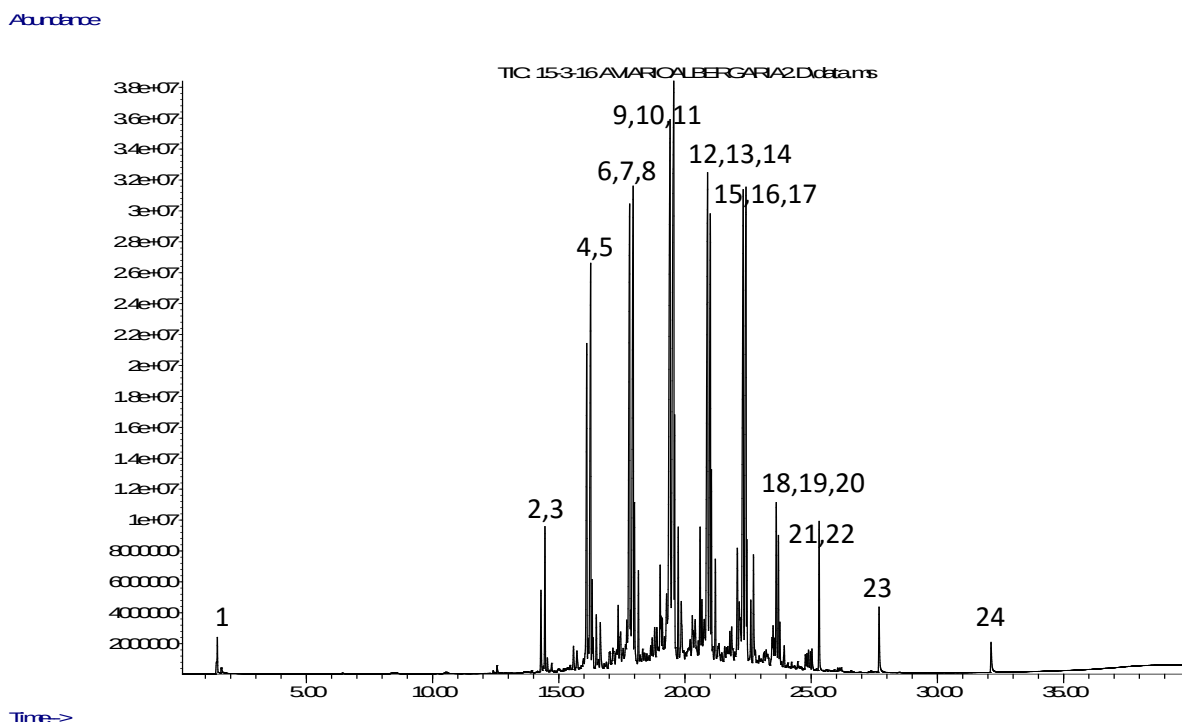
**Figure 4:** TIC of products produced from the sample 2 collected at *Fire Scene 1*. Peak identities: (1) Carbon dioxide; (2) Dodecene; (3) Dodecane; (4) Tridecene; (5) Tridecane; (6) Heptylbenzene; (7) Tetradecene; (8) Tetradecane; (9) Octylbenzene (10) Pentadecene; (11) Pentadecane; (12) Nonylbenzene; (13) Hexadecene; (14) Hexadecane; (15) Decylbenzene; (16) Heptadecene; (17) Heptadecane; (18) Undecylbenzene; (19) Octadecene; (20) Octadecane; (21) Dodecylbenzene; (22) Hexadecanoic acid methylester; (23) Octadecanoic acid methylester; (24) 1,2-Benzenedicarboxylic acid diisooctylester.

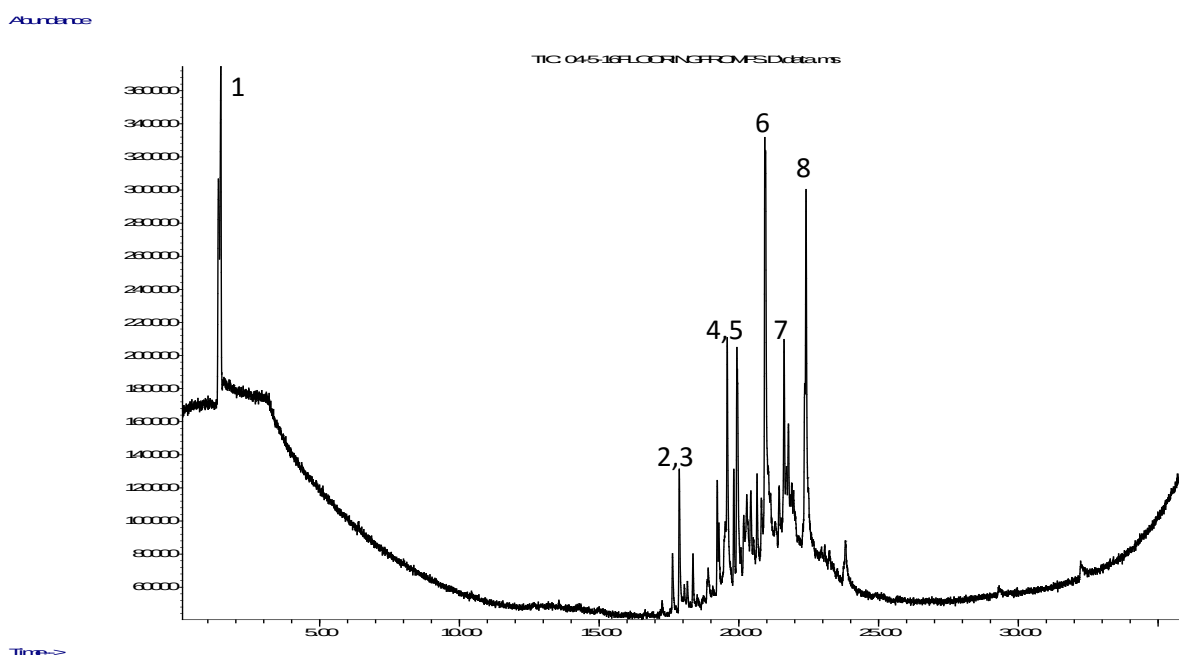
##### *Sample 1 – Plywood*

**Figure 5:** TIC of products produced from the sample 1 collected at *Fire Scene 2*. Peak identities: (1) Carbon dioxide; (2) Naphthalene derivative; (3) Low MW, low BP cyclic hydrocarbon; (4) and (5) Naphthalene derivatives; (6) Hexadecanal; (7) and (8) High MW, high BP hydrocarbon.

All TICs have a similar chromatographic profile, not many compounds are detected. The majority are products resulting from the background and the thermal degradation of the materials. None of the samples contains enough compounds that can constitute an IL according to ASTM standards.

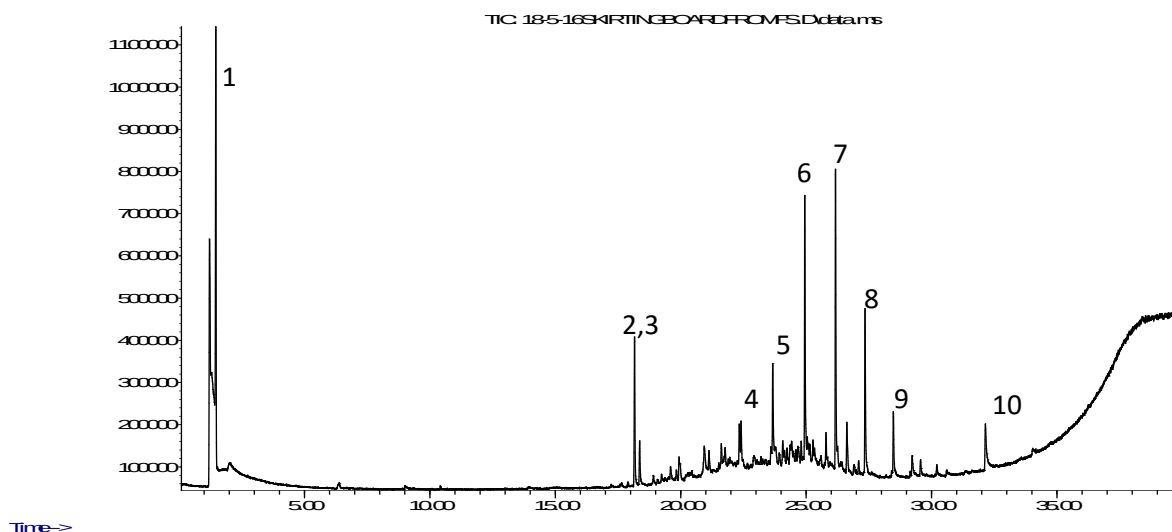
## Sample 2 – Skirting board

**Figure 6:** TIC of products produced from the sample 2 collected at *Fire Scene 2*. Peak identities: (1) Carbon dioxide; (2) Longifolene; (3) Naphthalene derivative; (4), (5) and (8) High MW, high BP oxygenated hydrocarbon; (6) and (7) High MW, high BP hydrocarbon; (9) Heptacosane; (10) 1,2-Benzenedicarboxylic acid diisooctylester.

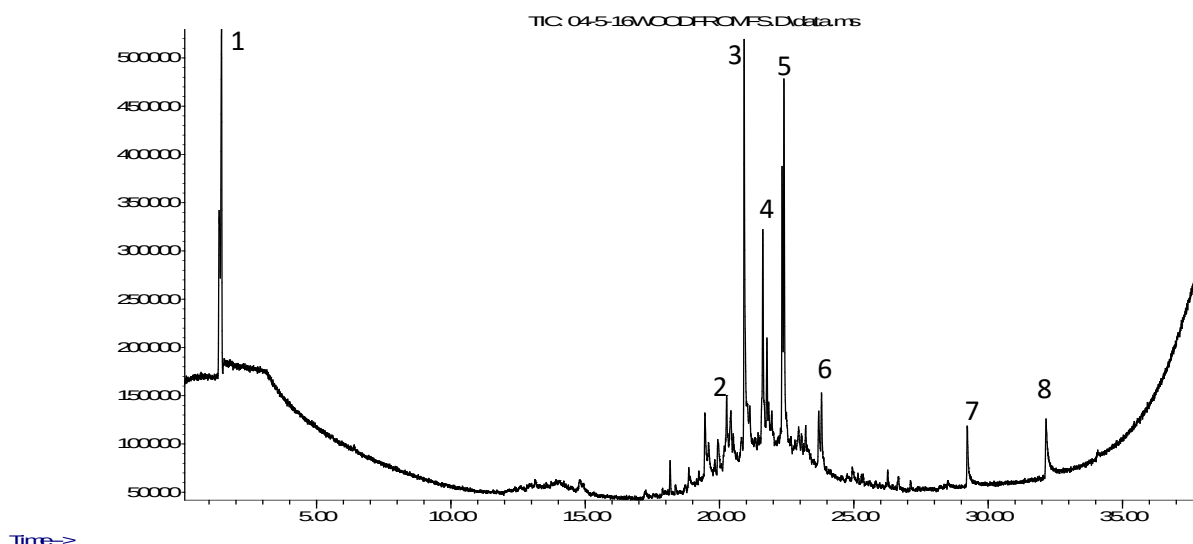
## Sample 3 – Wood

**Figure 7:** TIC of products produced from the sample 3 collected at *Fire Scene 2*. Peak identities: (1) Carbon dioxide; (2), (4) and (6) High MW, high BP hydrocarbon; (3), (5) and (7) High MW, high BP oxygenated unsaturated hydrocarbon; (8) Phthalic acid butylundecylester.

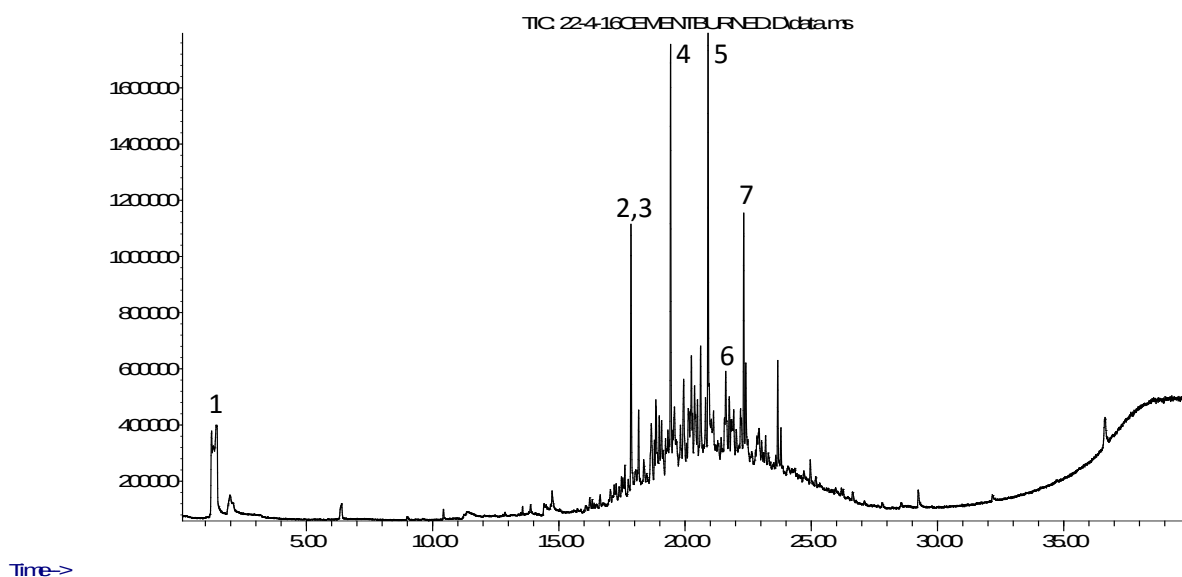
## Sample 4 – Cement

**Figure 8:** TIC of products produced from the sample 4 collected at *Fire Scene 2*. Peak identities: **(1)** Carbon dioxide; **(2)** and **(3)** Naphthalene derivatives; **(4)-(7)** High MW, high BP hydrocarbon.

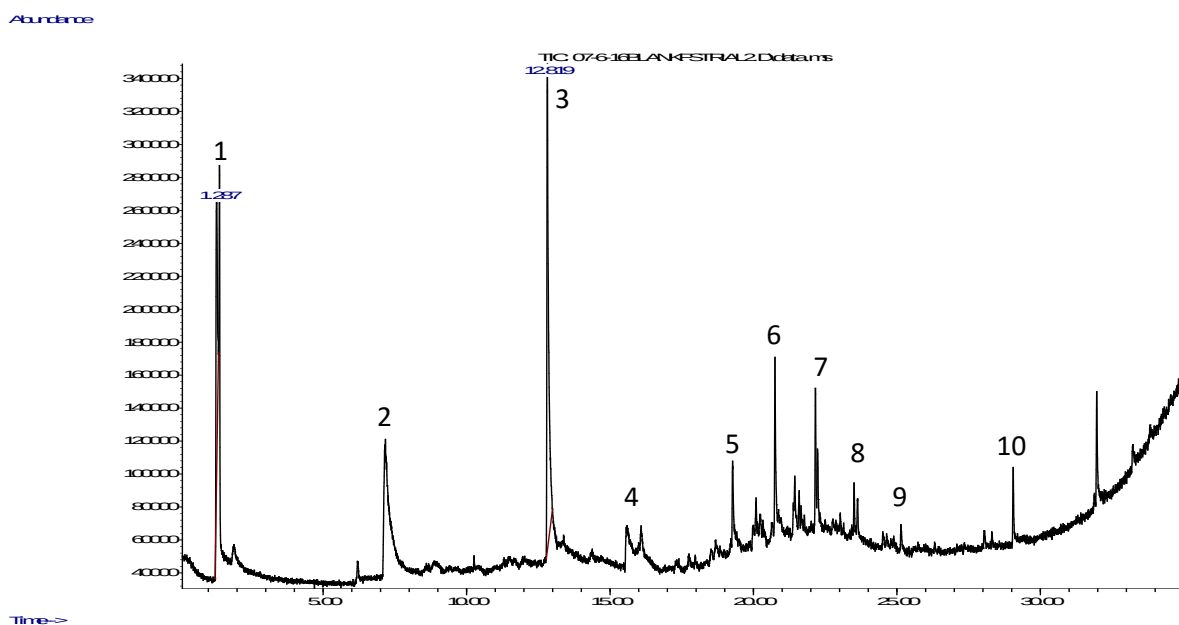
## Blank

**Figure 9:** TIC of products produced from the blank sample collected at *Fire Scene 3*. Peak identities: (1) Carbon dioxide; (2) Undecane; (3) Tetradecane; (4)-(7) High MW, high BP hydrocarbon; (8), (9) and (10) High MW, high BP oxygenated hydrocarbon.

By simple visual comparison of the blank sample with the samples from the suspected areas of origin, it can be clearly observed that not only is there a large difference in the abundance of the compounds detected, but also in the amount of substances found and the profiles created. The blank sample merely contains compounds that result from the background of the material and the combustion and pyrolysis occurred during the fire. The other three samples have a very rich profile that resembles that of a HPD and contain various compounds: isoparaffins, consecutive *n*-alkanes in the range of C<sub>9</sub> to C<sub>15</sub>, C<sub>2</sub>-, C<sub>3</sub>- and C<sub>4</sub>-alkylbenzenes; pristane and phytane, however, are not present. The parameters according to ASTM standard for the identification and confirmation of a HPD include a minimum of five consecutive *n*-alkanes in the range of C<sub>9</sub>-C<sub>20+</sub>, the abundance of alkanes, presence of cycloalkanes and aromatics and, for diesel, the presence of the doublets C<sub>17</sub>-pristane and C<sub>18</sub>-phytane is mandatory. All the parameters are fulfilled by the analysed samples. Additionally, by following the flow-chart presented by Stauffer on page 345 of his book '*Fire Debris Analysis*' (Stauffer et al., 2007), the product identified in the analysed samples is a HPD. Furthermore, comparison of the obtained TICs with the extensive collection of IL profiles obtained by GC-MS analysis provided by Reta Newman (Newman et al., 1998) results in the highest similarity obtained with a kerosene based jet-fuel (Distillate #38 and #41, pp. 174 and 194).

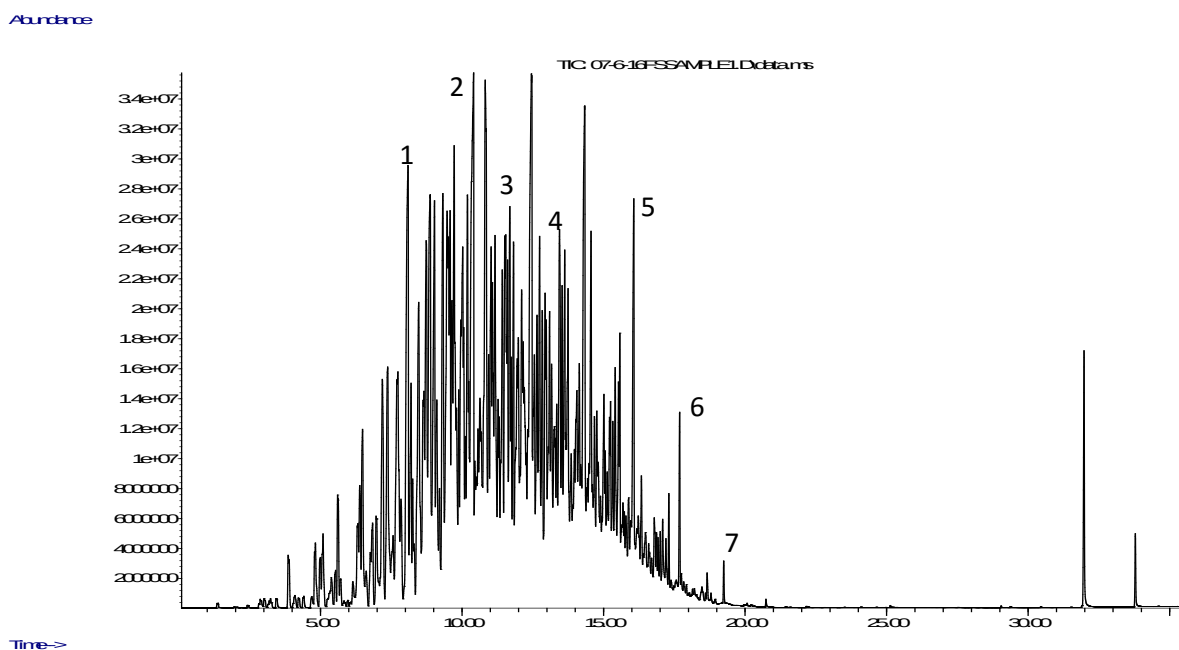
**Figure 10:** TIC of products produced from the sample 1 collected at *Fire Scene 3*. Peak identities: (1) Nonane; (2) Decane; (3) Undecane; (4) Dodecane; (5) Tridecane; (6) Tetradecane; (7) Pentadecane – a list of all compounds is found in the *appendix* section (**Table D7**).

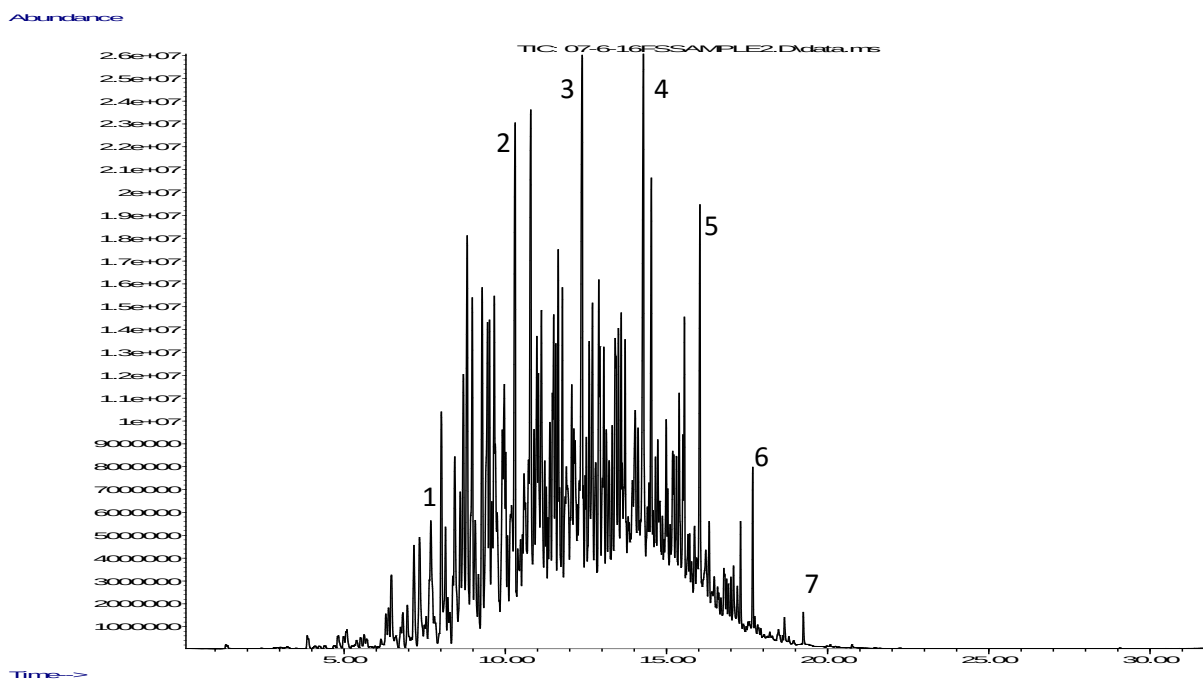
**Figure 11:** TIC of products produced from the sample 2 collected at *Fire Scene 3*. Peak identities: (1) Nonane; (2) Decane; (3) Undecane; (4) Dodecane; (5) Tridecane; (6) Tetradecane; (7) Pentadecane – a list of all compounds is found in the *appendix* section (**Table D8**).

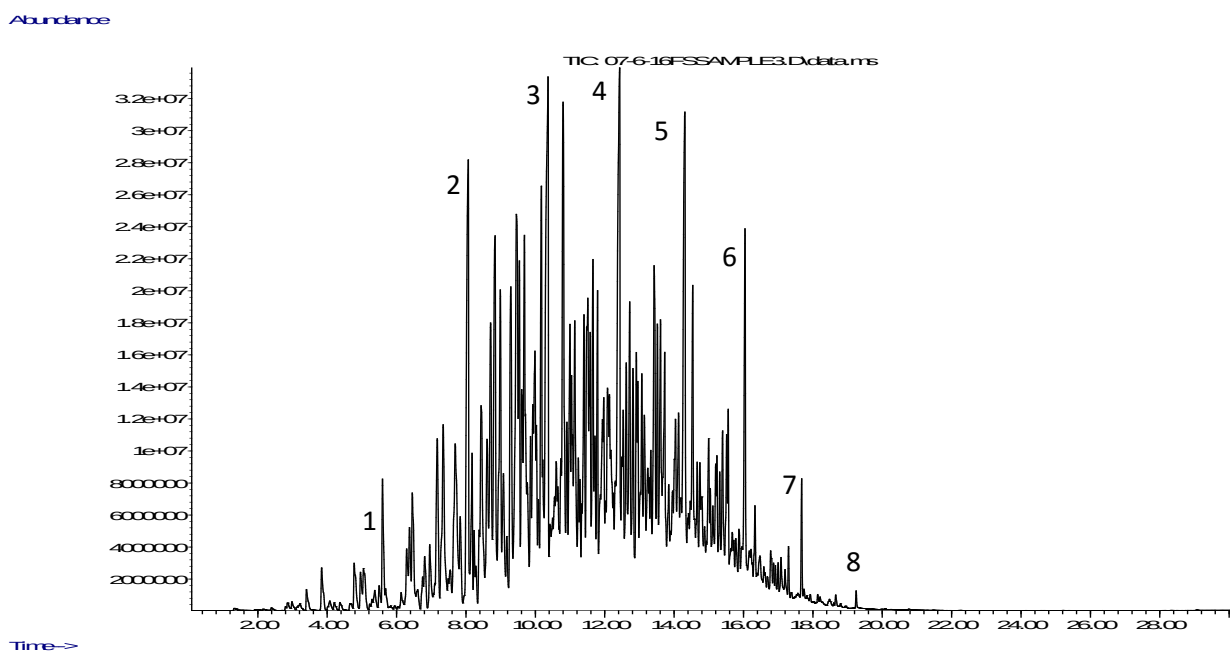
**Figure 12:** TIC of products produced from the sample 3 collected at *Fire Scene 3*. Peak identities: (1) Octane; (2) Nonane; (3) Decane; (4) Undecane; (5) Dodecane; (6) Tridecane; (7) Tetradecane; (8) Pentadecane – a list of all compounds is found in the *appendix* section (**Table D9**).

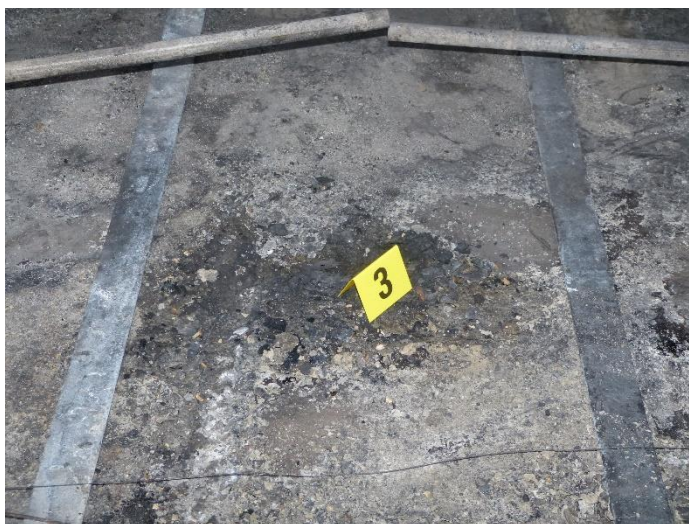
**Figure A1:** Residue of detoxification plaque 1.

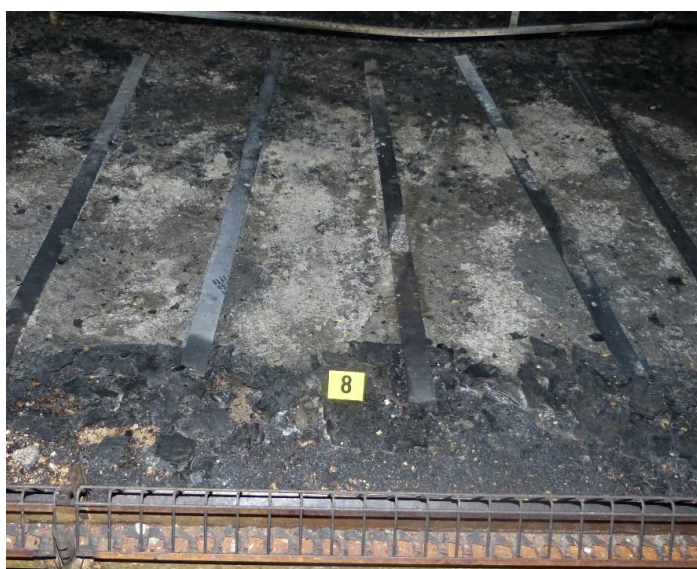
**Figure A2:** Residue of detoxification plaque 2.

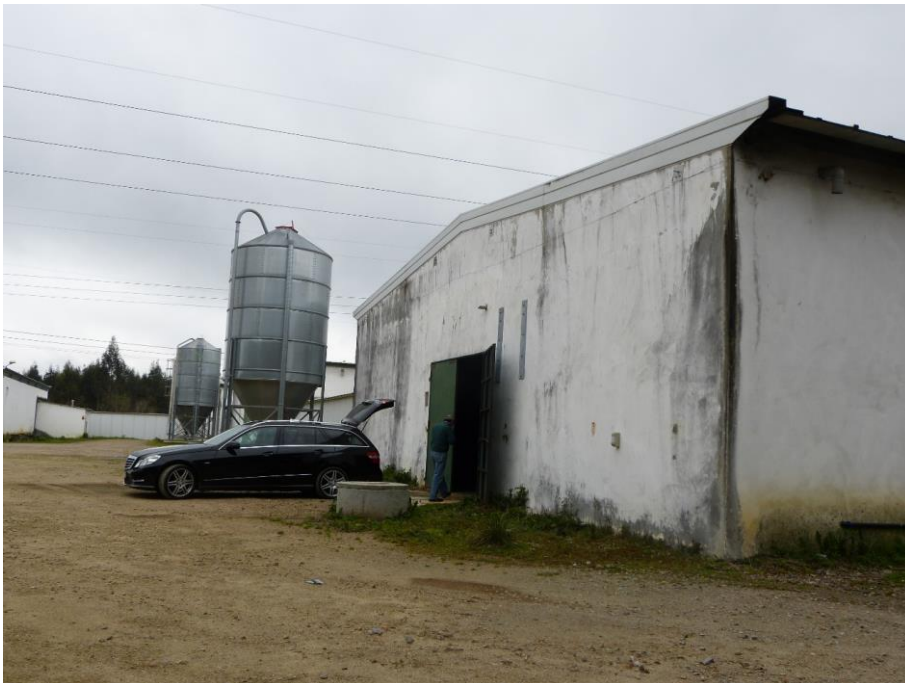
The analysis of the exterior of the building showed no major damages on the walls or doors (Pictures 01 to 03), merely soot depositions were observed on the exterior of the back door and back ventilation shafts (Picture 03). Also, the majority of the windows were found lying on the floor outside of the building, whole, with soot depositions above the window frames on the along the whole east wall (Picture 02), indicating that at some point during the fire the pressure build up and the heat removed the windows and the fire and smoke exited the building through those openings. Just with these observations, a general trend of the propagation direction of the fire can be determined as being from south to north (main front door to back door) and from the inside to the outside can be observed, since there is are no major fire damages on the main front door or on the exterior of the pavilion.

**Picture 01** - Outside view of main entrance – no visible damage or signs caused by the fire.

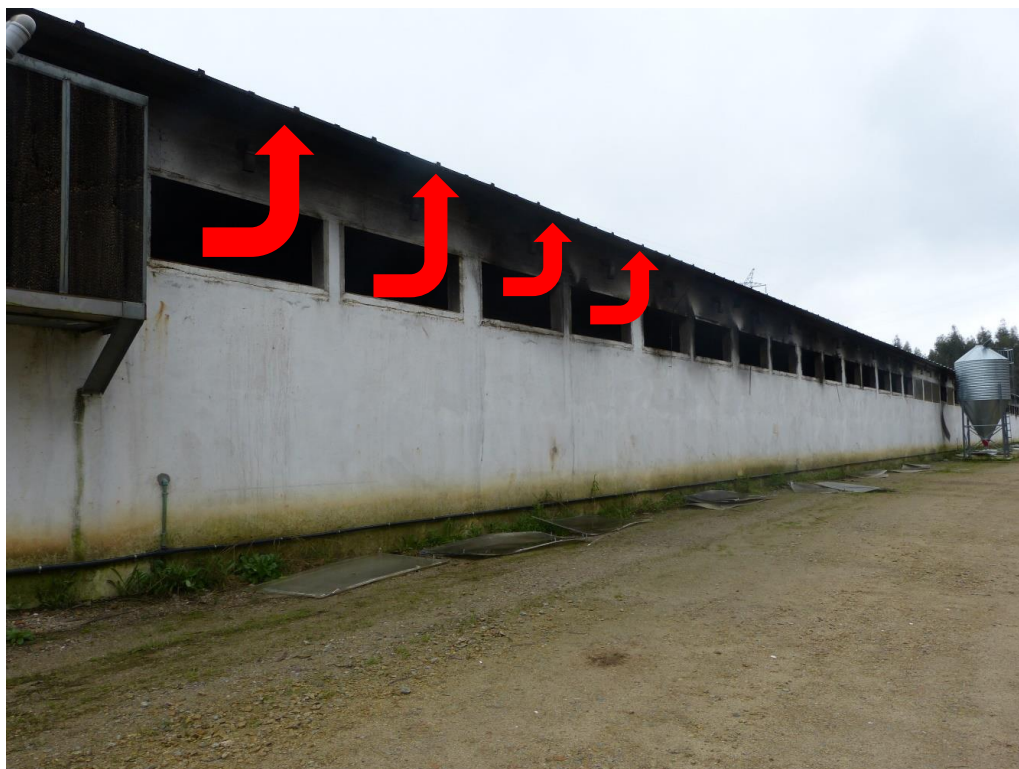
**Picture 02** - Outside view of east wall of the pavilion – soot deposition on the top of all window frames, the direction of the flames and smoke coming out of the windows is indicated by the red arrows.

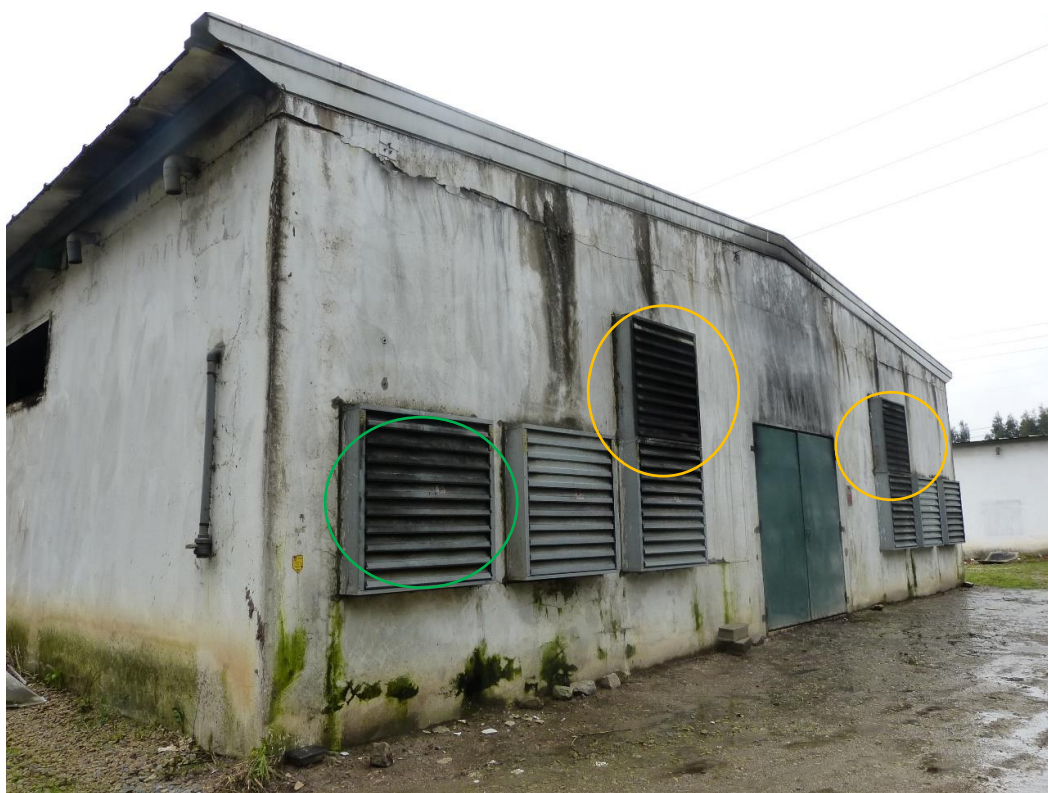
**Picture 03** - Outside view of backdoor (north to south) – compared to the front entrance, here there are signs of the fire visible, on top of the main door and on the two top ventilation shafts (orange circles) and on the left one (green circle); darker soot present on the top shafts than the top one, indicating that the smoke and flames were at a high level at the time when they reached the end of the pavilion.

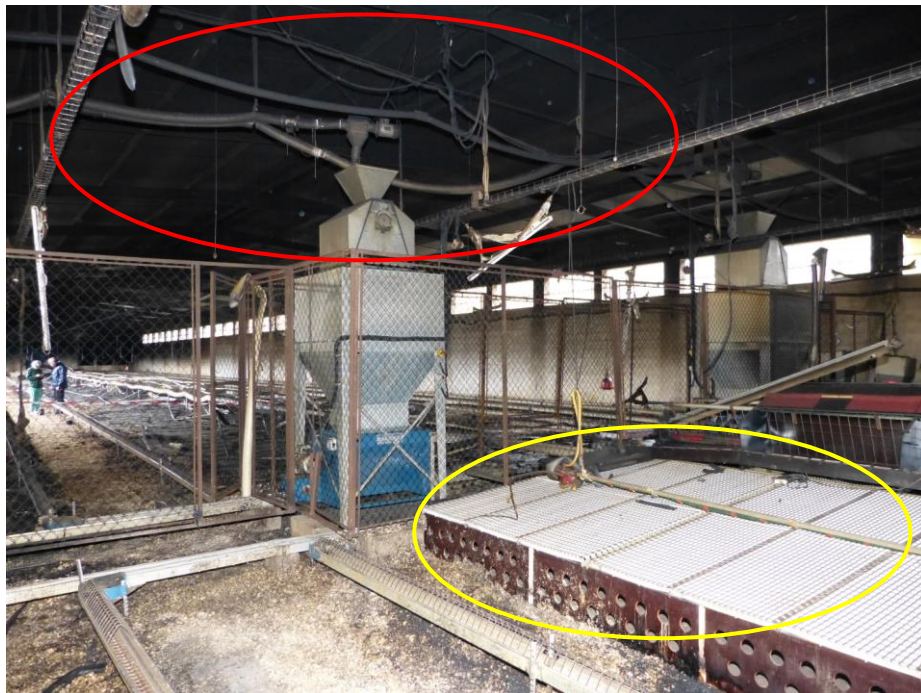
However, the damaged area is not that big, since it did not reach the end of the first part of the pavilion (Picture 07), which is intact, meaning that the fire in the first area must have been of a slow rate. On the other hand, the second major damage area is bigger (Picture 09), resulting in high damages on most of the area in the rear part of the pavilion. Here also a propagation direction from south to north can be observed as well as from the bottom up and then from the inside to the outside.

**Picture 07** - Food supply machines – view from south to north, no discoloration or oxidation signs, chicken-houses almost intact (yellow circle) while ceiling shows soot deposition (red circle) signs of direct contact with flames and propagation on top, indicating point of origin further away from there.

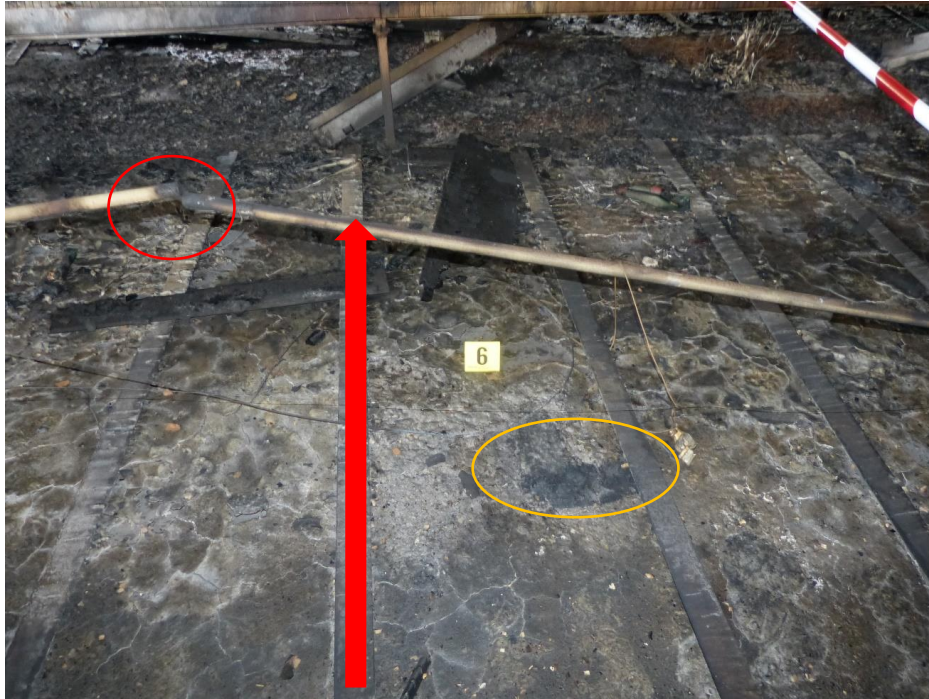
The floor around the second major damage area shows highly combusted and carbonized materials, with still visible residues of the detoxification blocs (Picture 10 and 11). The damage observed on the floor is increasing from west to east (bottom to top of picture) and also the metal bars show a higher degree of oxidation on the top part, indicating a higher proximity to the ignition source, since this damage is caused by high temperatures and direct contact with the flames. The metal bars also show a concentric increasing damage that point towards the area around and underneath the motor (Pictures 12, 15 and 16), indicating a high probability of that point to be the point of origin. The high deformation of the metal bars right in front of the motor indicate a relatively slow heat transfer but at very high temperatures. When having

**Picture 10** - Tag #6 – residues of detoxification blocs (orange ellipse), possible point of origin; high degree of carbonization and combustion can be observed on the floor, indicating a slowly progressed fire; red circle indicates the breaking point of the metal bars, indicating a long and high heat transfer in that point; the red arrow indicates on the metal bars on the floors an increasing damage and carbonization level from the bottom to the top of the picture (west to east).

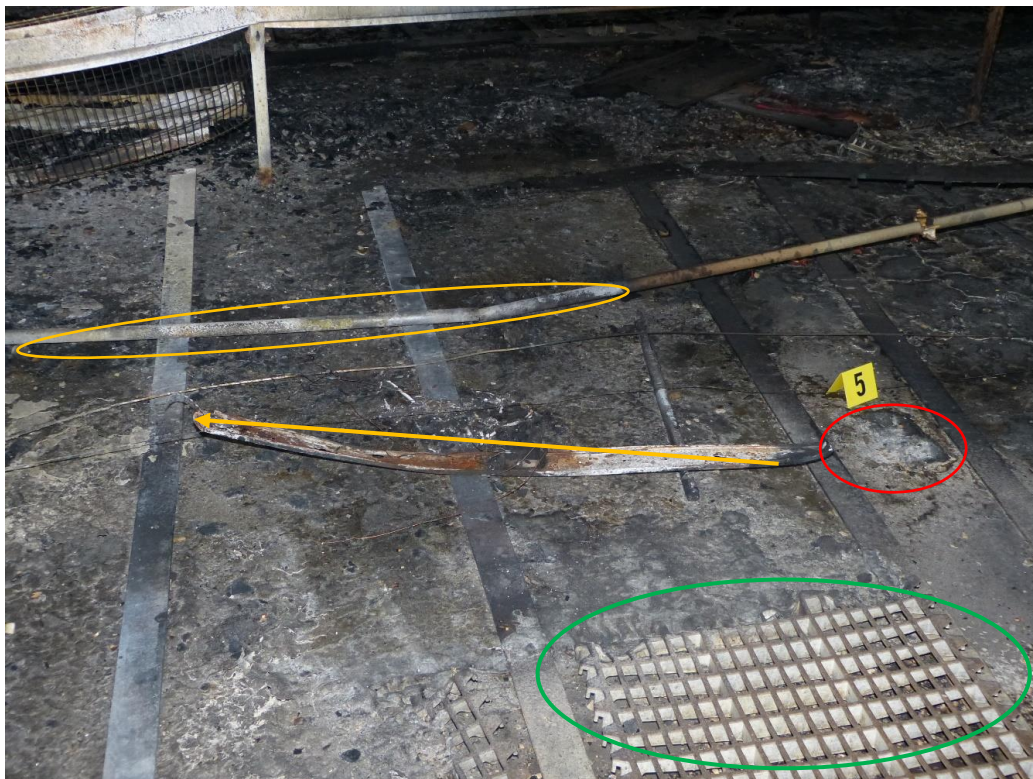
**Picture 11** - Tag #5 – residues of second detoxification bloc (red circle) and potential area for point of origin; signs of high exposition levels can be observed on the metal bars (orange ellipse), increasing from the right to the left of the picture (south to north) with signs of oxidation (orange arrow); presence of part of the PVC-roof (green circle) indicates that the fire was not travelling towards that direction, since it otherwise would have destroyed it completely, but it was affected by radiant heat of being in close proximity of the fire.

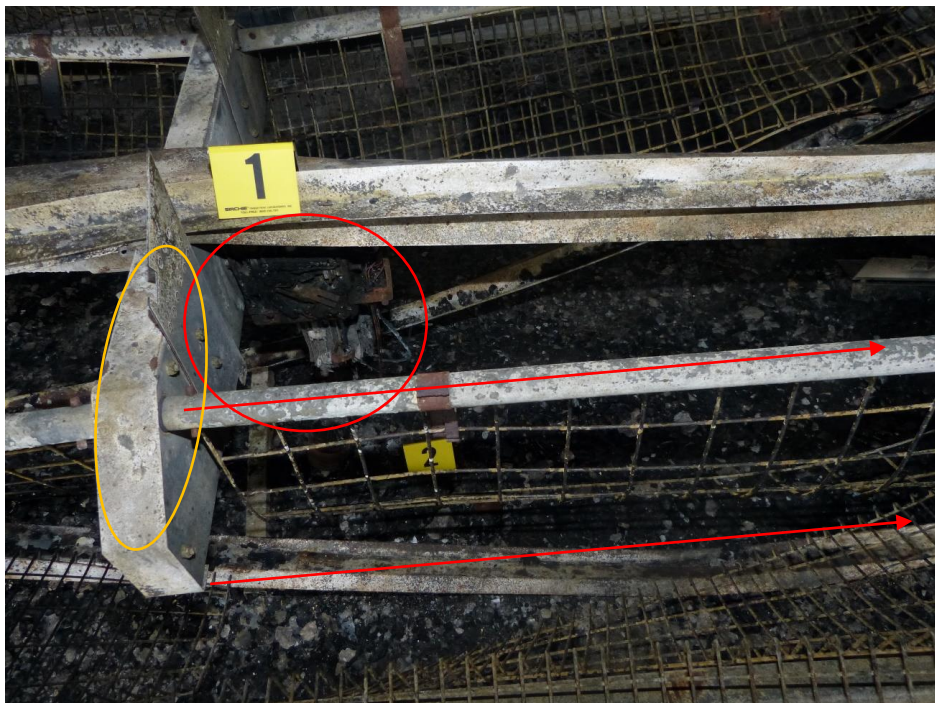
**Picture 13** - Tag #1 and #2 – view from above – high levels of destruction and carbonization (red circle) on the engine; high oxidation and exposition signs on the metal bars, with decreasing levels from left to right (red arrow, north to south); high deformation of metal bar on bottom, indicating high temperature impact and the exposition signs indicate direct flame contact; transversal metal bar (orange ellipse) shows a clean burn pattern, indicating a high temperature and long persisting direct contact with the flame, which makes sense if coming from the engine.

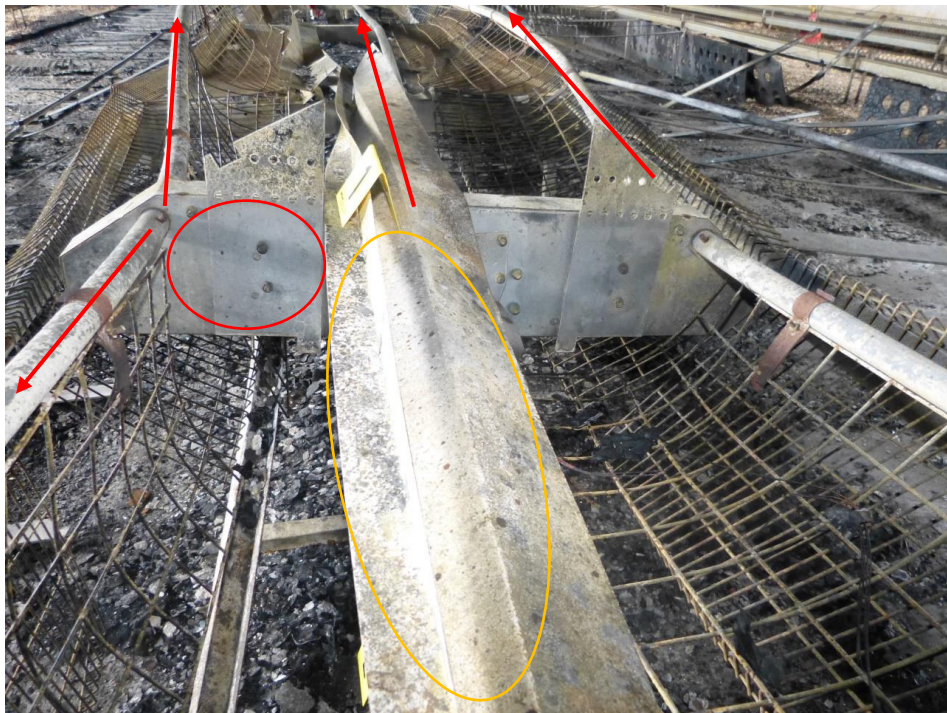
**Picture 15** - Tag #1 – View from the top, south to north – damage decrease from north to south (orange ellipse), side is clear (red circle), indication of direct flame contact for a prolonged time, while the other side is protected; red arrows show direction of propagation.

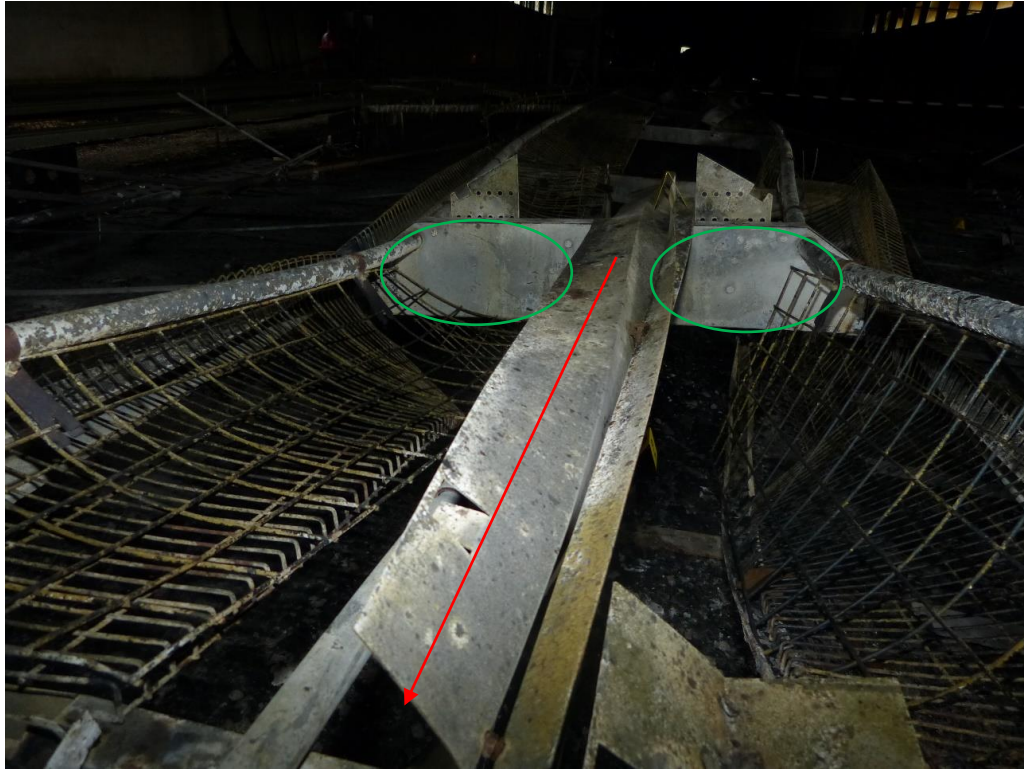
**Picture 16** - Tag #2 – view from the left side (north to south) – middle horizontal metal bar is protected from this side (green ellipses) – vertical bar in the middle shows decreasing damage/oxidation from south to north, confirming the direction of propagation of the fire.

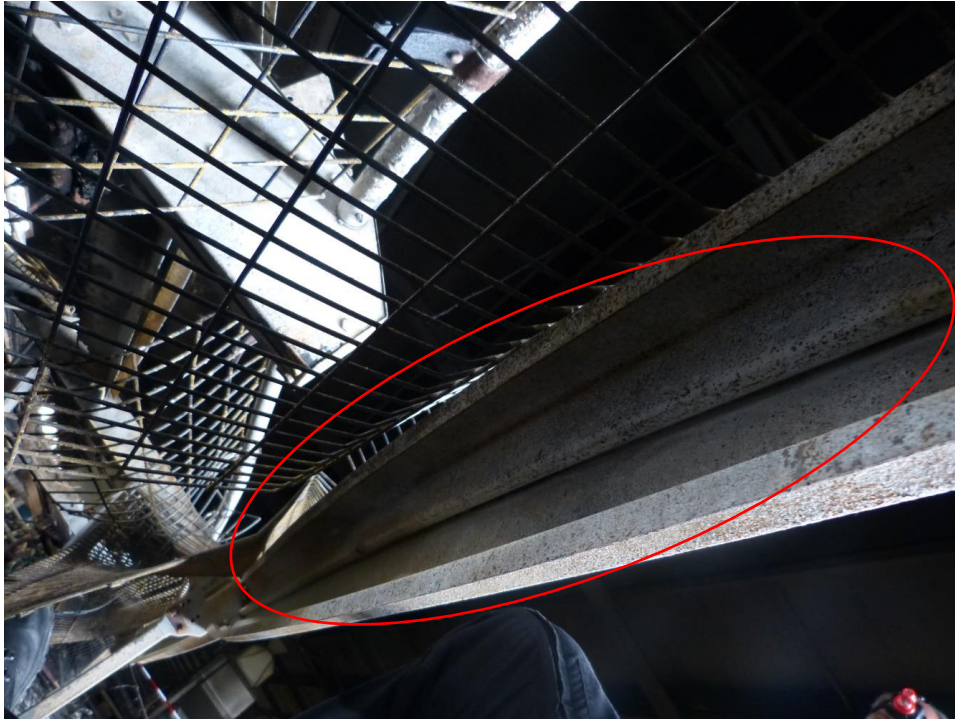
a closer look at the area in front of the motor, a clean burn pattern can be observed, confirming the high temperature impact and therefore the direct flame contact. The motor shows high degree of damage from the front as well as from underneath (Picture 14 and 25), where melted plastic can be observed, indicating that a dropdown occurred. The dropdown also caused a secondary fire, since damage on the area on the floor and underneath the motor (Pictures 12, 17 and 23) do not match with a fire started in the motor and propagated from there. However, this fire was very small and slow, since the metal bars around that area do not show any signs of damage coming from underneath (Picture 18).

**Picture 18** - View from underneath of metal bar on right side of previous picture – protected area (red ellipse), indicating fire did not come from underneath.

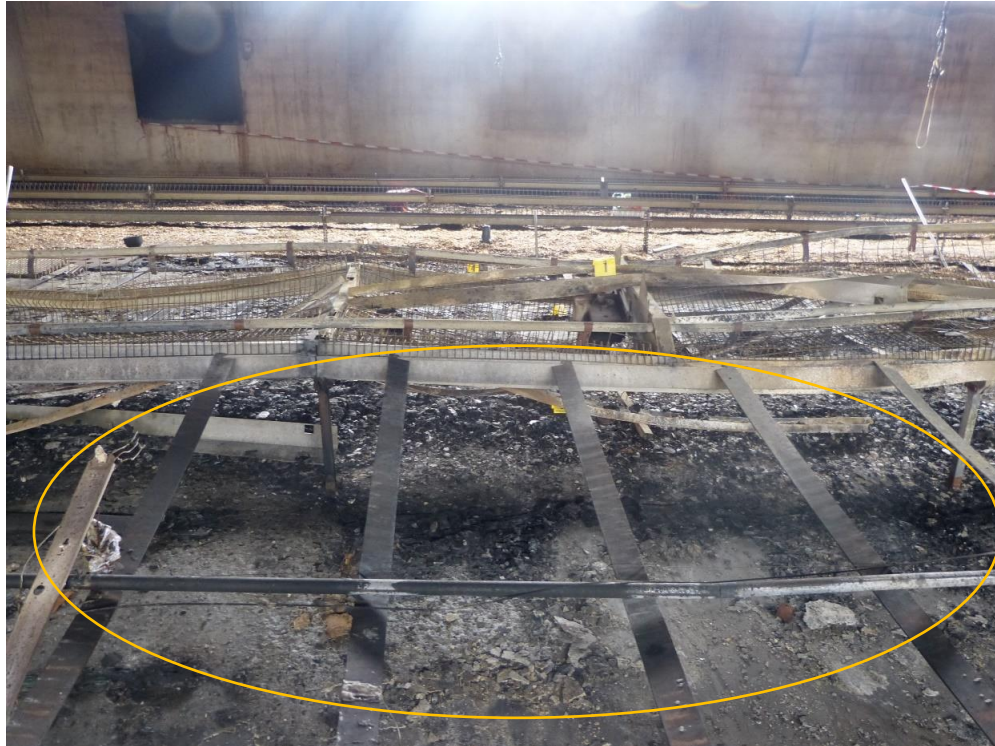
Direction of propagation of the fire starting from the motor and then going concentrically in the surrounding area and the front (west wall) is also confirmed by the less damage observed in the area behind (east) the motor (Picture 20). Removing of the debris underneath the motor (Pictures 27 and 28) does not show any ignitable liquid pattern, confirming that the fire was not caused by an accelerant. The patterns observed around the detoxification bloc (Picture 22) does not match with a fire that started in that point.

**Picture 20** - View from east to west of tags #1-4 – metal bars are still in their original position, even though with levels of soot deposition and damage increasing from west to east; less damaged area than in the area behind (west) tag #1, indicating that the direction of travel of the fires was not towards this direction.

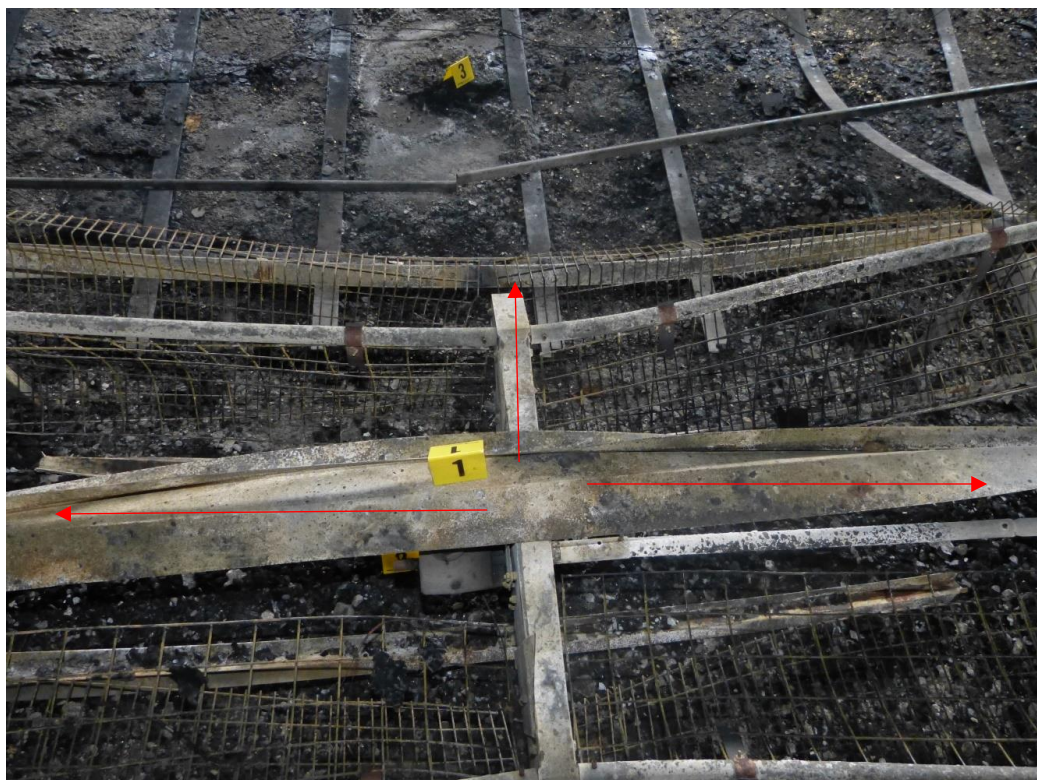
**Picture 21** - View from top of tags #1-3, west (top) to east (bottom) – exposition levels on the metal bars are decreasing from tag #1 in the marked directions (red arrows); again, high deformation of metal bars shows exposition to high temperatures for a long time; high levels of carbonization on the floor (tag #3), indicating also a low level fires in that point.

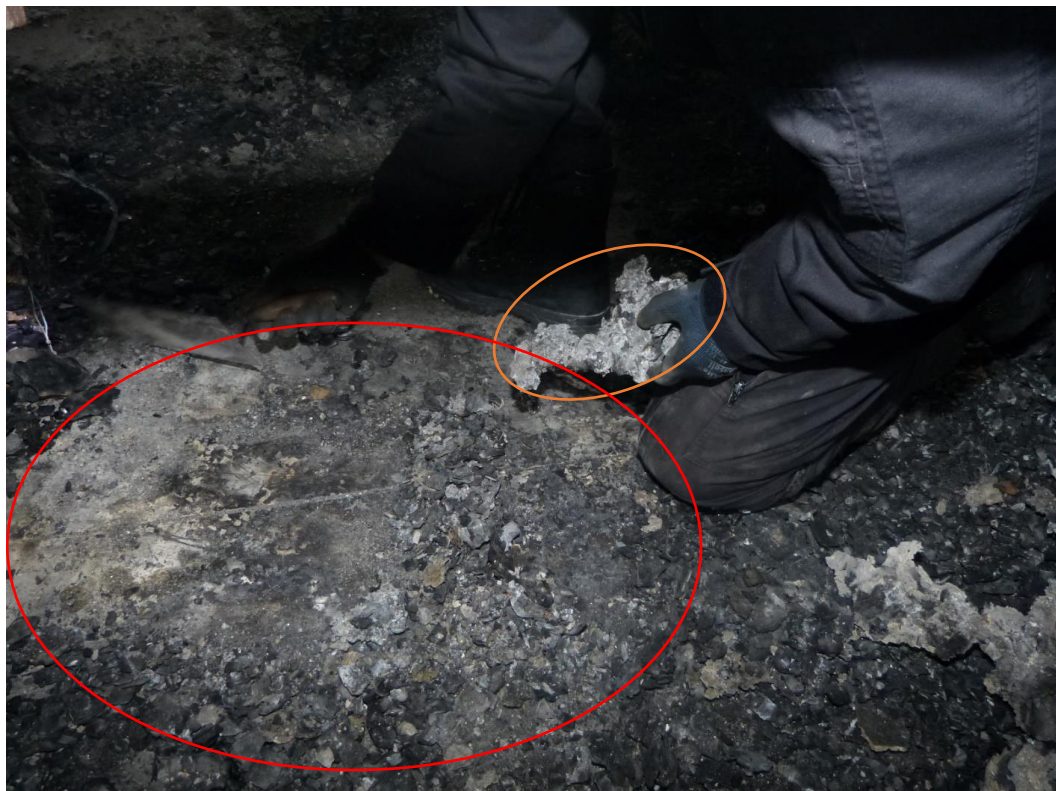
**Picture 27** - View of floor area around tag #2 – completely melted bottom part of the engine (drop-down, orange ellipse); high levels of carbonization, no signs of ignitable liquid residues (red ellipse).

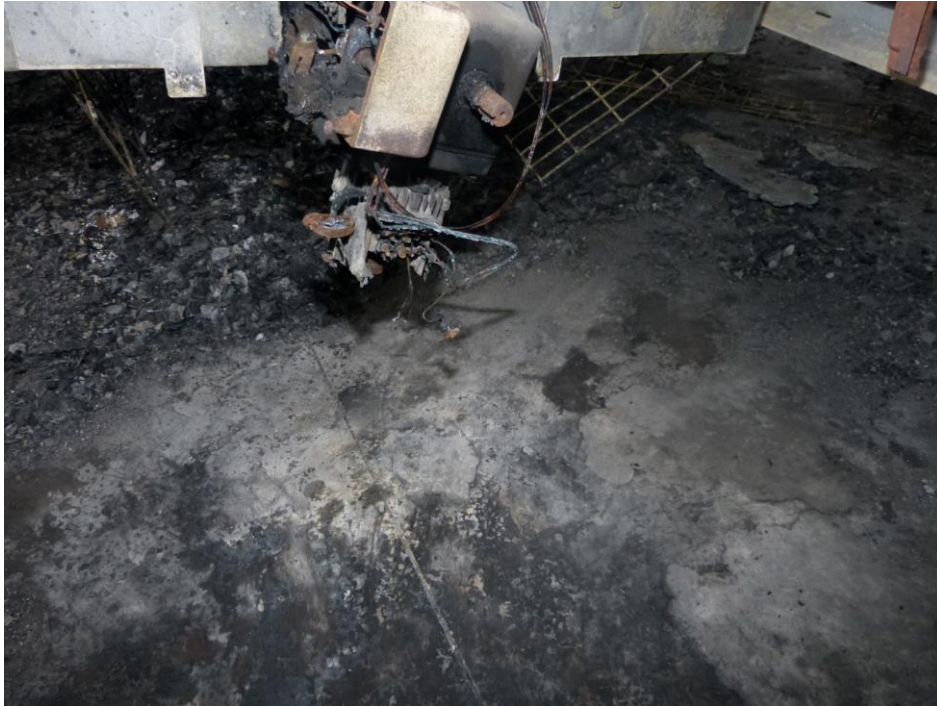
After removal of the debris underneath the motor, no signs of ignitable liquid residues can be observed, confirming that no accelerant was used.

**Picture 28** - View of floor area around tag #2 after removal of fire debris – no ignitable liquid residues visible.
