# **MASTER THESIS**

***“Contribution to Portuguese Urban Fire Investigations  
– Forensic Fire Debris Analysis”***

**STEFANIA OLIVERIO**

**JULY 2016**

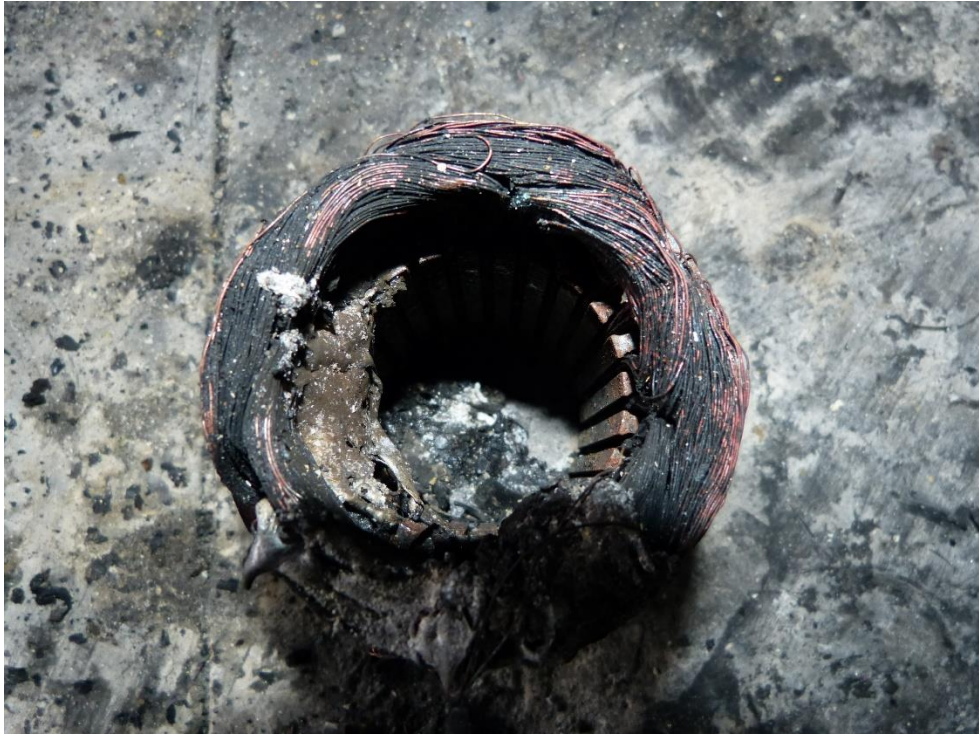
**Picture 31** - View from top of part of motor (tag#1) that dropped to floor.

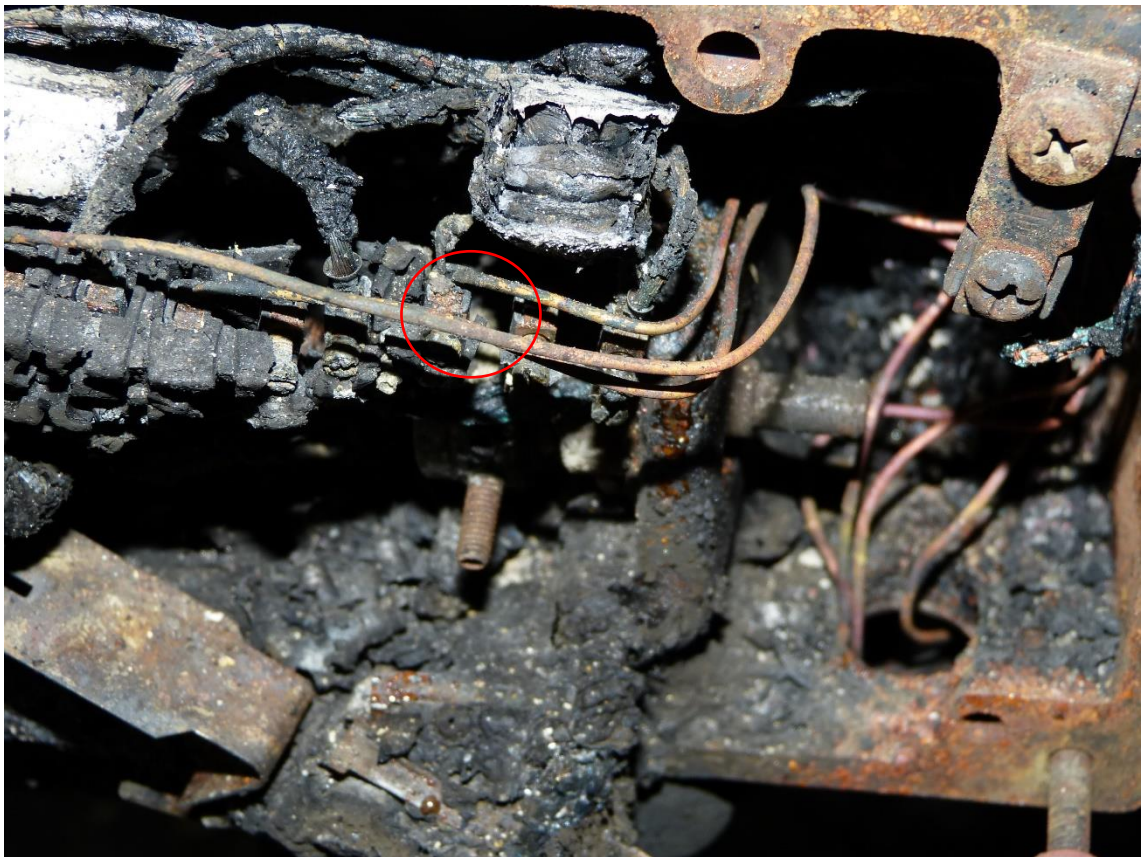
A closer look at the motor shows the highest degree of damage between the 2nd and 3rd contacts (Picture 29 and 32), with a 'V-pattern' observable from there and a high damage area of melted material underneath the contacts. Very high oxidative damage can also be observed on the main metal frame of the motor, also indication of high temperature impact for a prolonged period and of direct flame contact.

**Picture 31** - Close up view of motor (tag#1) from top – point of origin (red circle).

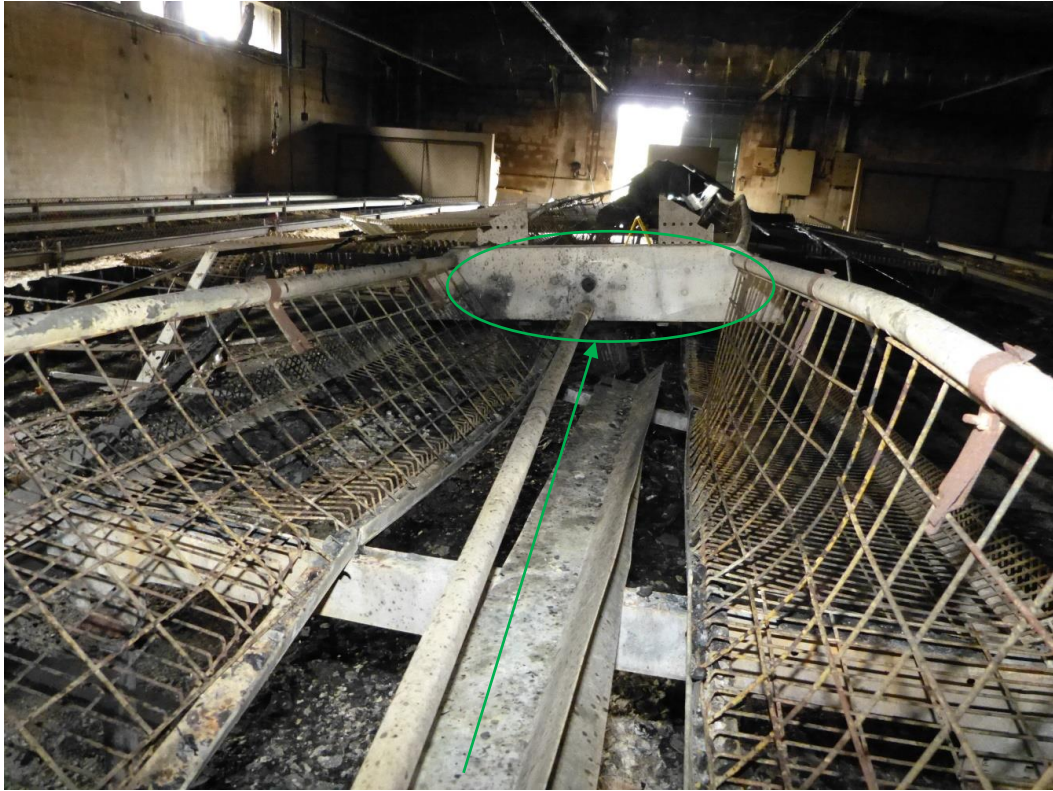
**Picture 34** - Tag #7, view from left side (north to south) – increased oxidation level from north to south (green arrow), protected left side of metal bar on left of tag#7 (green ellipse).

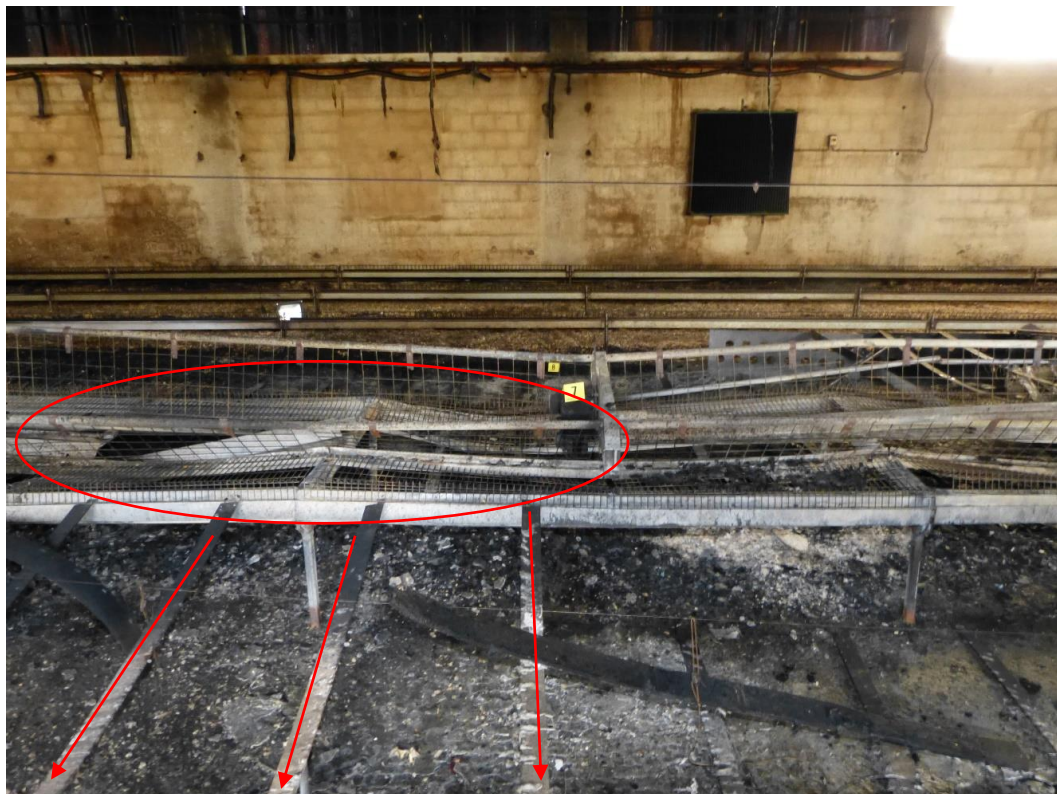
**Picture 37** -View from back of tag #7 and #8 – metal bars show decreasing damage inside to outside, metal grids show more damage and deformation on south side of tag#7 than north side.

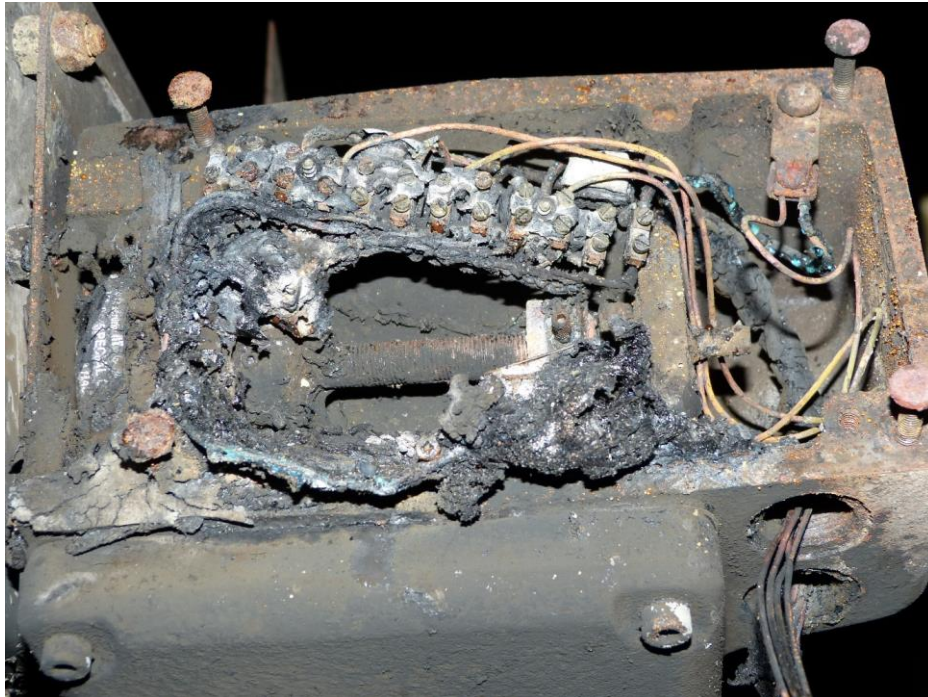
**Picture 39** -Close up view of motor (tag#7) II – high oxidation levels on the upper right side but higher damage levels on the lower left side, indicating that the fire started there, but then traveled downwards.

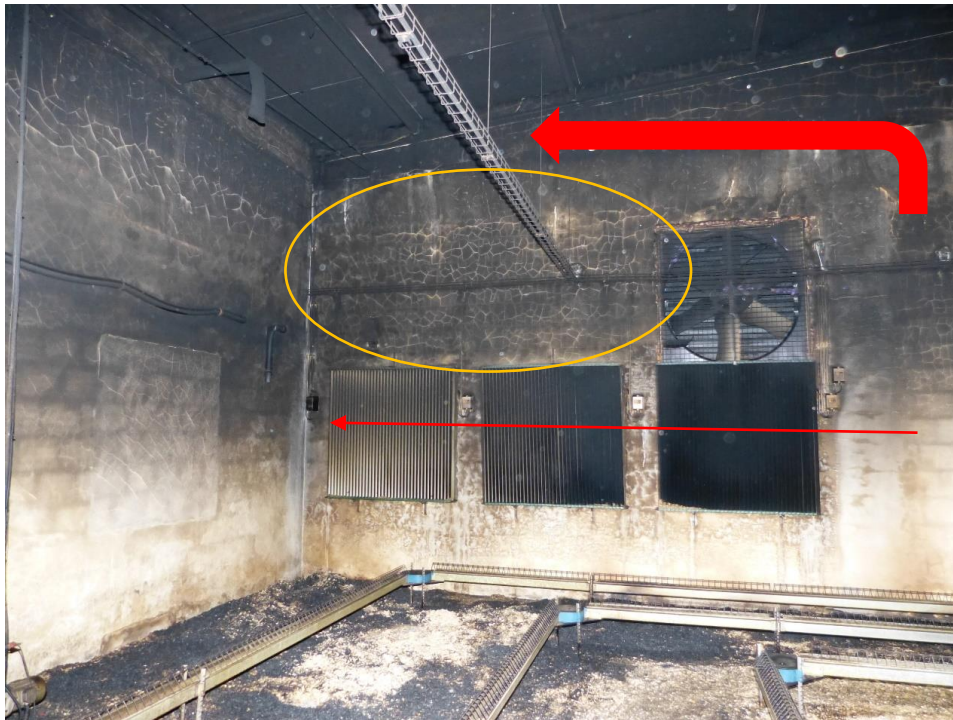
**Picture 42** -Corner of west and north walls – alligator marks (orange ellipse), signs of dehydration after a long persistence of high temperatures and smoke; decreased damage from up to down and from right (east) to left (west).

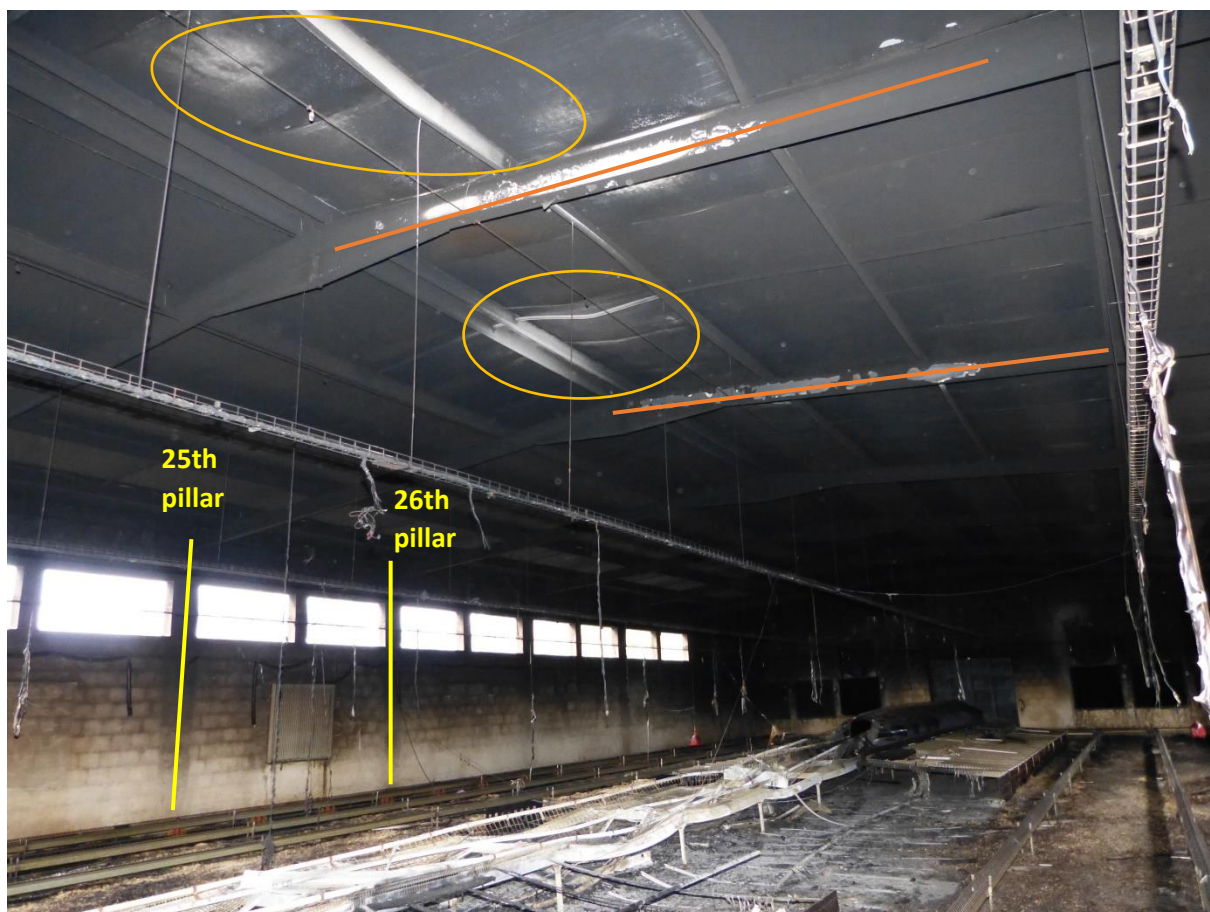
**Picture 44** - Ceiling in rear part of the pavilion, view from east to west – close up view of Picture 49.

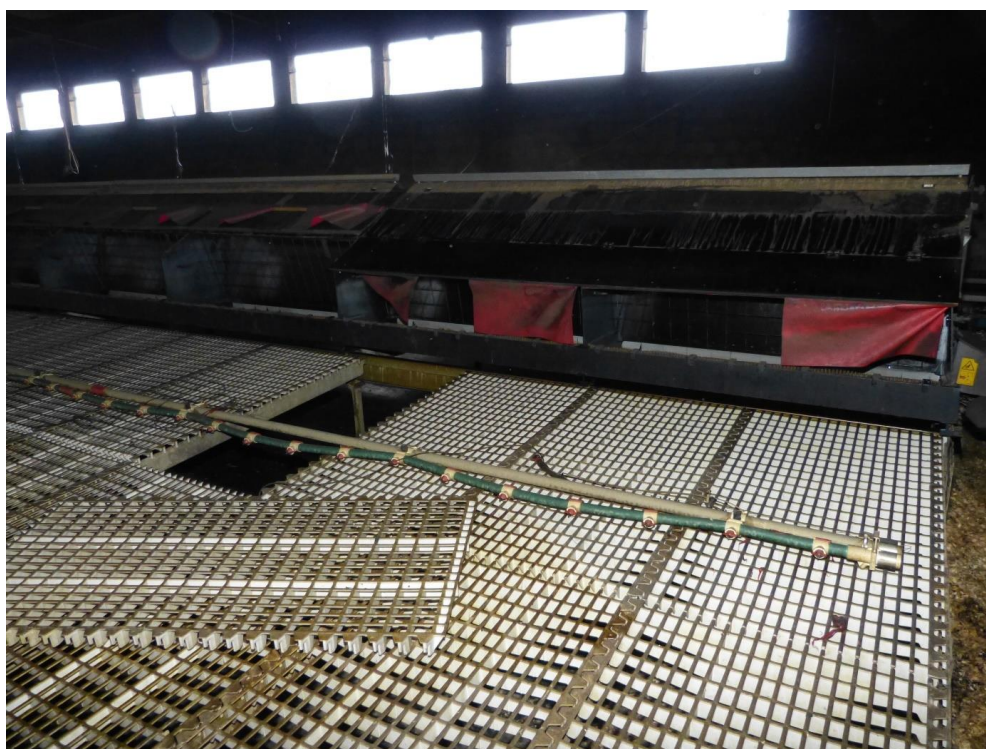
**Picture 45** - Chicken houses without damage – open (left) and closed (right) positions of 'doors', PVC grids, pump with water supply (green).

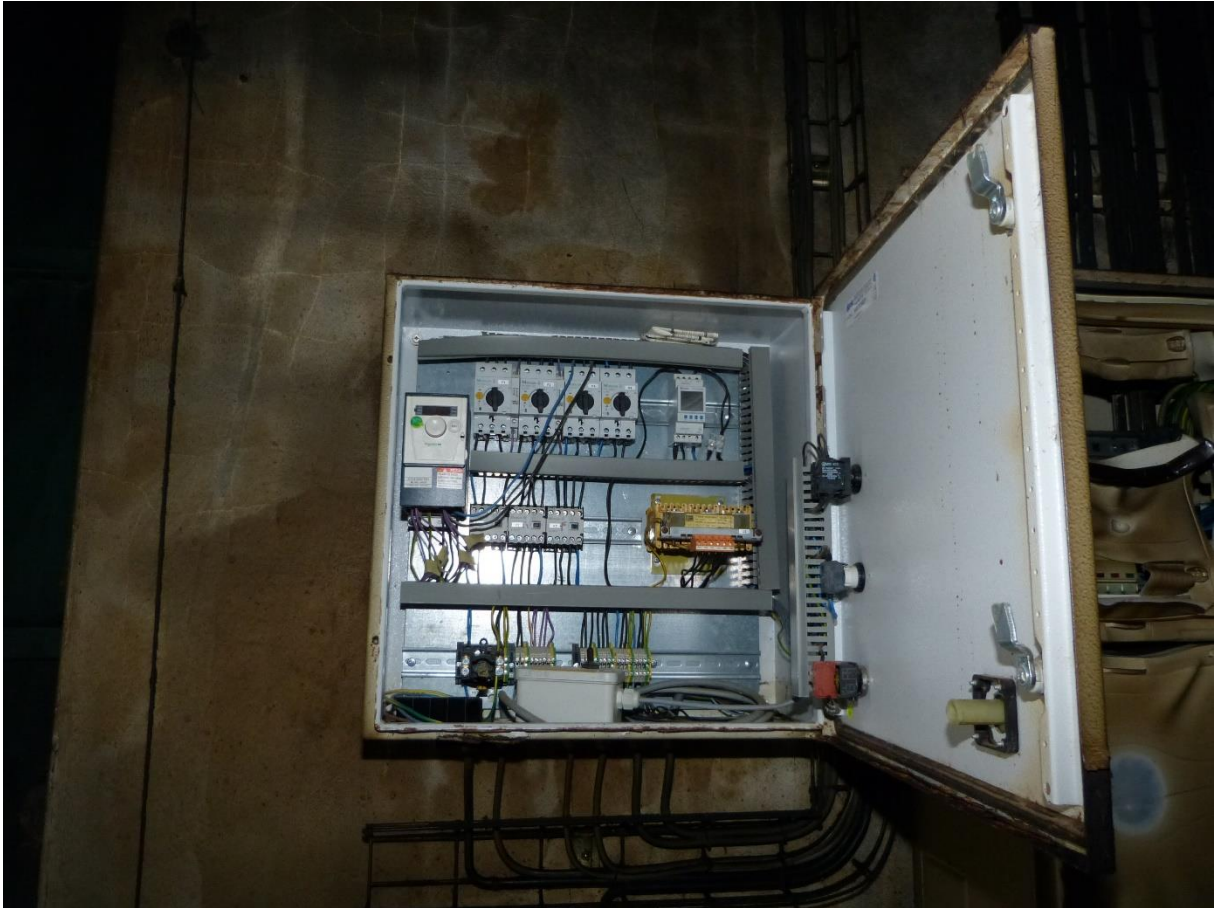
**Picture 47** - Electrical box 2 – timer.

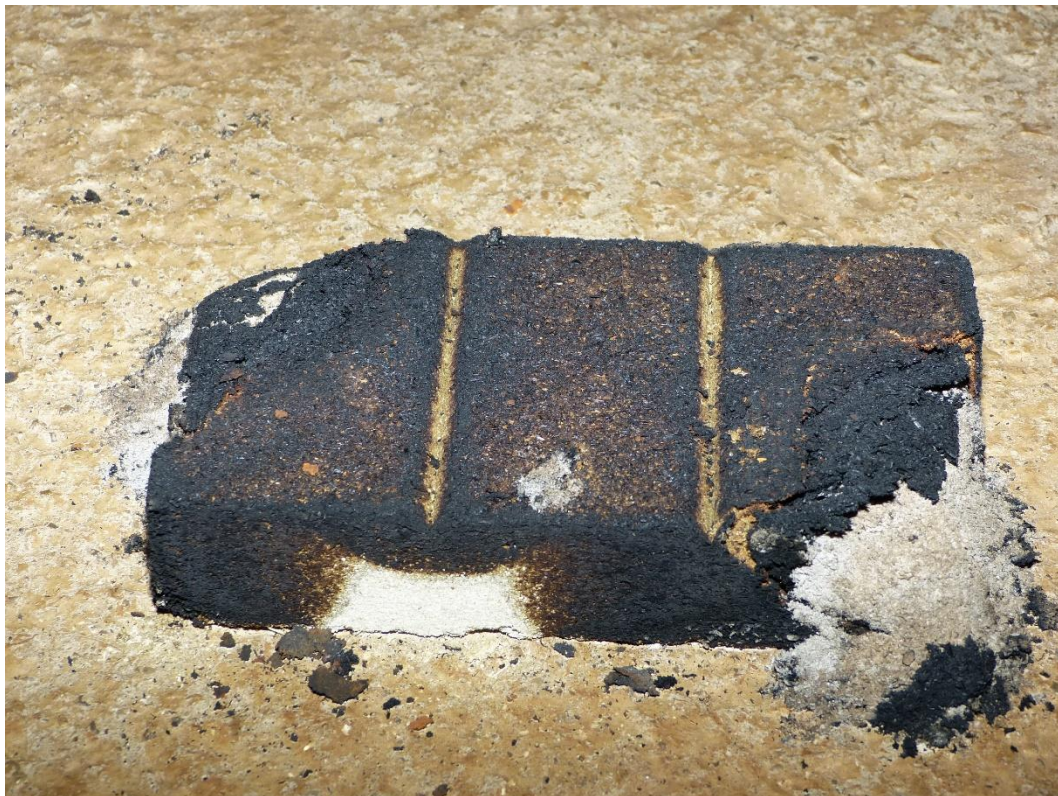
**Picture 48** - Residues of fumigation plaque.

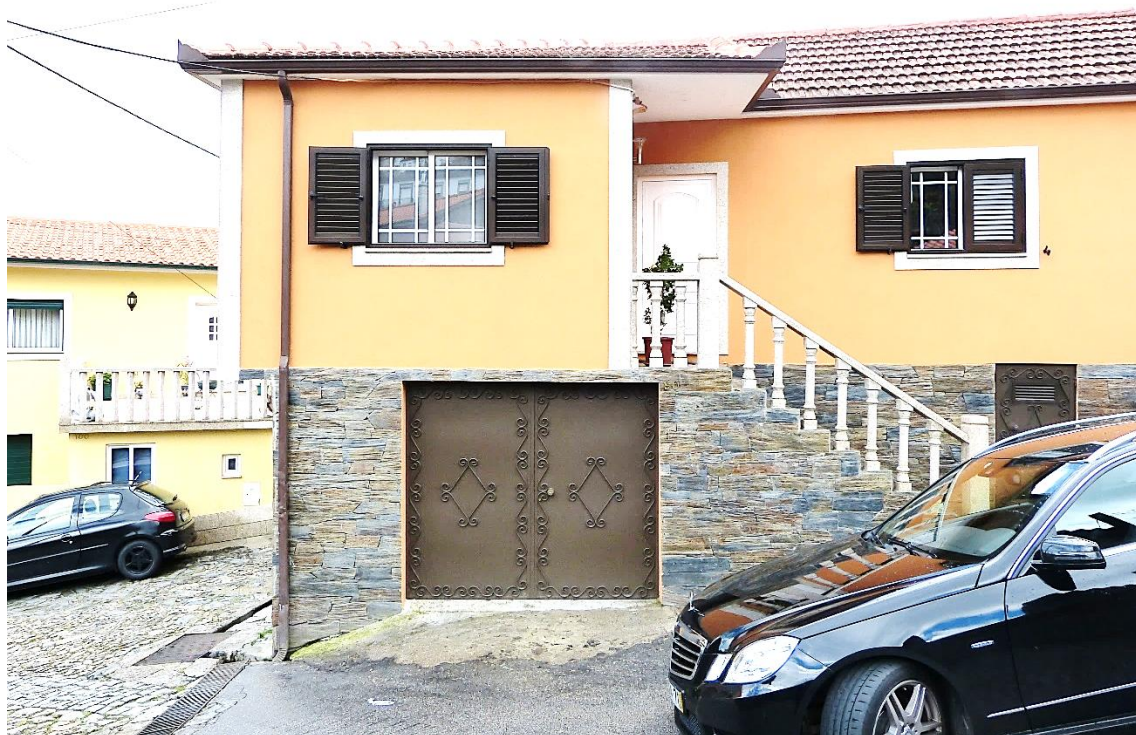
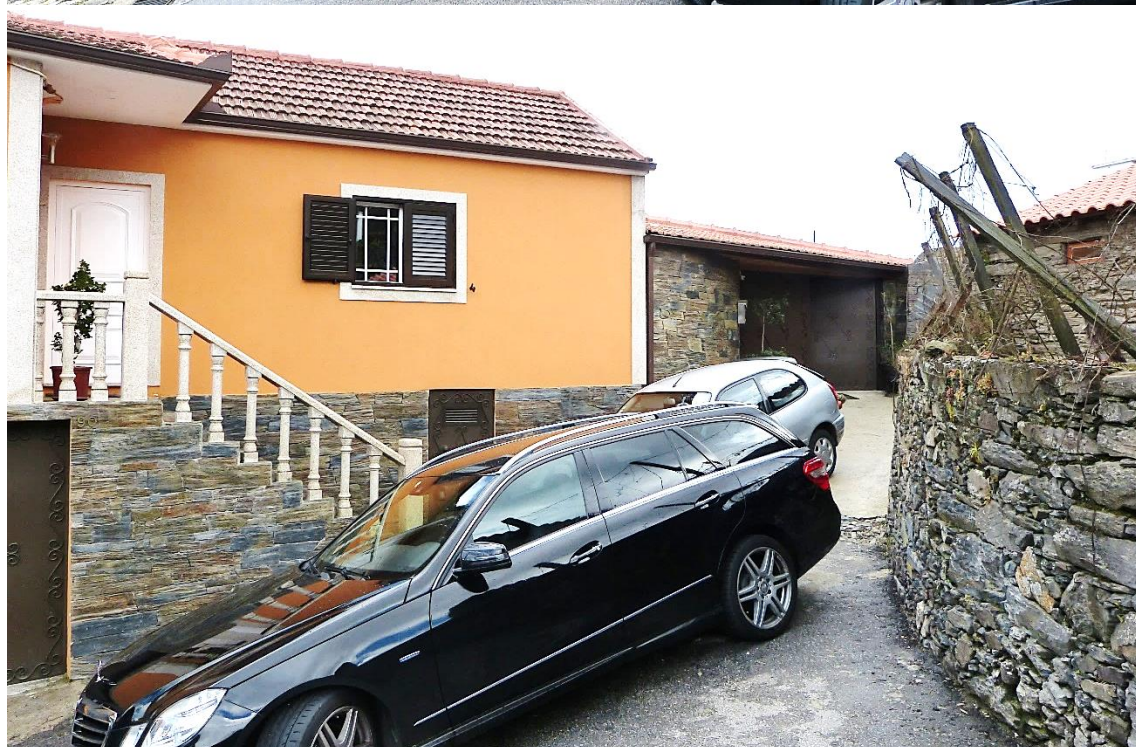
The remaining facades did not exhibit any damage due to its remoteness from the starting point of the fire (Picture 02).

**Picture 02** – No damages were observed in the other parts of the house.

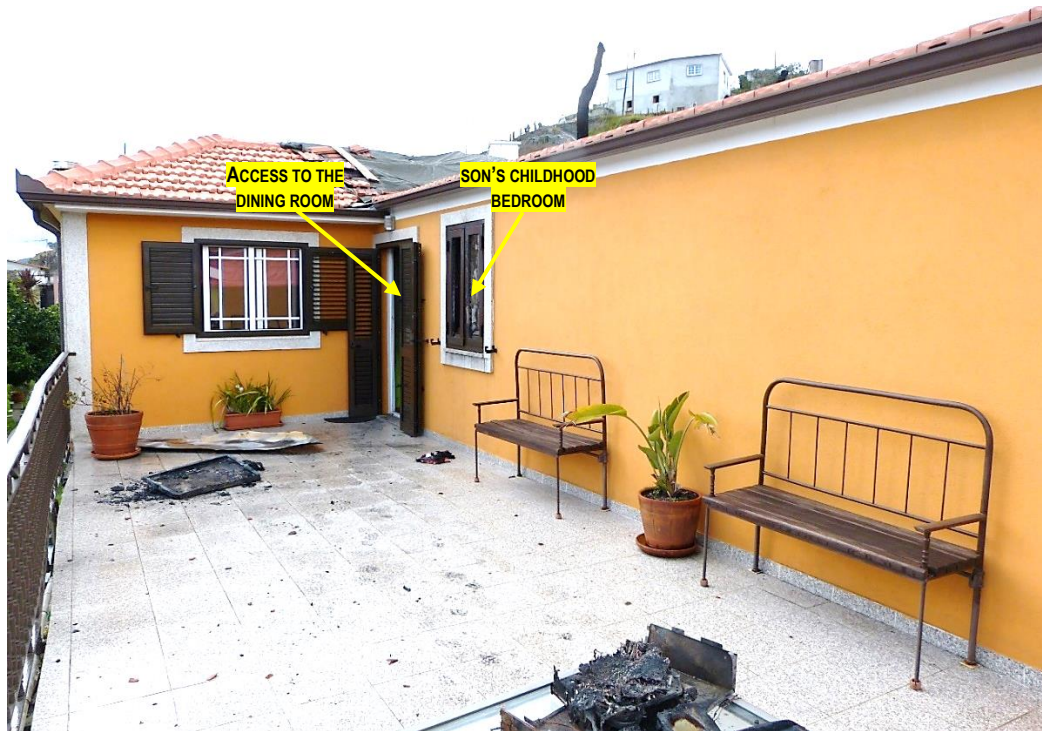
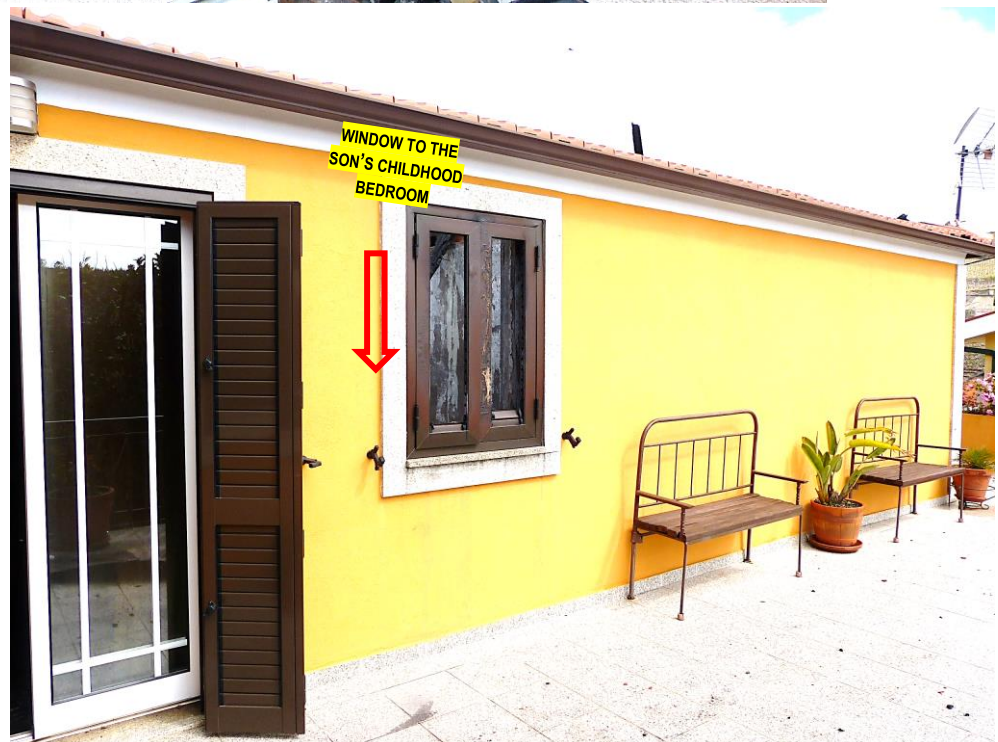
During the analysis in the delimiting facades of the area of the rooms, including the insured's son's bedroom, it was found that the fire acted on the window structures as a result of the heat transferred by hot air currents downwards (Picture 03).

**Picture 03** – View from outside of the window to the son’s childhood bedroom – damage with a propagation direction downwards (red arrow).

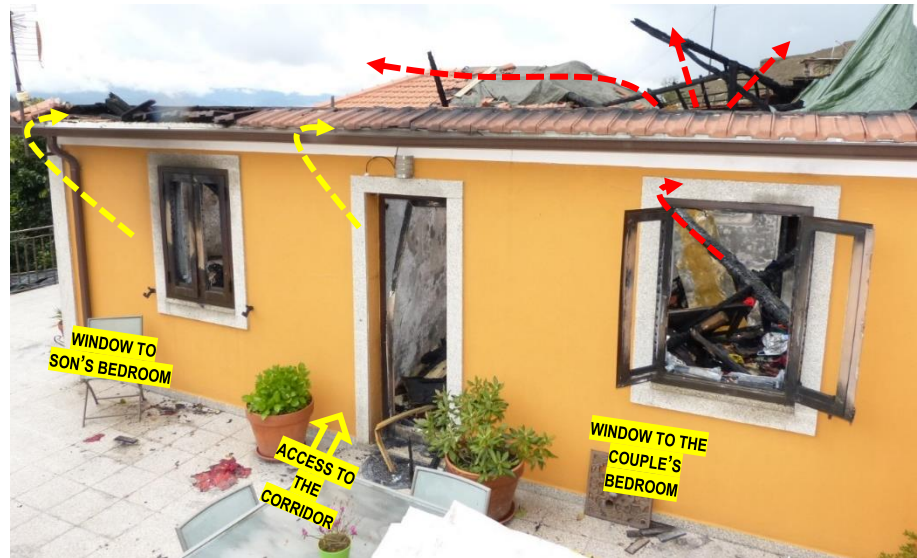
However, the opposite side – couple's bedroom- showed a carbonization circumscribed with low intensity but persistence in time. The observed low exit of the smoke from the room is consistent with the breaking of glass in a late stage of the fire, since the heat received gradually over an extended period of time prevented the establishment of an early phenomenon of thermal shock, characteristics that occur close to the point of origin (Pictures 04 and 05).

**Picture 04** – On the side with access to rooms, two different types of damage are identifiable. In the window of the son's room, as well as the coverage area above a resultant destruction due to a sequential propagation in great amplitude of the available materials –wood and synthetics – is observed, consistent with the distance to the starting point, due to the increased the temperature generated by hot air flows –yellow arrows.

Comparatively, on the opposite side – master bedroom - , the similar structures show a more limited degree of damage, particularly to the window level, where a lower rate of smoke exit is observed. This comes from the action of heat from a slow combustion, which affected the molecular structure of glass progressively, avoiding its abrupt breaking, as opposed to what happened in the son bedroom window – red arrows.

The destruction of the cover above this division was another factor that prevented a high damage the facade, allowing the smoke extraction to occur directly in a vertical way.

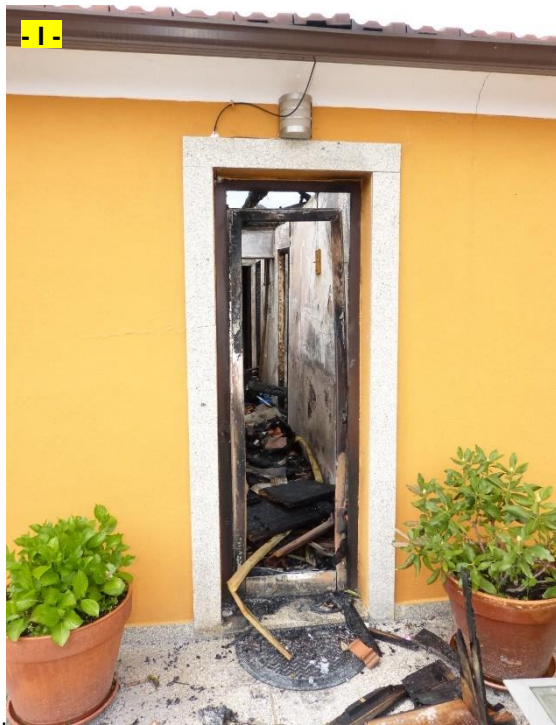
**Picture 05** – In detail the contrast between the destruction observed along the front window of the son's (-II-) and couple's (-III-) bedroom, identifying a sense of clear spread in the latter resulting from a combustion point located at a lower level on the right side –red arrow. On the contrary, in the corridor area and the son's bedroom window, the marks are the result of a heat accumulation in downward direction and in greater range, consistent with a fire already spreading.

After breaking the window glass, as the roof had not collapsed here, smoke extraction of hot air changed direction to being vertical –yellow arrows (Picture II).

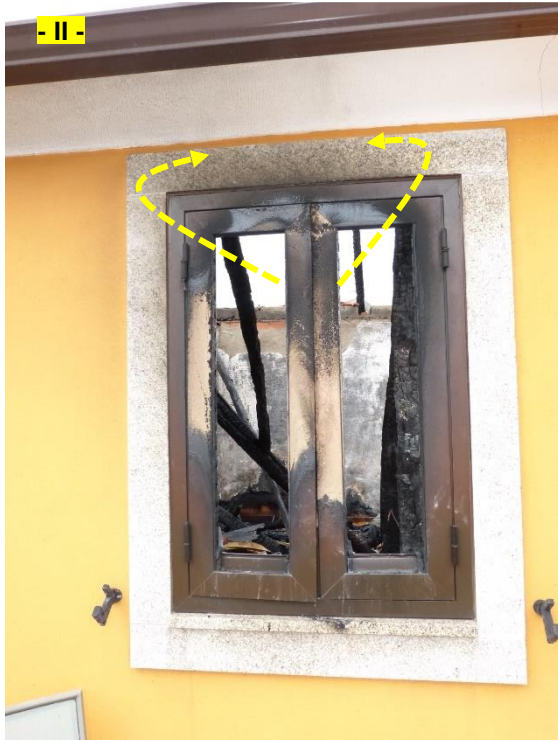
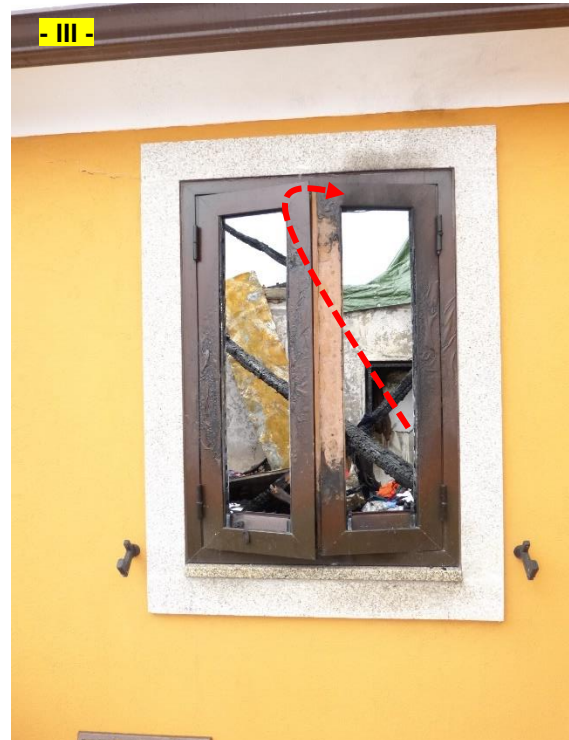
The observation of the damage on this window allowed us to conclude that the right side of the aluminum frame – observed from the front of the window- showed a destruction level confined to a small section, which coincides with the reception of heat slowly from a heat source located on that side of the room and at a lower level (Pictures 06 and 07).

**Picture 06** – The master bedroom window shows, albeit to a lesser extent, a higher concentration of the damage on the right side of the aluminum frames –yellow frame-, in line with the incidence of a low heat source with intensity but slowly – red arrows - from a point below and located on that side.

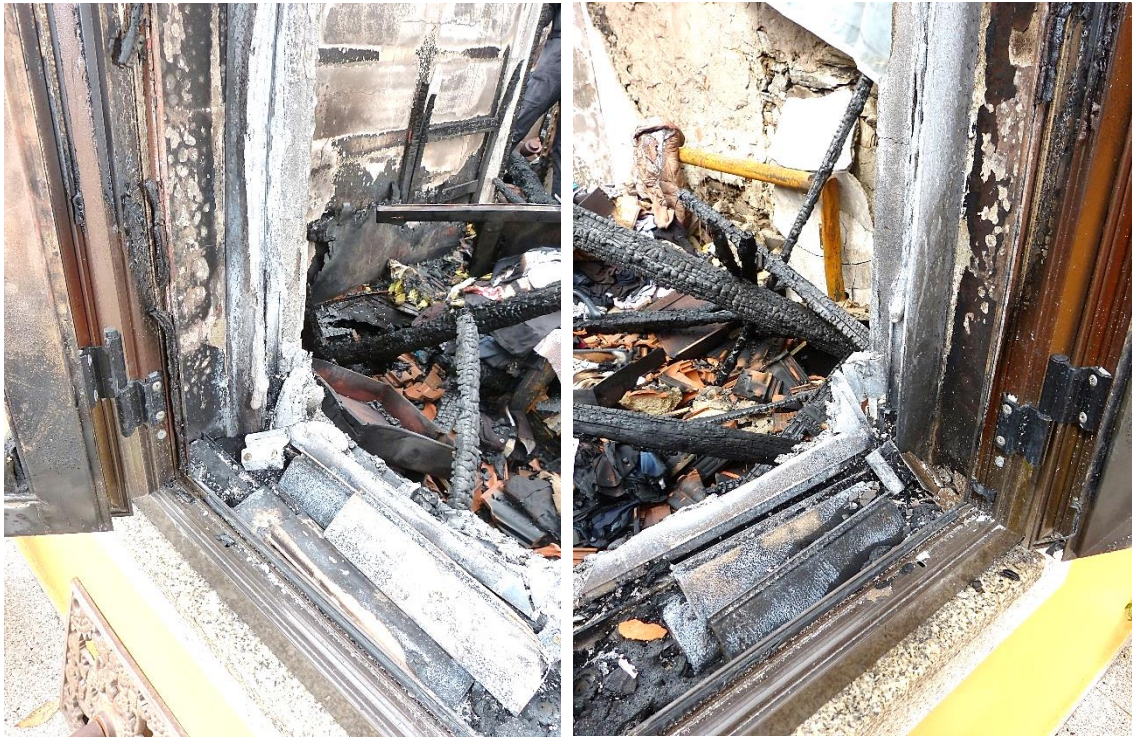
**Picture 07** – Lower part of the window, confirming the direction of propagation.

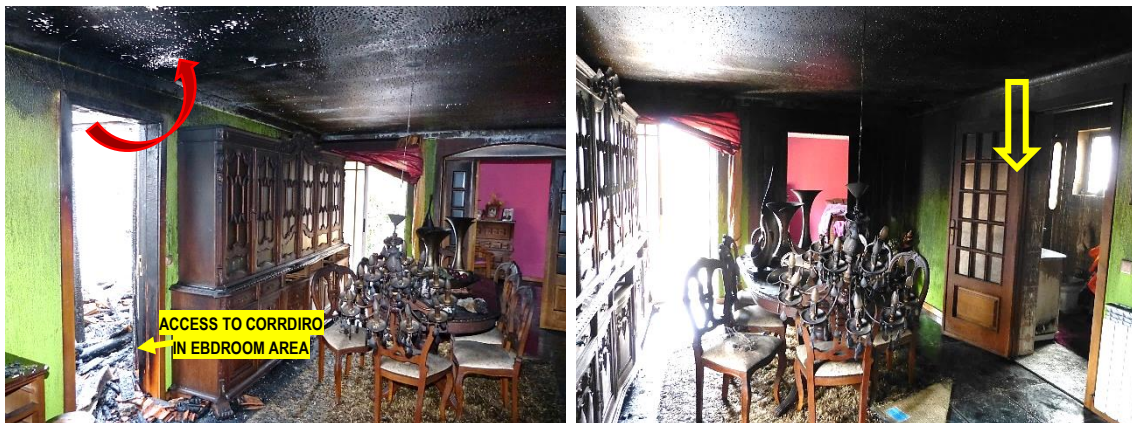
**Picture 08** – General view of the dining room and access to the corridor leading to the bedroom area – damage observed on the ceiling – red arrow and in a downward direction - yellow arrow.

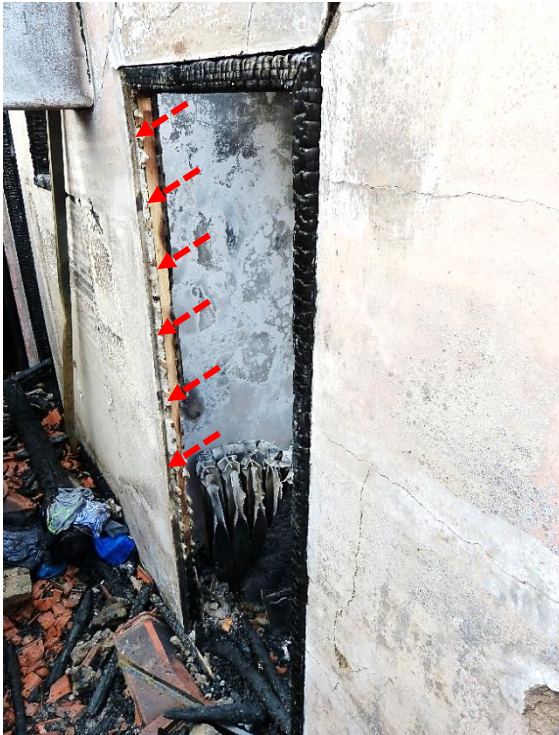
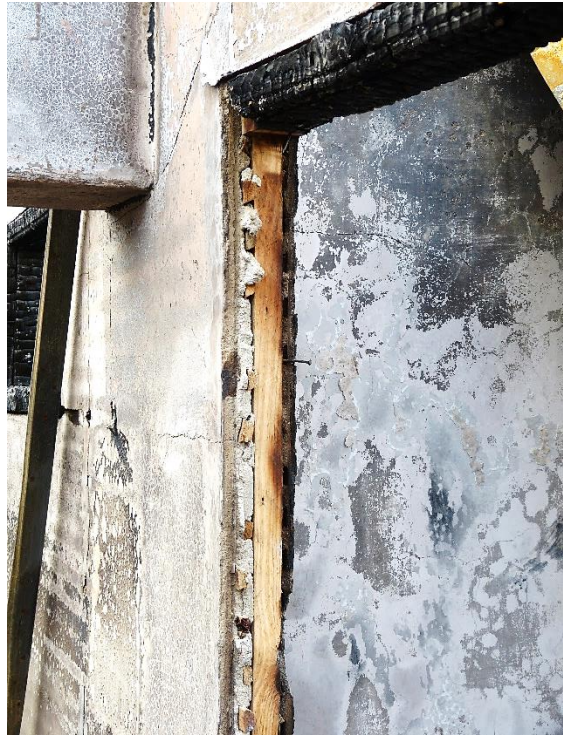
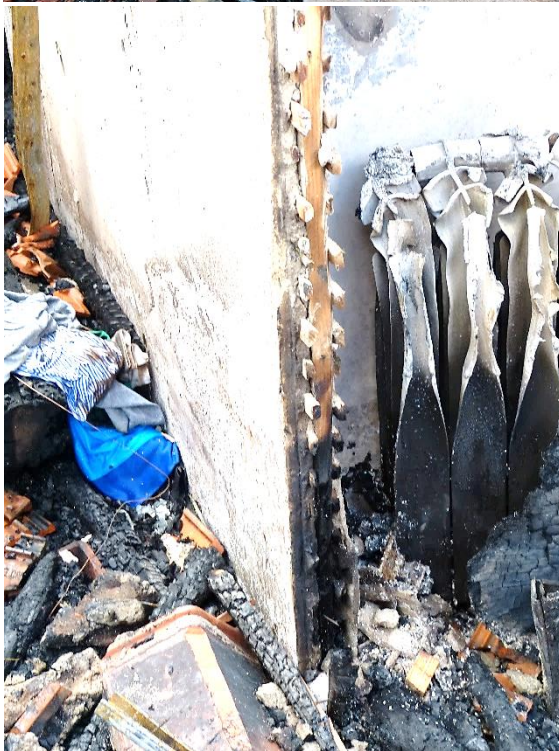
This damage is due to a greater exposure in time of the material of that side, to the action of heat downwardly along the corner as a result of the position of the door in that moment (open) (Picture 11).

**Picture 11** – Access door to the master bedroom. Major destruction of the doorjamb on the wall opposite to the window is observable.

This derives from a higher accumulation of hot air downwardly and over a longer time period, due to the door being open at the time of the start and spread of the fire-red arrows. The same type of damage is observable on the radiator, which is located behind the bedroom door.

It's confirmed that this is the room where the fire had its origin.

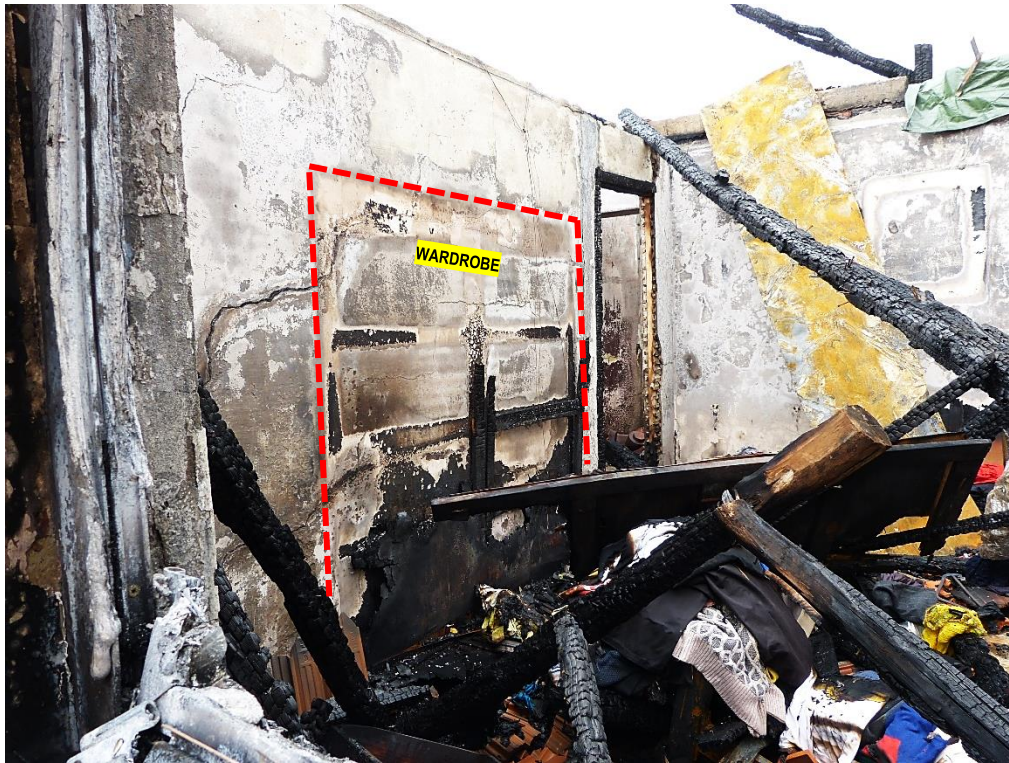
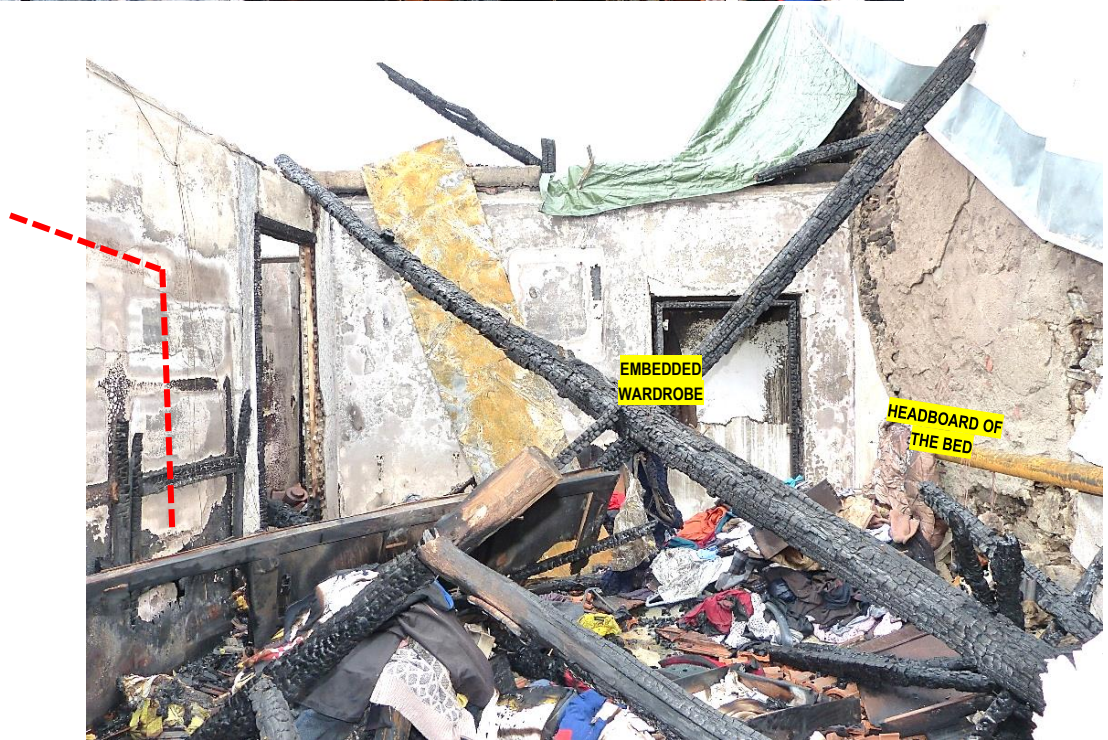
The walls exhibited a similarity, in what the degree of damage is concerned, due to the combination of the generated calorific power and, after the bulging of the upper structures, which occurred due to oxygenation of the space which promoted the destruction of the outer wall layer, which is in greater depth in the section at the head of the bed due to the closeness to the initial heat source (Picture 12).

**Picture 12** – Overview of the room where the fire started. To be noticed, a greater depth in the degree of damage can be observed, particularly on the wall at the bedside, consistent with proximity to the initial heat source. In the wardrobe leaning against the opposite wall, the damage occurred in the downward direction by the effect of convection currents – red line.

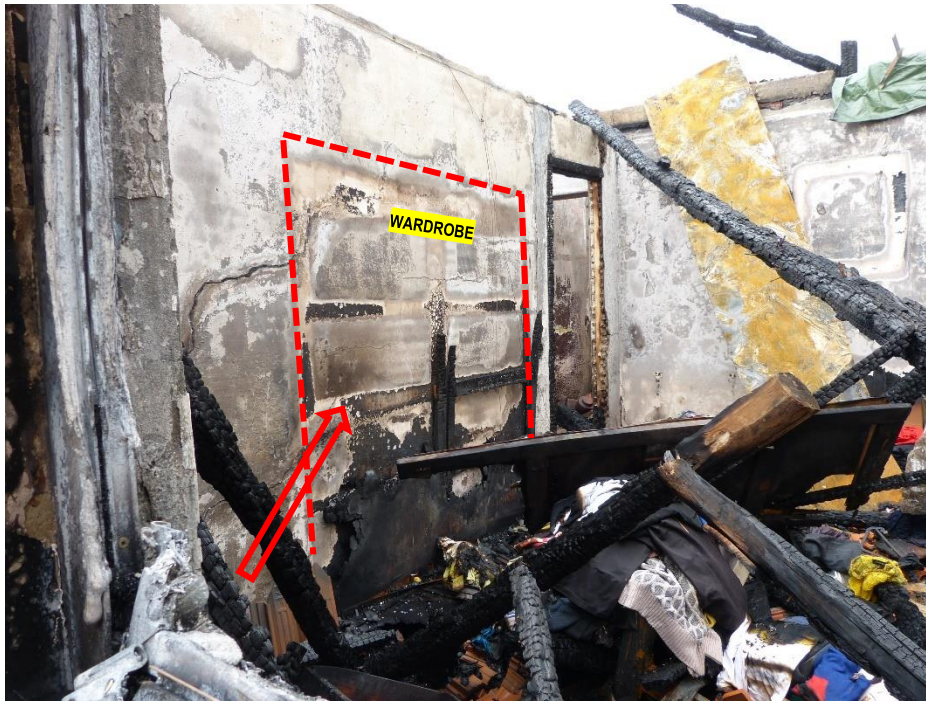
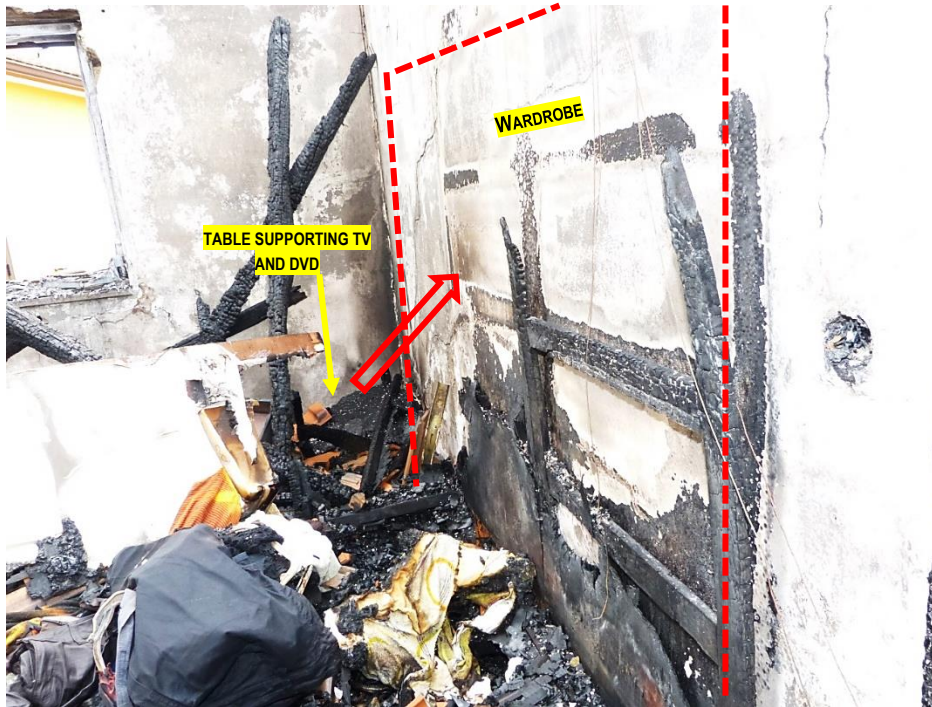
Further in the investigation, it was found that the wardrobe was in damaged atypically and with a "V"-shape pattern, with the greatest concentration of damage on the right side of it and from a lower level next to the corner, in line with the transmission of heat by radiation (Picture 13).

**Picture 13** – Observing the heat transfer along the wall where the closet is located, a degree of atypical damage is seen, with a higher degree of carbonization on the left side and starting from a low level, as well as a damage in "V"-shape, resulting from heat received by radiation from the combustion of table, which was covered with a cloth, that supported the TV and DVD –secondary fire-.

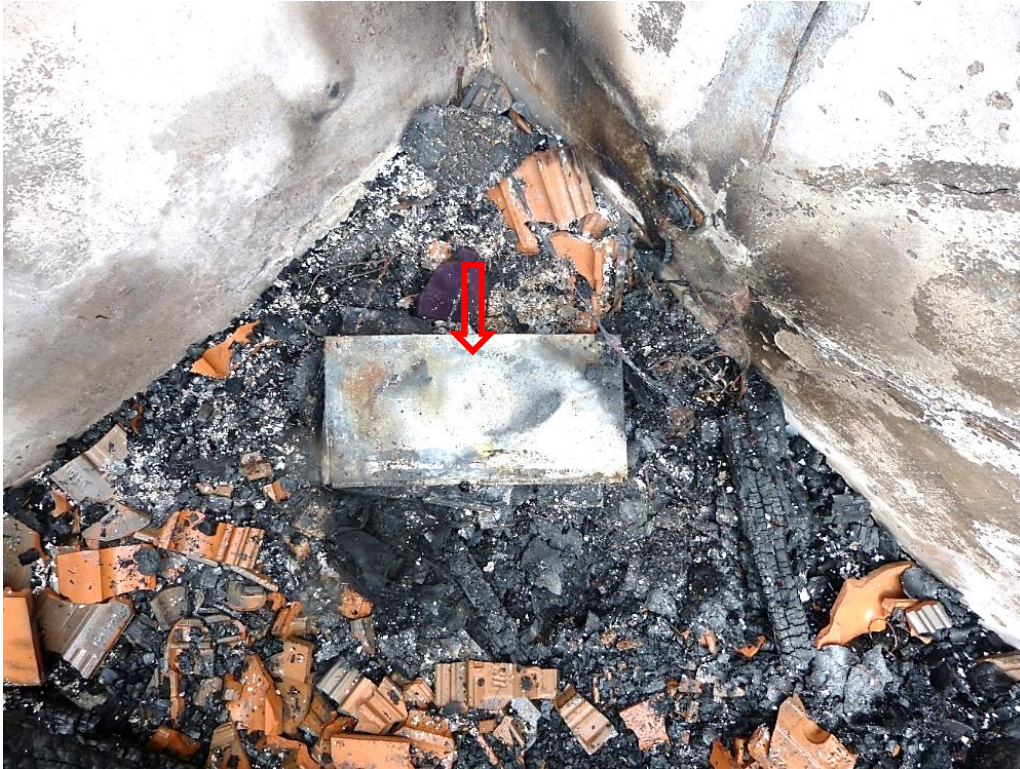
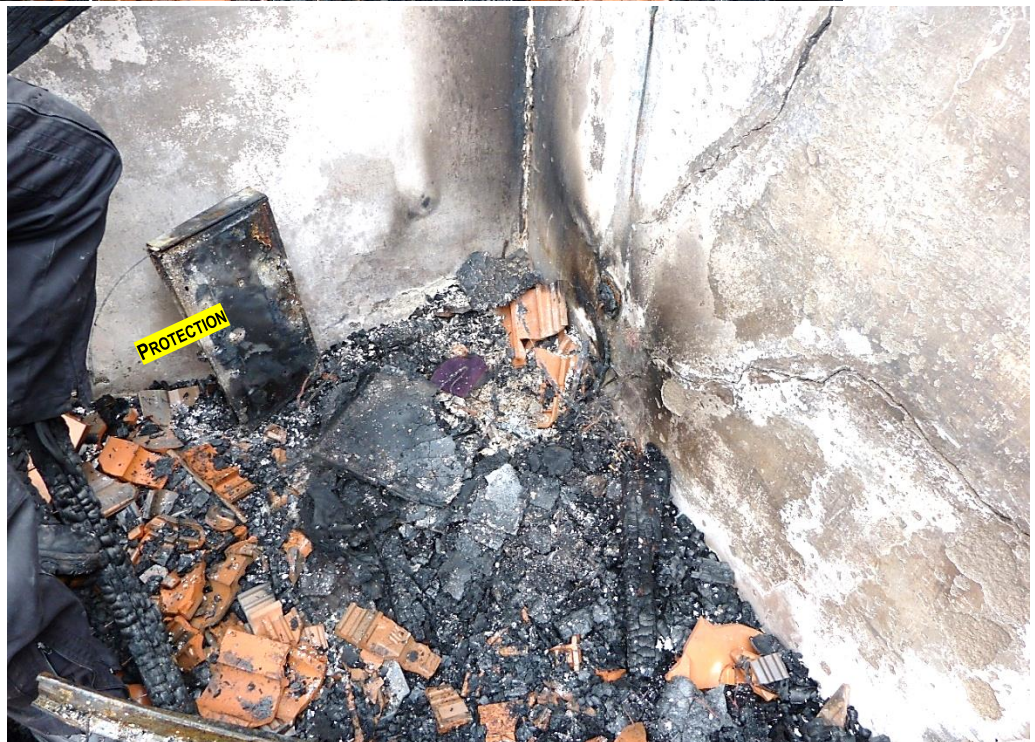
After removal of combustion residues was possible to recover the DVD player (which was not connected) and the TV, which also evidenced a homogeneous destruction due to the hot air from an external heat source (Pictures 15, 16 and 17).

**Picture 15** – In the same area the DVD player was recovered, which was disconnected and located on a shelf below the top of the table and showed a similar damage concerning the degree and direction –red arrow.
