# **MASTER THESIS**

***“Contribution to Portuguese Urban Fire Investigations  
– Forensic Fire Debris Analysis”***

**STEFANIA OLIVERIO**

**JULY 2016**

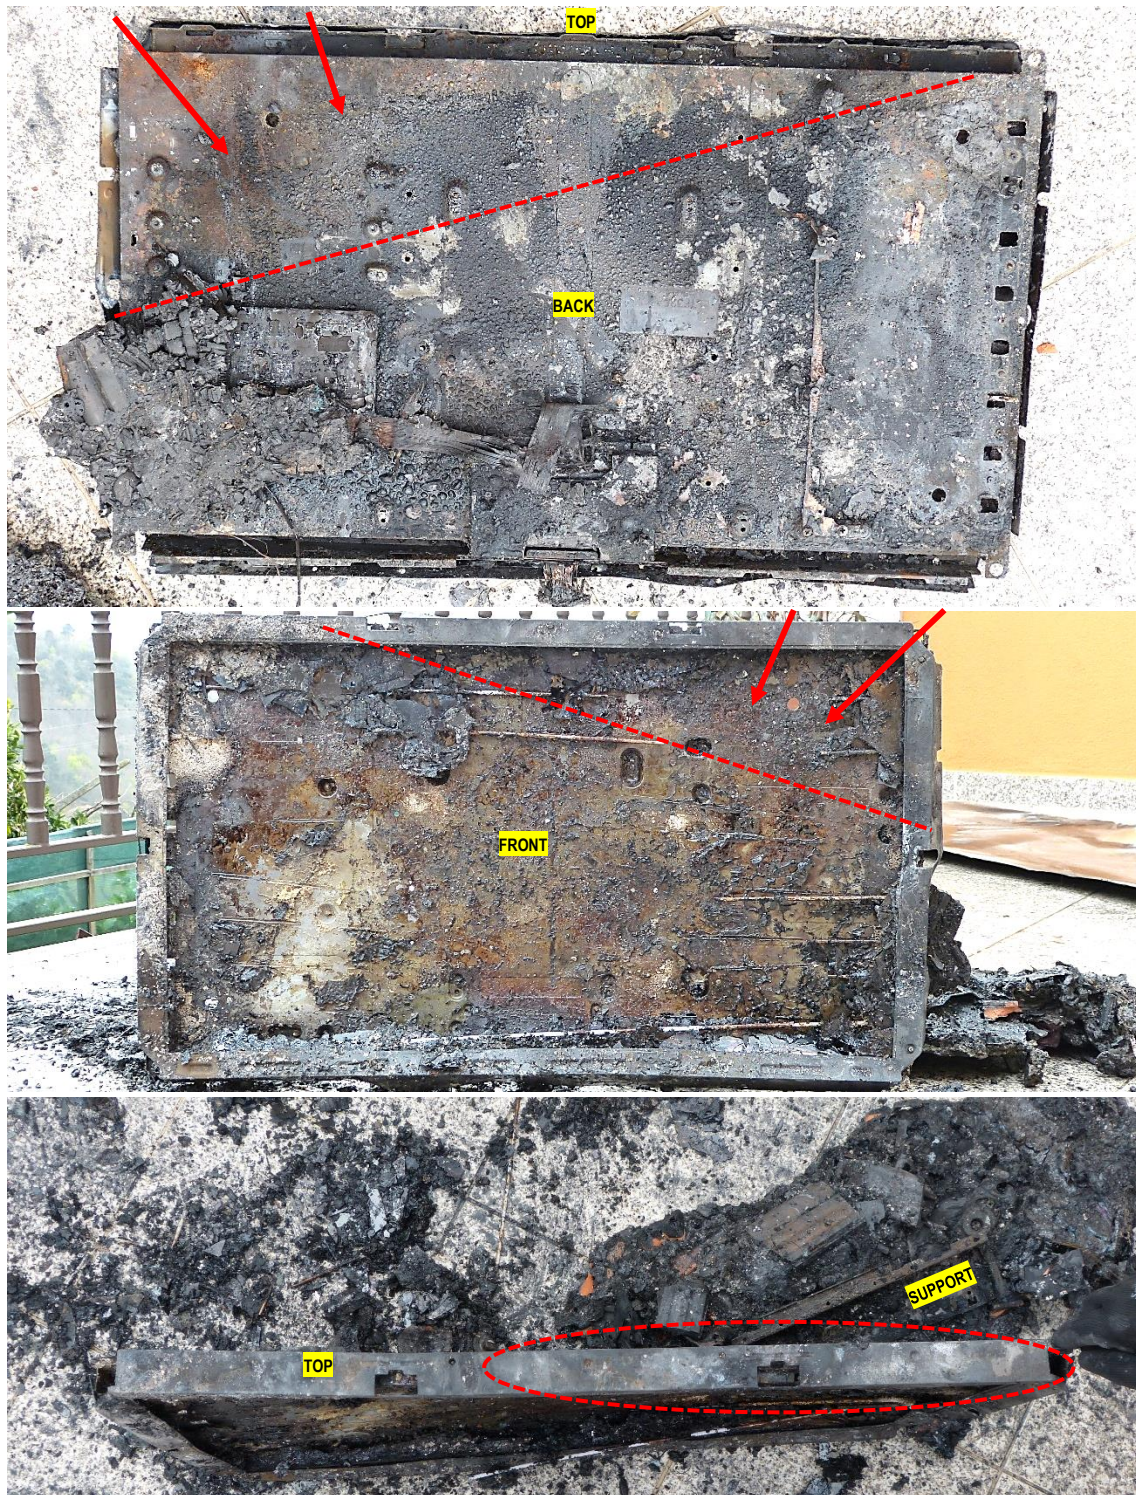
After removal of combustion residues was possible to recover the DVD player (which was not connected) and the TV, which also evidenced a homogeneous destruction due to the hot air from an external heat source (Pictures 15, 16 and 17).

**Picture 17** – View of the TV, with observation of the direction of propagation being from outside to inside and from the right side (direction of observation) upwards, which has a high level of oxidation due to the exposure to convection currents. This indicates that the heat source was located on the opposite side.

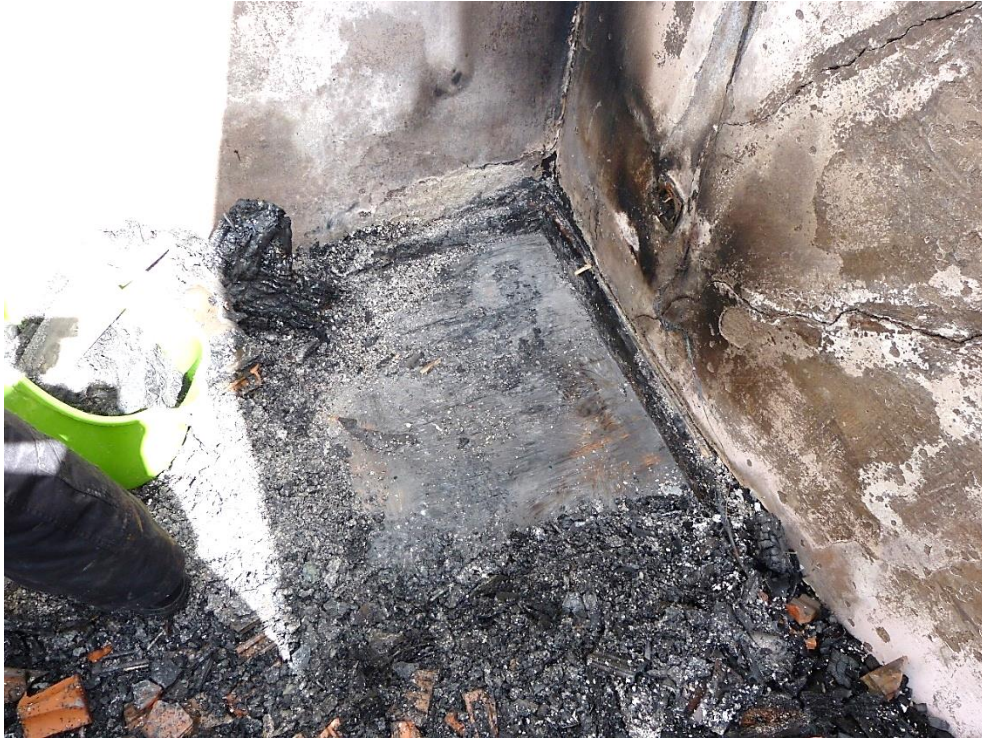
In addition to identifying the location of this secondary focus, it was also confirmed that no ignitable liquid was spill on the pavement, due to the evidence and analyzed patterns after removal of the debris around that area. It can be seen that the parquet floor was protected, which would not occur if ignitable liquid was poured on it (Picture 18).

**Picture 18** – Detailed view of the floor where the table was located (see previous photos). After removing the debris, there was the absence of any damage to the floor level, which allows us to exclude that a fire started at that point, especially with the use of an ignitable liquid as a fire accelerant.

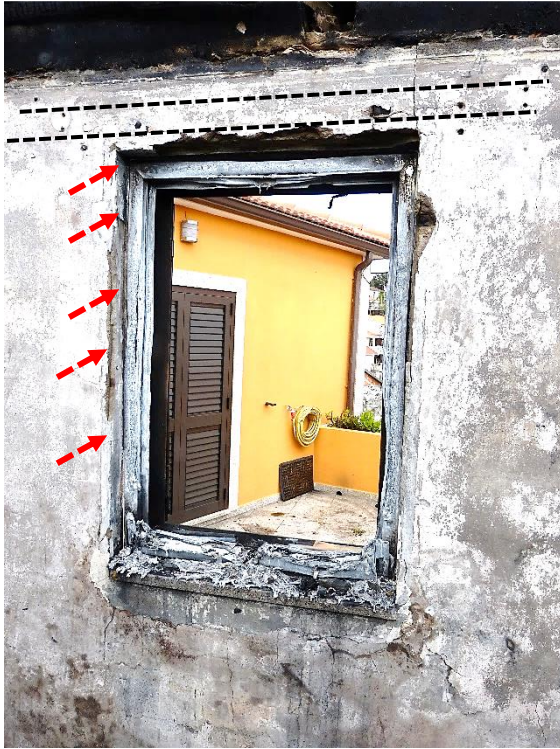
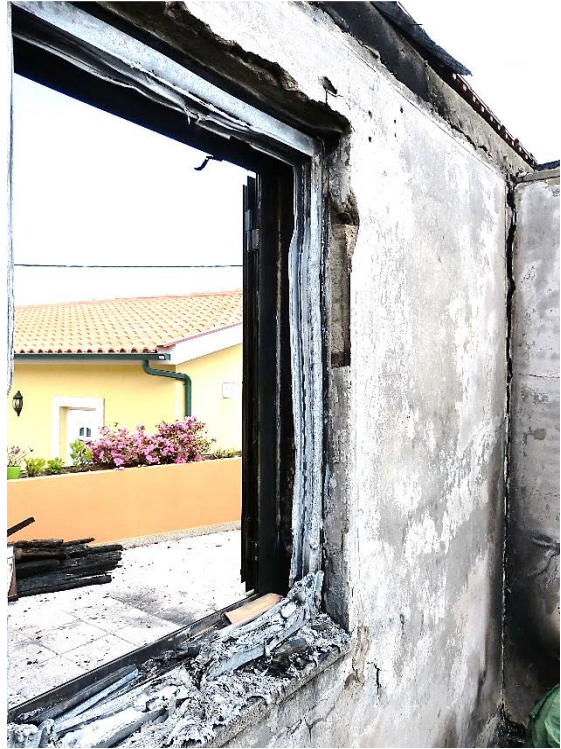
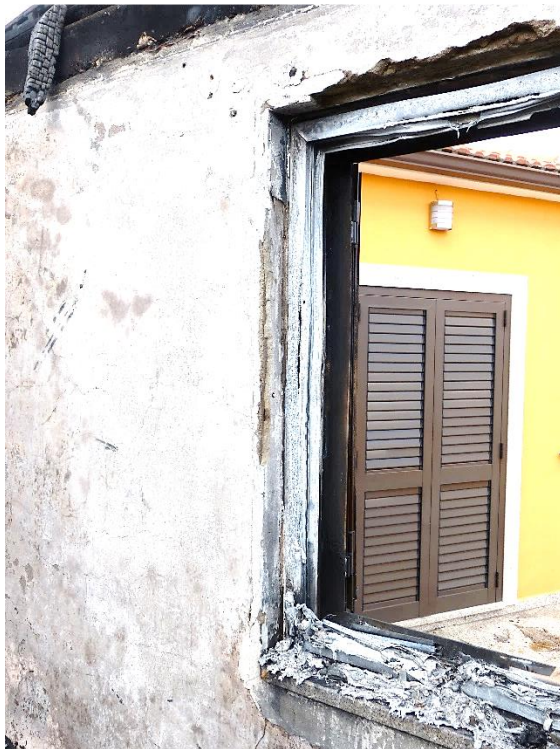
Through the examination of the window and in accordance with data from the external facade, according to the degree of damage and carbonization marks in its structure, it was possible to determine the direction of propagation of the fire from one area close to the wall next to the headboard of the bed (Pictures 20 and 21).

**Picture 20** – Concomitantly with the observed on the outer face, the inner window had a greater concentration of damage on the left side –red arrows, consistent with exposure to heat for a longer time interval.

The wall around the window reflects a high degree of destruction, with the total consumption of their outer layer present there as a result of fuel load, consisting of synthetic material – curtains.

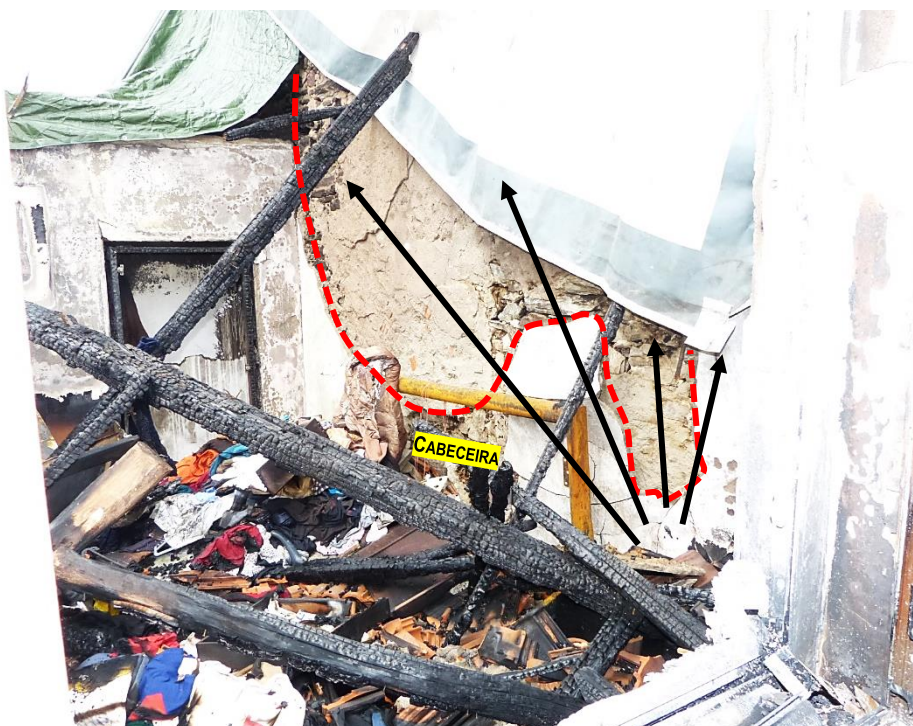
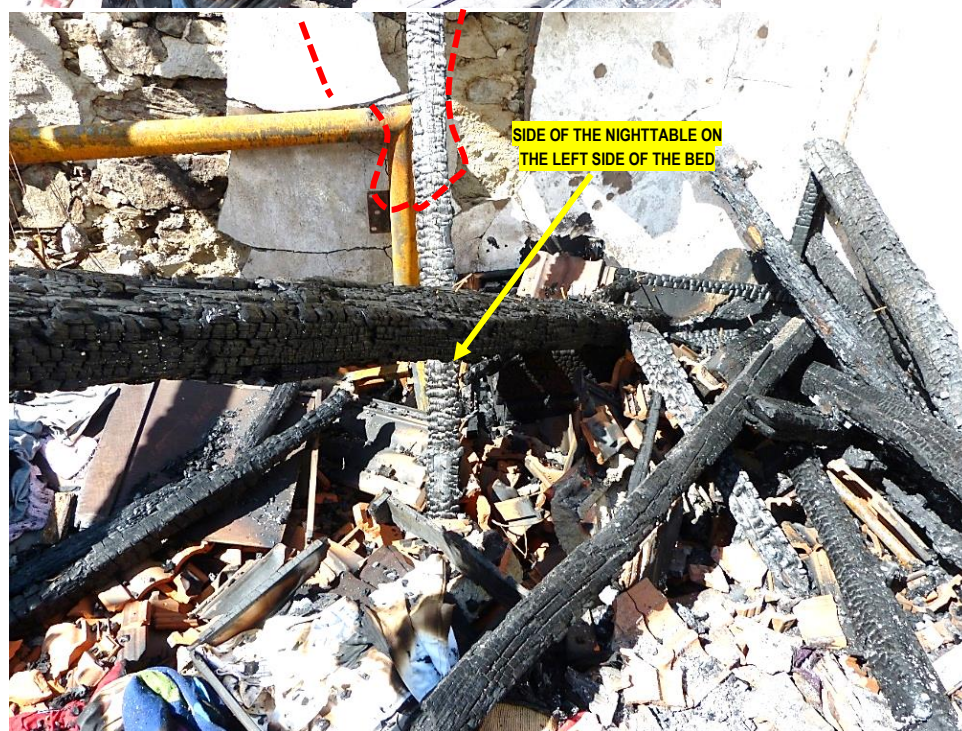
**Picture 21** – Headboard. High degree of damage along the whole length of the wall above the bed, particularly on the left side, where the destruction of the plaster denotes an area of greatest and heterogeneous damage, consistent with the position of the bedside table in line with the incidence of a direct source of heat for a longer time period.

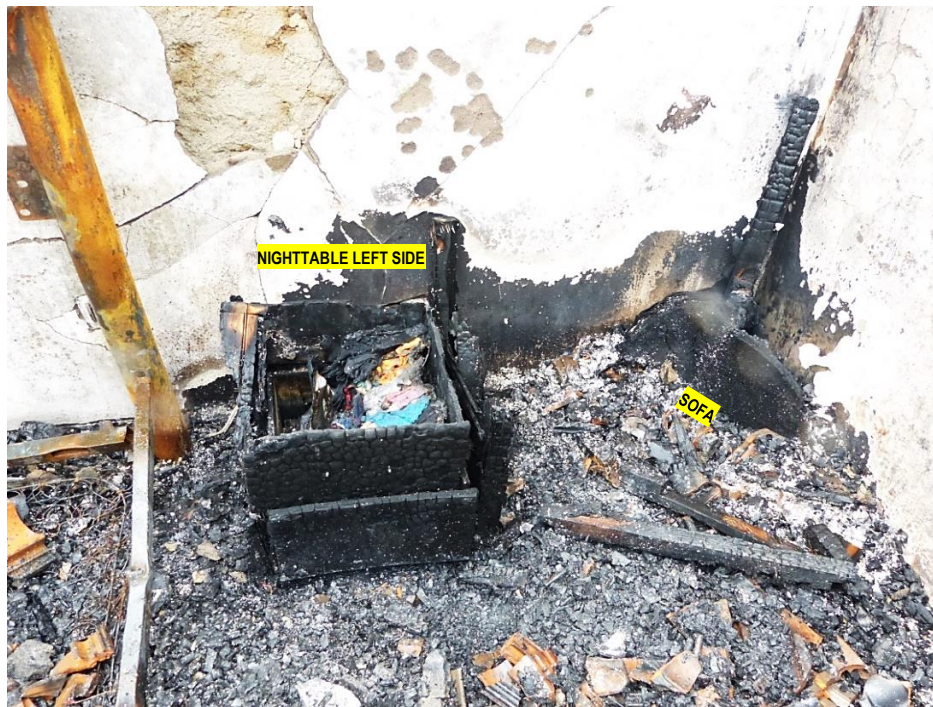
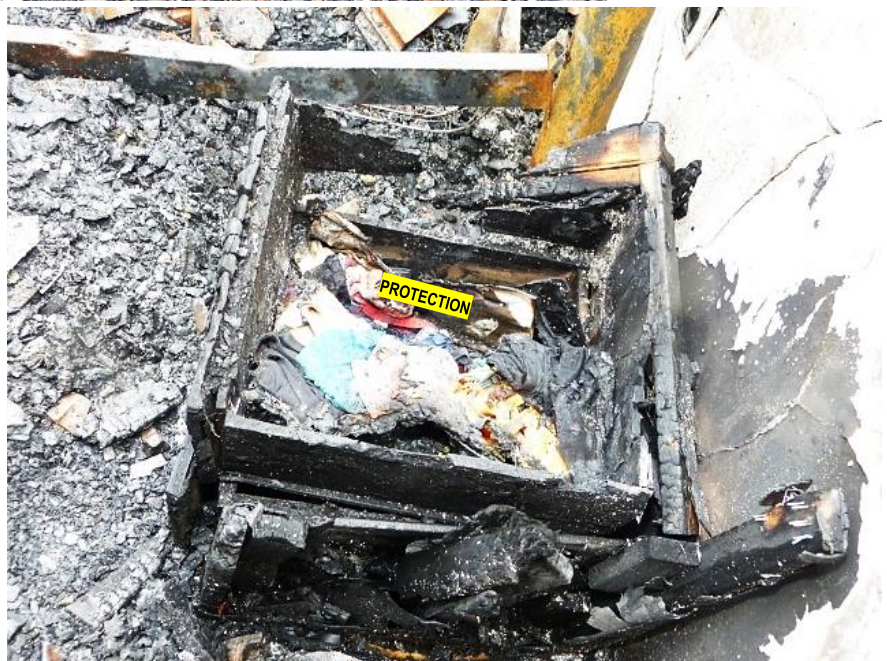
transmission of heat slowly and downwards from the top. Similarly, the bed frame and spring mattress exhibited a high degree of punctual discoloration and in depth in the section exposed to the side (Photo 22) for having received heat slowly, coinciding with what observed in the initial area of propagation.

**Picture 22** – Overview of the area with higher degree of damage - the high damage to the chair results from the heat received directly by the emissions of the starting point of the fire, which led to the subsequent light-up of the chair .On the side of the table exposed to the chair and in its interior some areas of protection are observed, determining the development of combustion from an higher area, at a level around the top of the table.

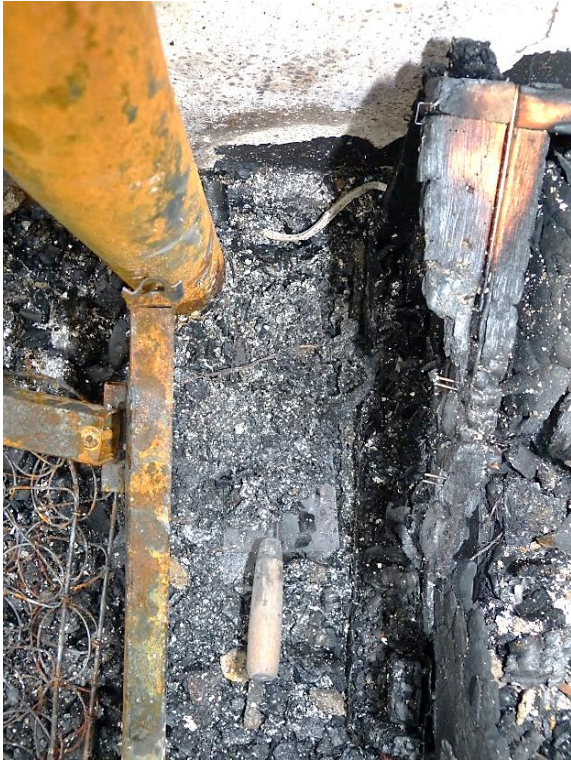
On the floor between the bed and the bedside table traces of an alarm clock that was usually on the right side on the top of that table were recovered, which coincided with the starting point of the fire (Picture 23).

**Picture 23** – On the floor between the bed and the bedside table debris of the alarm clock that was originally located on the right side of the table top, coincident with the area of start of fire were recovered.

The clock was connected to the power strip plugged into the wall socket, along the headboard, along with the lamp power plug.

The total destruction of case of the alarm clock and some of the components did not allow the reconstitution of it.

However, due to the observed marks and indicators, it can be concluded that the combustion is developed from a source of low intensity and punctual heat over a large period of time.

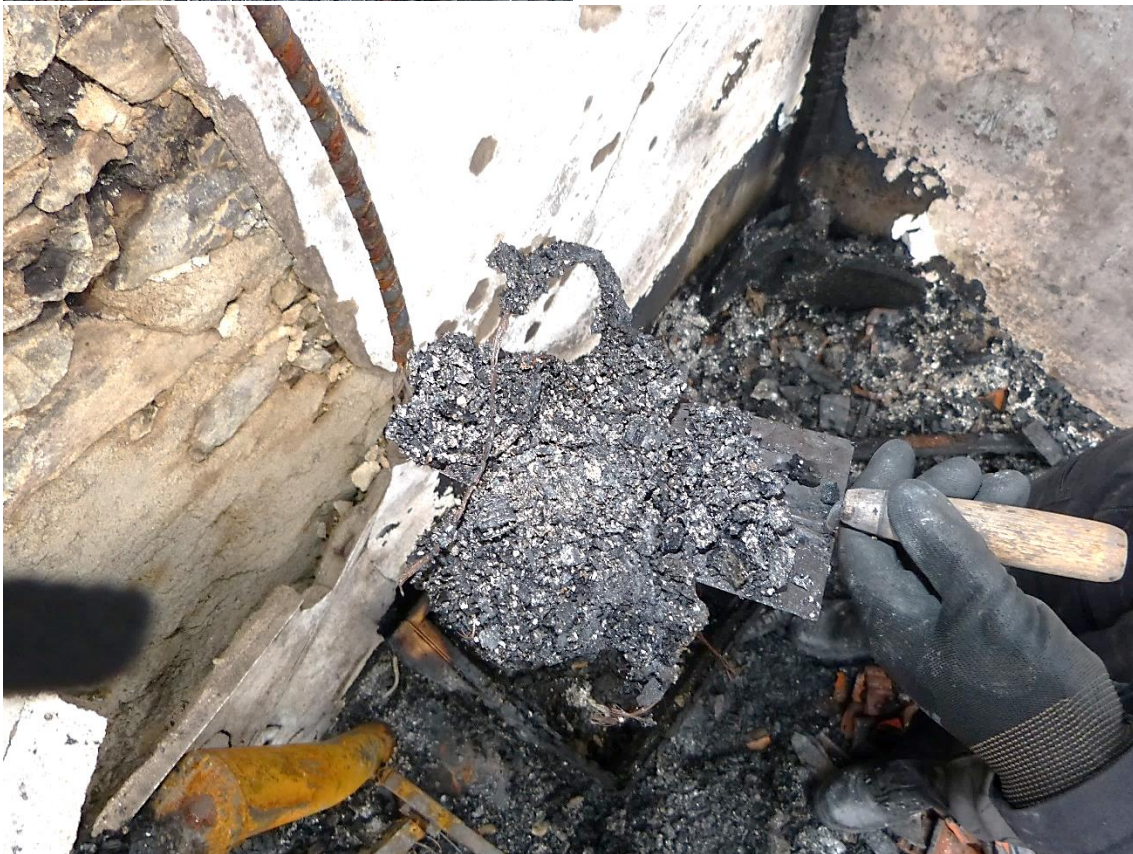
From the analysis of these components, it was determined that the sign of electronic components had received heat from the outside, with a homogeneous, contrary to the printed circuit board of the display, which exhibited damage coinciding with localized heat, resulting in failure of one of the elements. This caused an unusual overheating over a large period of time, giving rise to a combustion that sequentially lead to the spread to other structures and materials in the house (Pictures 24-28).

**Picture 24** – Detailed view of the remains of the electrical components belonging to the alarm clock after cleaning of the fire debris. Homogeneous damages can be observed, which result from the reception of an external heat source.

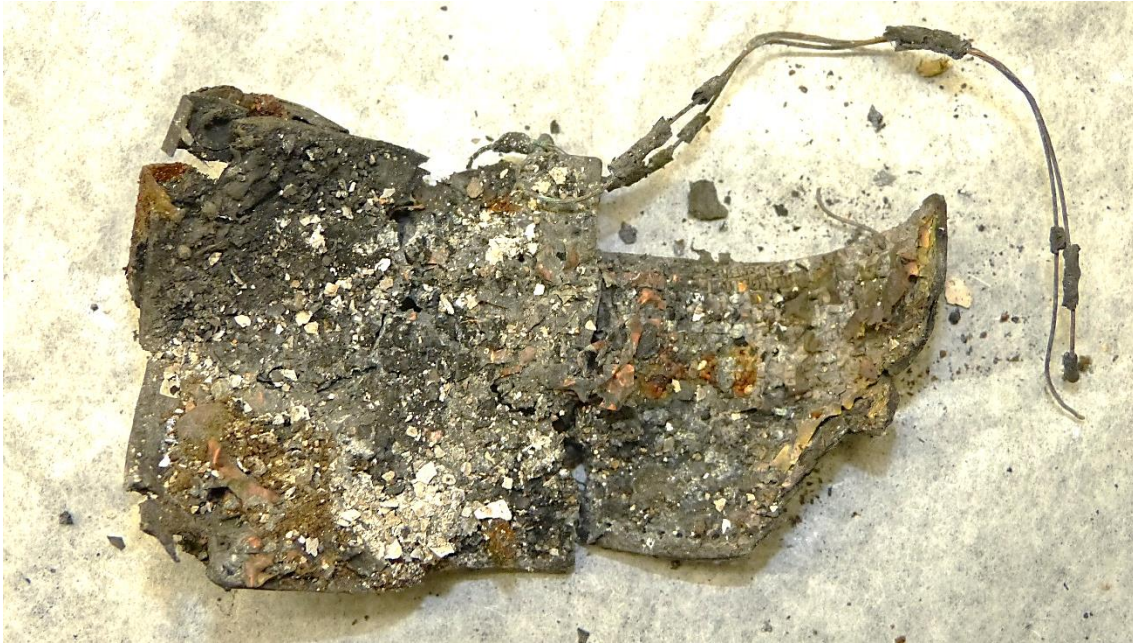
**Picture 27** – Detailed view of the back part of the internal electrical components.

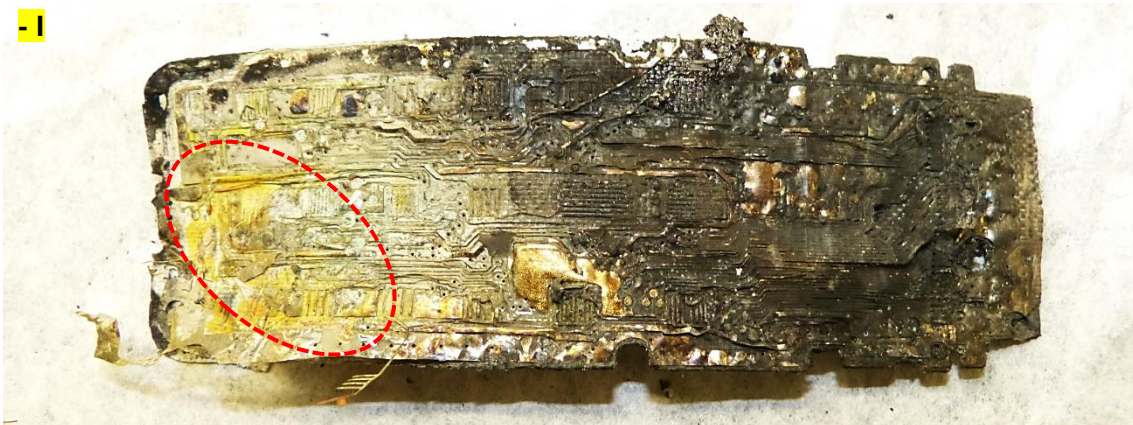
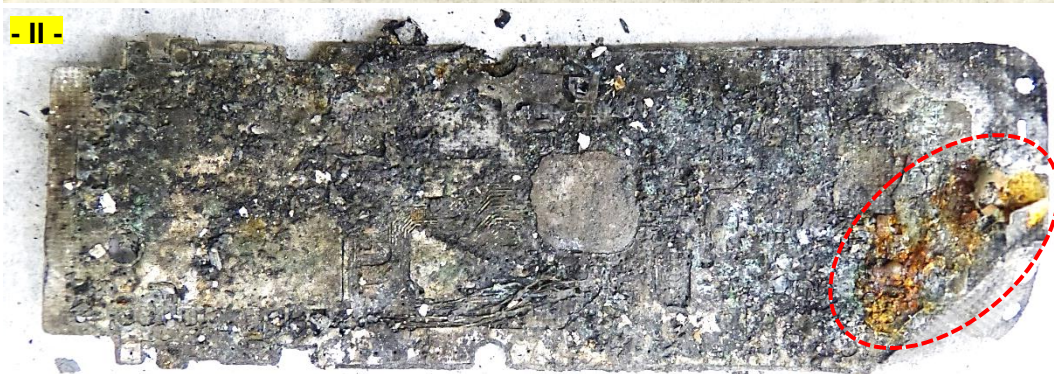
**Picture 28** – Circuit board, view from the front (I) and back (II). Due to the higher degree of damage observable – higher oxidation and discoloration of the material due to reception of heat during a longer period of time – it is possible to determine the ignition point – red circle – resulting from an overheating of a faulty electrical component.

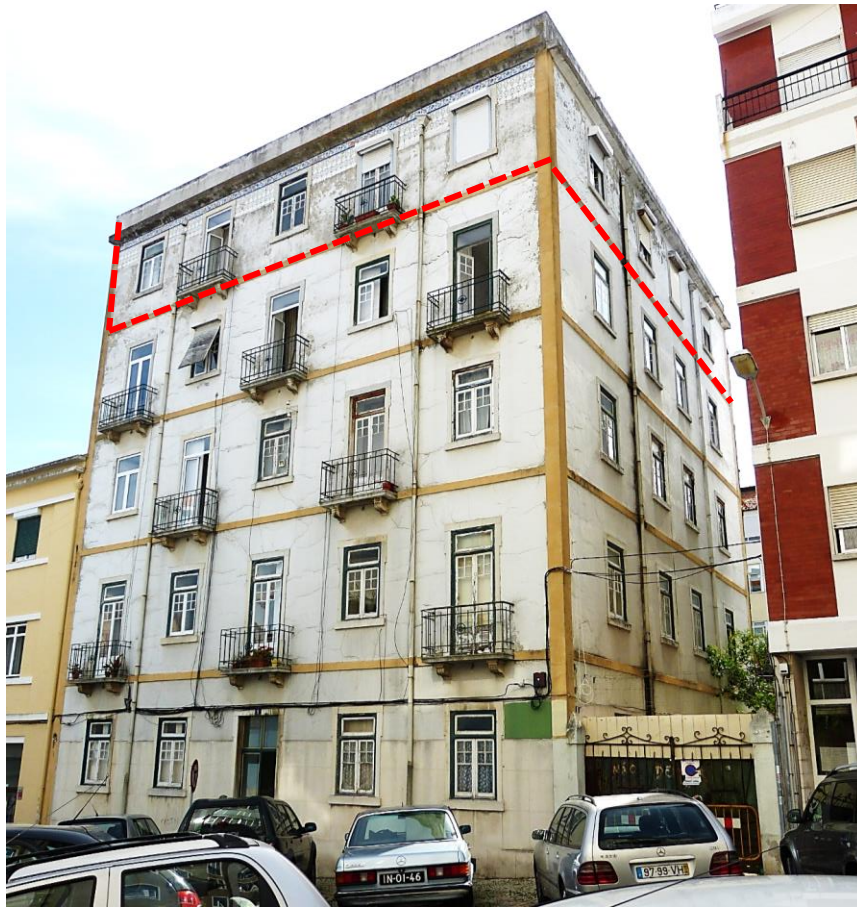
According to this methodology, absence of damage - internally and externally – was observed on the entire length of the facades. This indicates that the origin of the fire is at the upper floor of the building, the smoke and heat movement developed vertically after the collapse of the ceiling (Pictures 01).

**Picture 01** – View of the damaged building from the outside; to note that all the facades of the apartment in question – delimited by the red line – do not show any signs of damage.

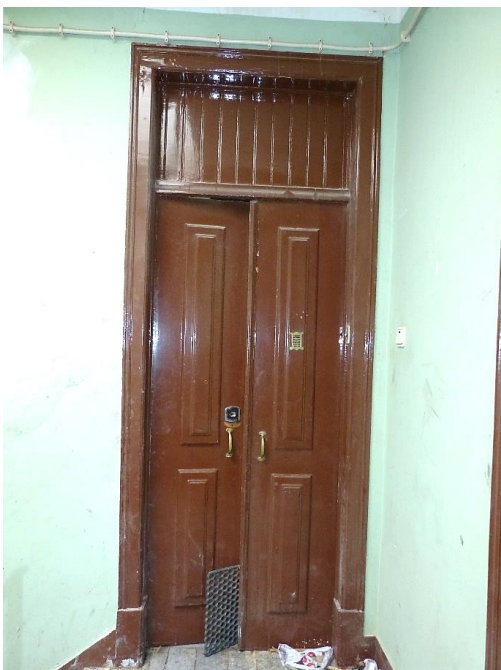
The access door to the apartment –fourth floor, left side- was analysed based on the locking points - bolts, locks and security chain. No signs or traces of forced entry were observed (Pictures 02 and 03).

**Picture 02** – Main door of the damaged apartment – outside view.

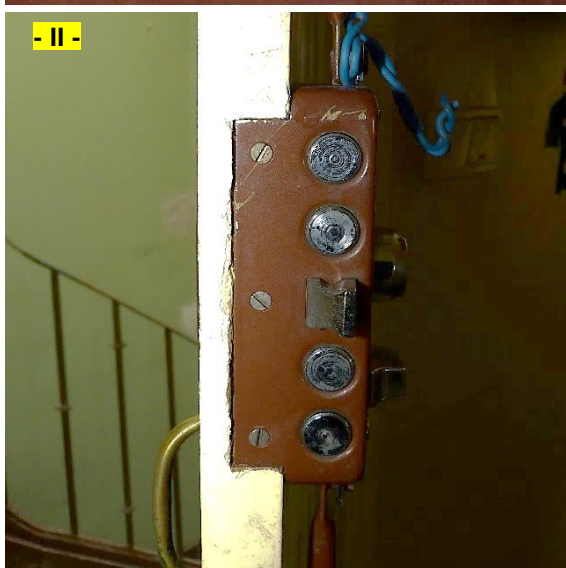
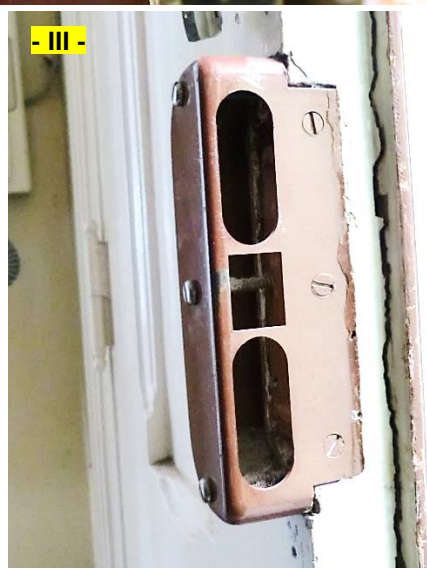
**Picture 03** – Detailed view of the lock from the outside (I), the main frame (II) and the connecting part on the other side of the door (III) – no signs of forced entry.

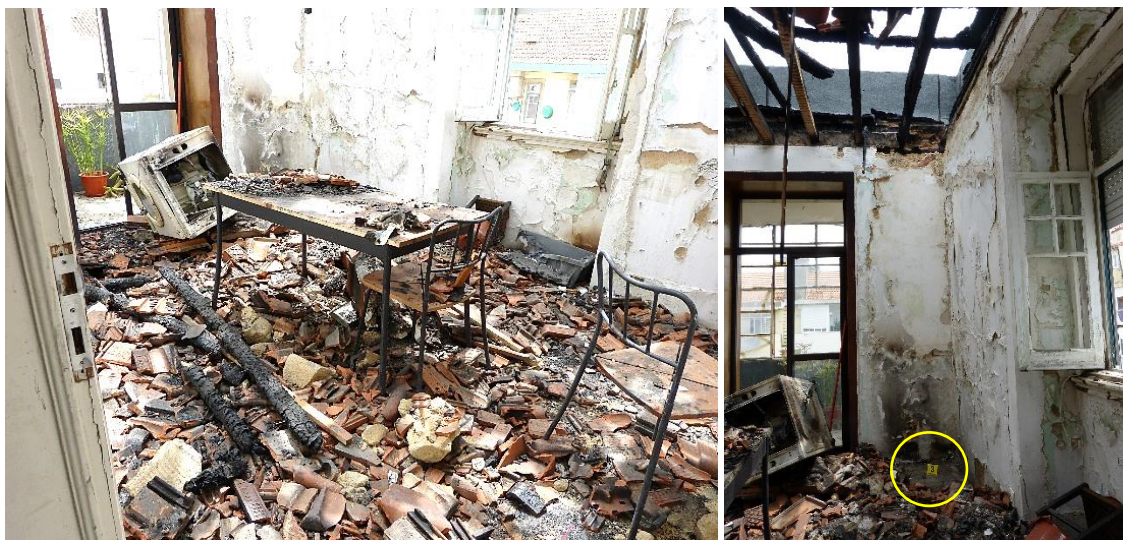
Further on during the investigation of this area, the extent of the damage observed evidenced a circumscribed and heterogeneous section where the degree of carbonization was high, consistent with the proximity to a source of heat resulting from a point of origin (Pictures 05 and 06). A sample was collected in this area – tag #3 – for laboratory examination.

**Picture 05** – Inside of the dining room, observing a degree of complete destruction of the ceiling and the main wooden structure between the floors. Accordingly, it appears that the lower face is protected, consistent with heat acting downwards from an upper level, the attic. This damage is particularly visible at the corner, where it is limited and the degree of carbonization of the structures is higher, resulting from its proximity to a circular point of origin – red circle. Yellow circle indicates tag#3, where a sample was collected for laboratory analysis.

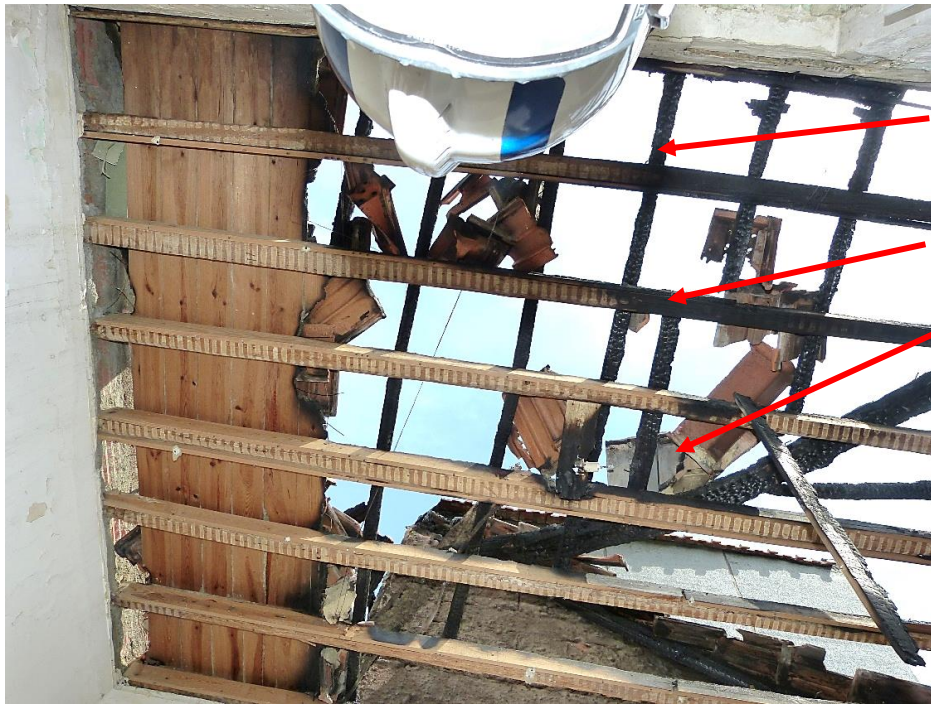
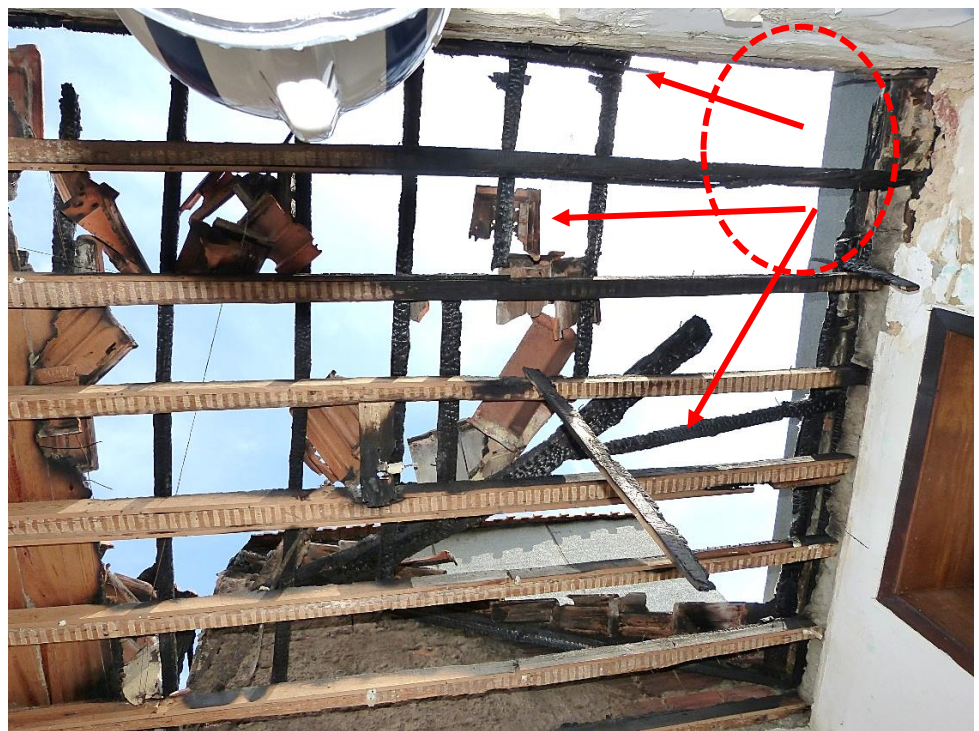
**Picture 06** – In the roof area it is possible to observe a converging carbonization area along the support beams near the corner -red circle-, which results from the proximity to a point of origin. The absence of a greater extent of damage throughout the room, in particular by soot-fixation, arises from the rupture of the ceiling, which allowed the smoke of a small secondary fire outbreak to exit upwards.

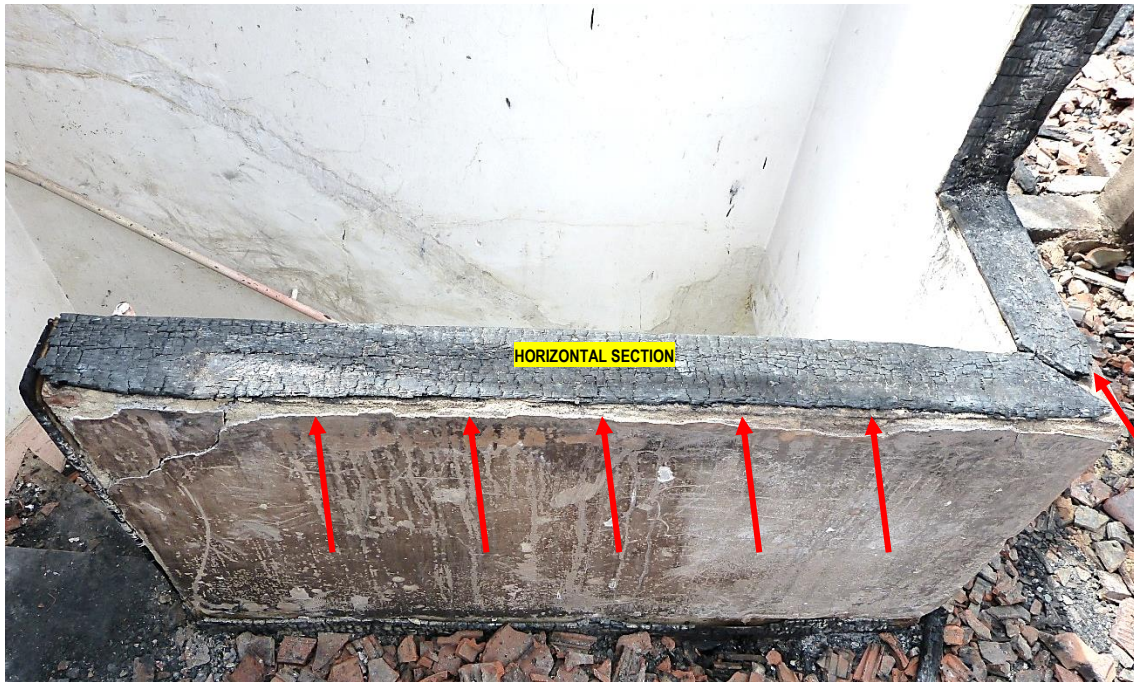
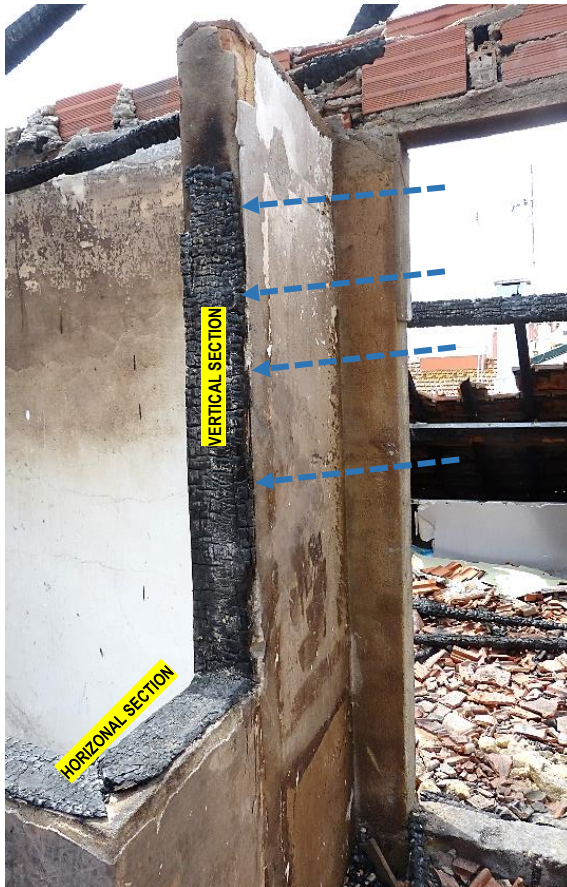
The examination of the wood coating on top of the handrail of the staircase showed that the horizontal section has received heat from the front. In contrast, the adjacent vertical section, showed a higher carbonization side opposed to its counterpart, which were clearly produced by the hot air flow coming from two different directions of two, indicating that they originated from two separate points (Pictures 07 and 08).

**Picture 08** – Detailed view confirming the divergence of the damage present on the wooden balcony, identifying both directions of propagation of the fire in the sections of the horizontal and vertical profiles –red and blue arrows..

These indicators allow us to conclude the existence of spreads from two fires located on opposite sides of the attic.

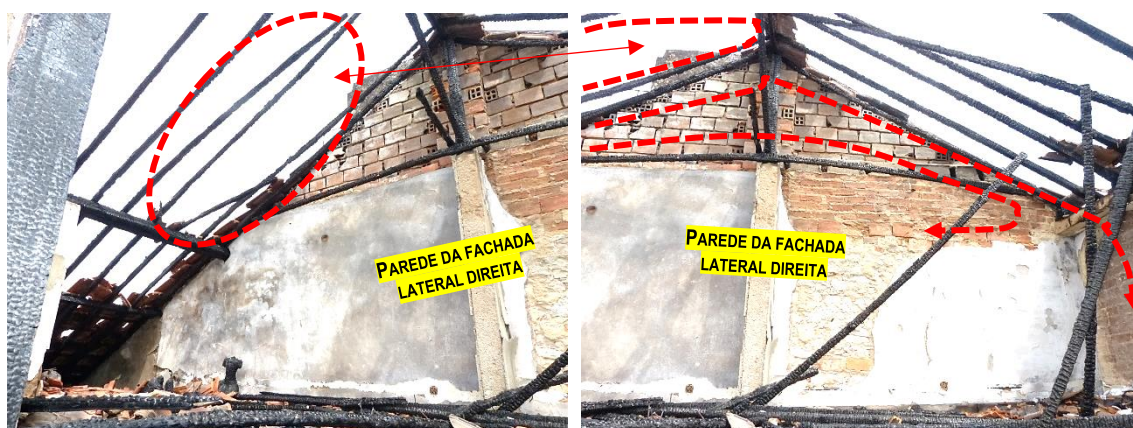
plaster layers located above the false ceiling, were found, indicative of the incidence of a heat source during an extended period, coming from the main facade (Picture 12).

**Picture 12** – In the upper area of the room there has been a complete consumption of the false ceiling and an intensive destruction of the coverage (the "Rafters"). This damage is particularly visible in the "Rafters" and "slats" of the structure that exhibit a greater concentration of damage on the front right section of the building –red circle. Also observable are damages resulting from convection currents –in the orientation from the main façade to the back wall, red arrows-, consistent with the direction of propagation from a separate point of origin.

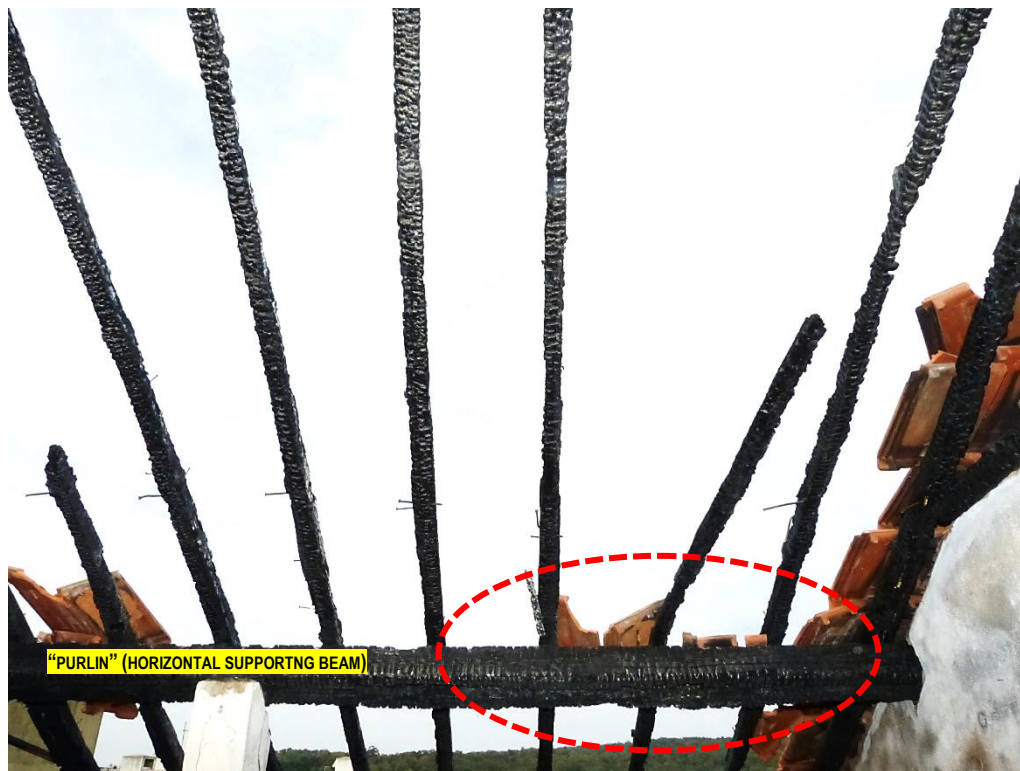
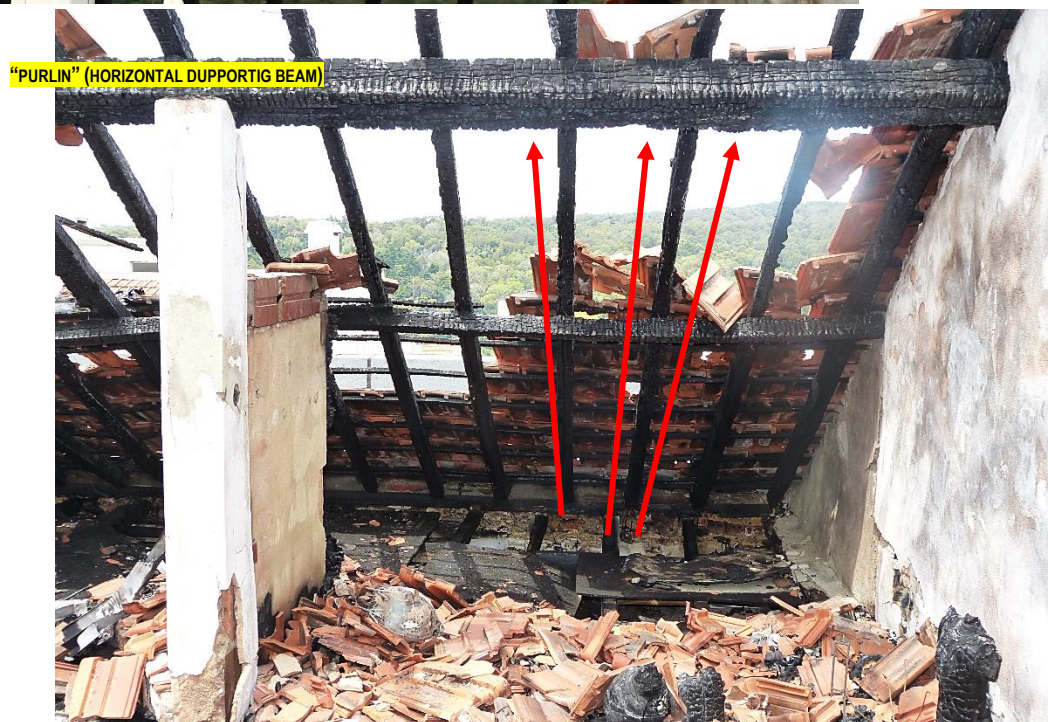
Simultaneously, by observing the "slope" of the cover in that area, a greater destruction of the beams ("studs") exposed to the sidewall was observed, as a result of heat accumulation resulting from an upward movement of the hot air coming from the side adjacent to the corner (Pictures 13 and 14).

**Picture 13** – In detail, seeing that the structures of the "rafters" exhibit charring marks in greater depth close to the "purlin" horizontal support beams- red circle- resulting from longer exposure to the action of heat –red arrows- from a point of origin at a lower level.

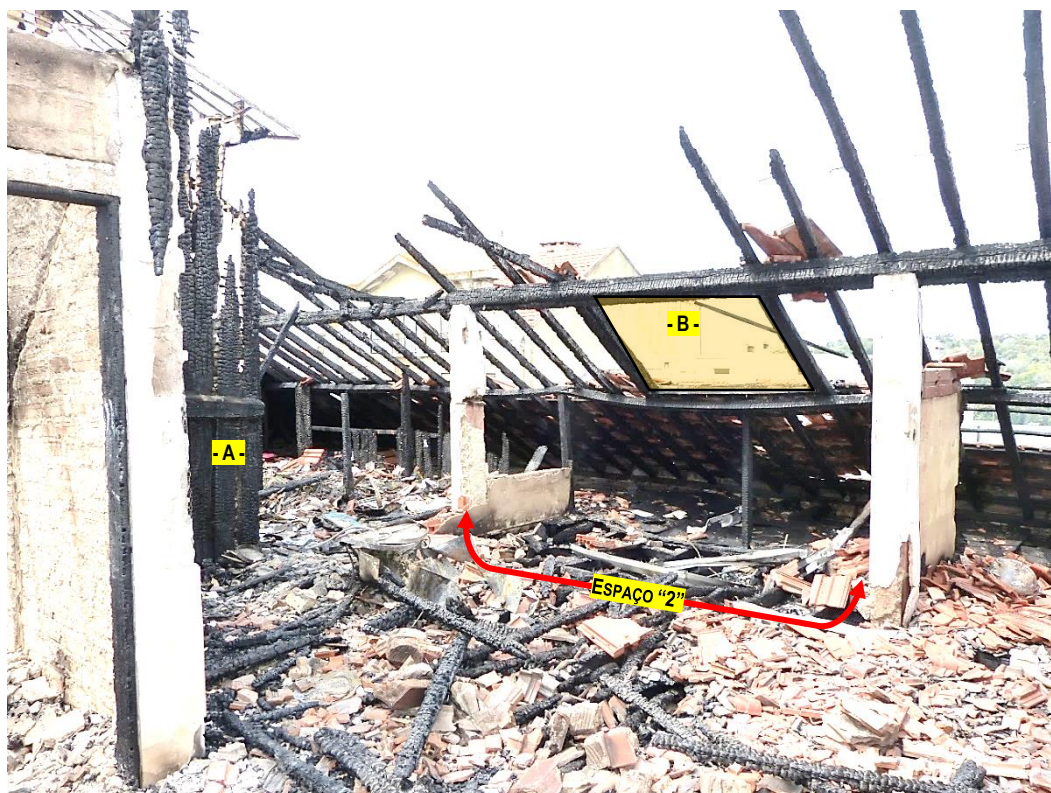
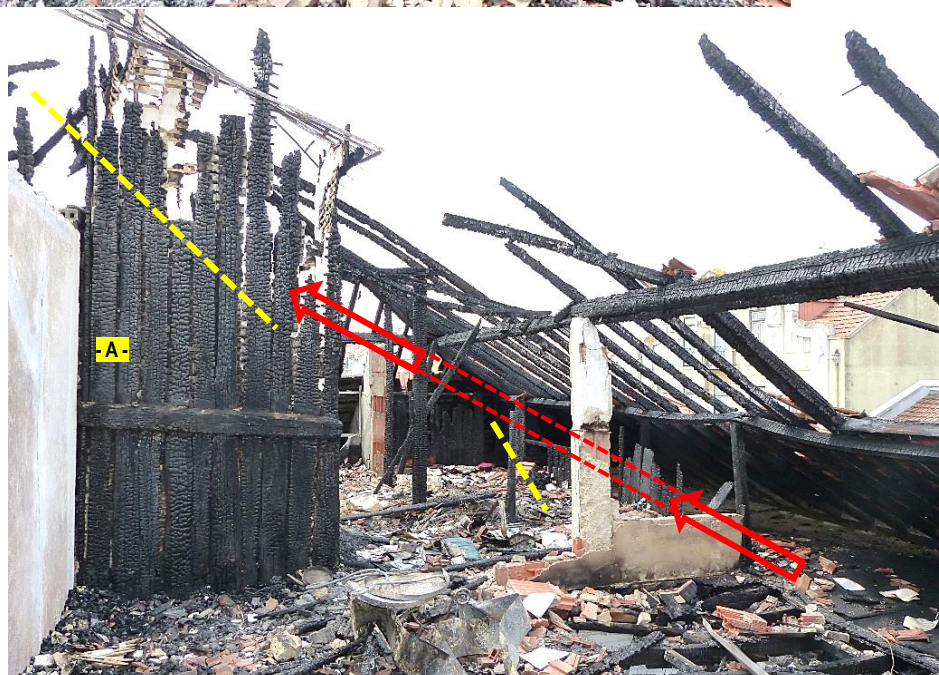
Continuing the examination of the area, a geometry and morphology of destruction in a "V"-pattern was found in the structure of the wooden box below the skylight, consistent with the action of heat received at upwardly from a point in close proximity but at a low level (Picture 15).

**Picture 15** – Perspective of the remaining area. In the structure of the stairwell-box "A" and the masonry pillar damage in a "V"-pattern can be observed, which results from the exposure to direct action of heat transmitted by radiation for an extended period of time from a second point of origin –tag #2 - present on the right side –red arrow-, on the main facade and one level below the window - B -.

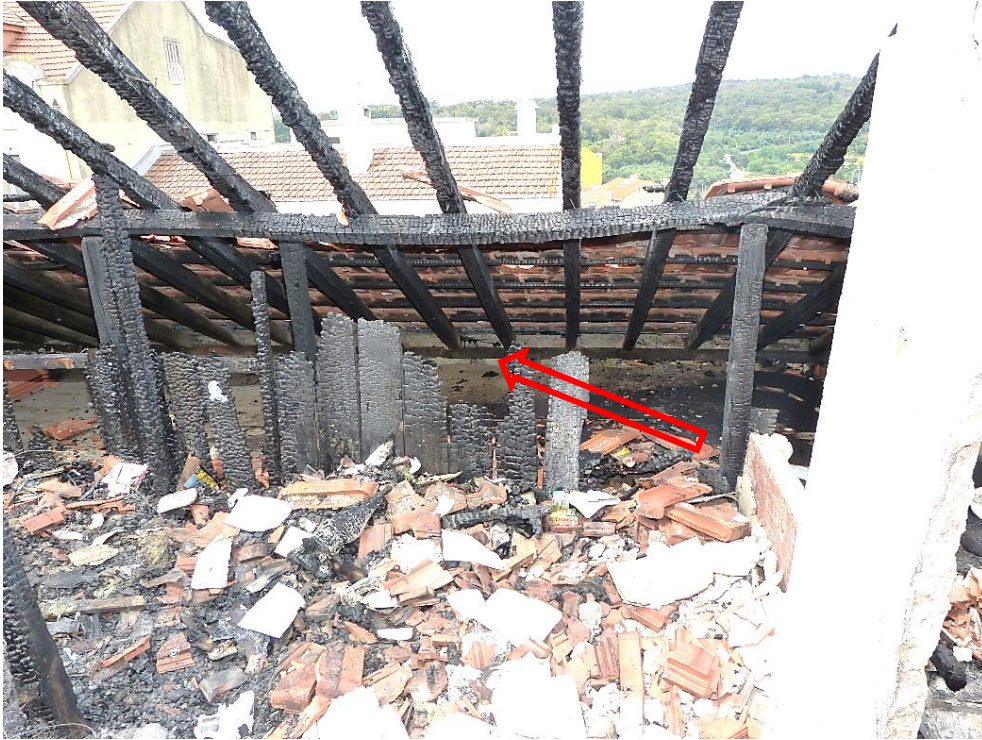
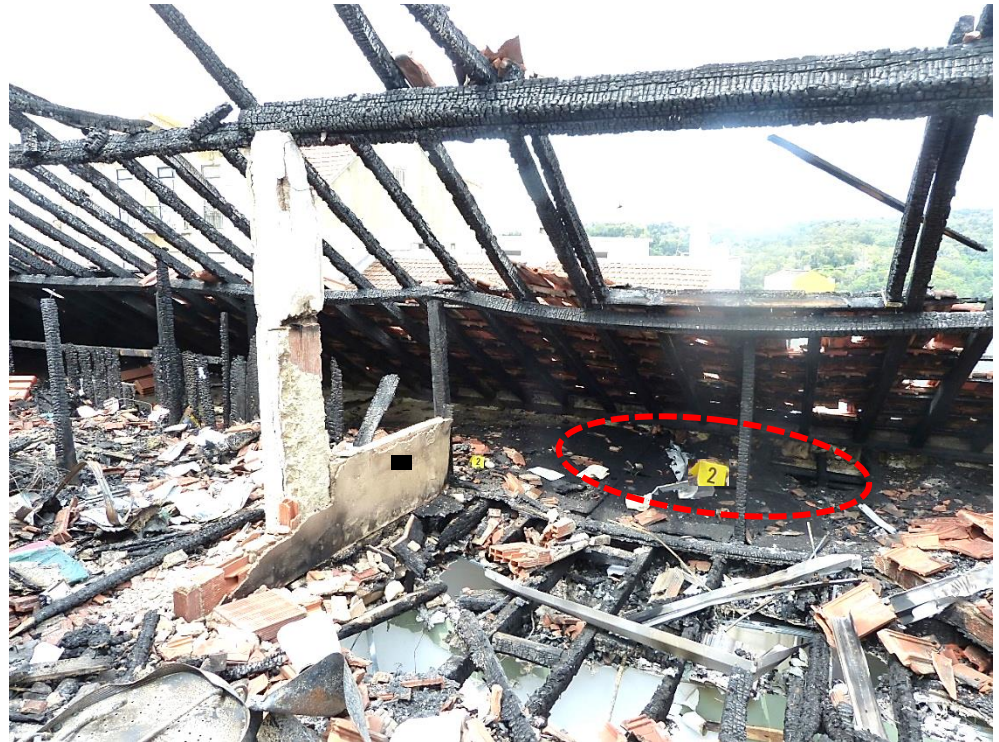
Following the same methodology, a similar damage to the wood structure delimitating the storage area (Picture 16) was found (tag #2), showing a heat-convergence area on the left

**Picture 16** – In the adjacent space (towards facade on the left side) charring of the structure of the delimiting area was observed in an upward direction –red arrow- consistent with the incidence of a heat source- tag #2, which was close but at a lower level on the right side –red circle-.
