# **MASTER THESIS**

***“Contribution to Portuguese Urban Fire Investigations  
– Forensic Fire Debris Analysis”***

**STEFANIA OLIVERIO**

**JULY 2016**

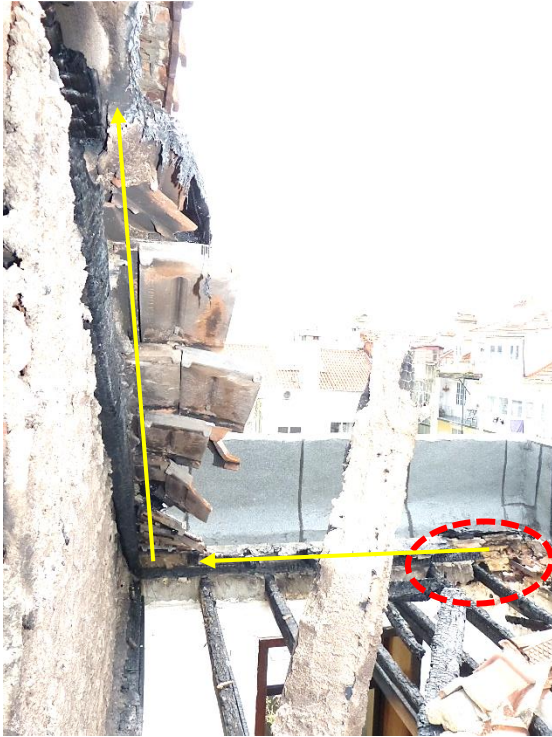
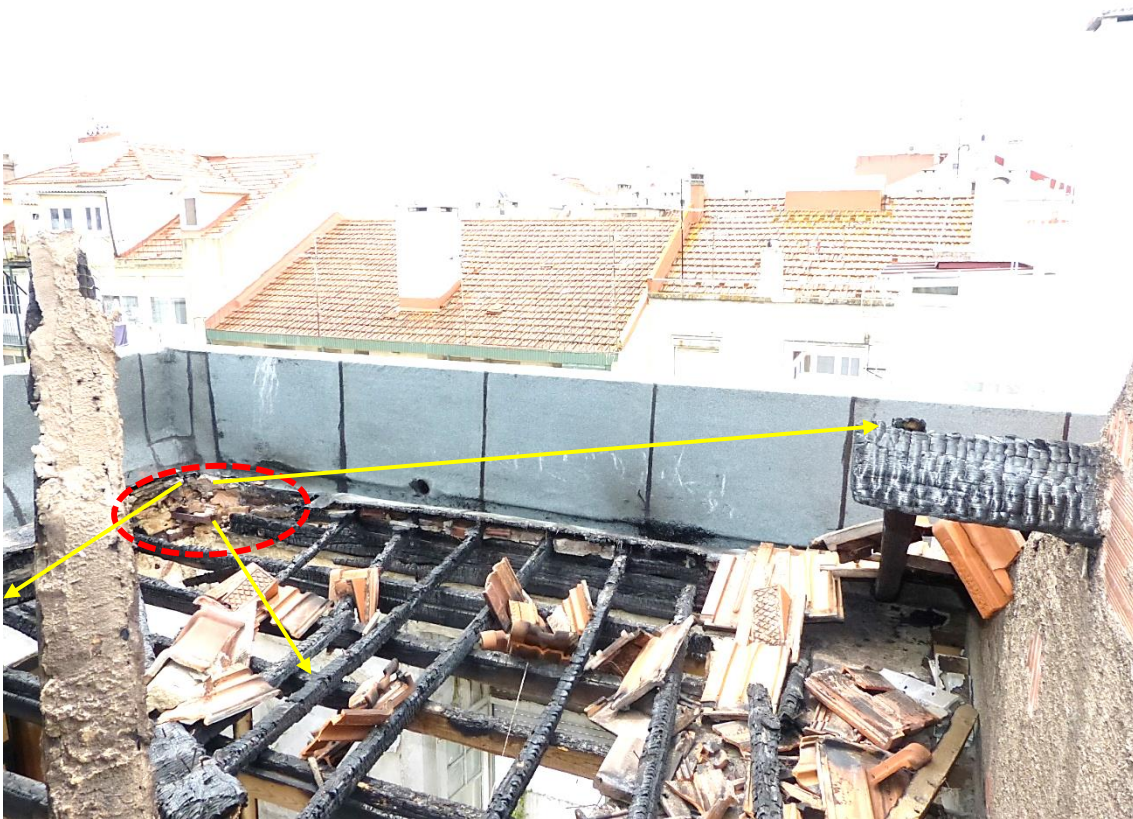
The interpretation of the marks indicated a third point of origin in storage area (tag # 3), more specifically, on the floor near the corner formed by the walls of the left side and the masonry. In this place there was no suitable combustible material nor any means capable of generating heat that somehow could function as activation energy to the system and cause combustion, so we can infer that energy had to be transported to the site (Picture 19).

**Picture 19** – Perspective of the area along the corner between the walls of the facades on the left side and the building's outer masonry.

The degree of damage to the structure of the wooden beams in the corner is higher than those observed in the remaining space of the room, in addition to showing a downward development, suggesting a third point of origin in that corner – red circle.

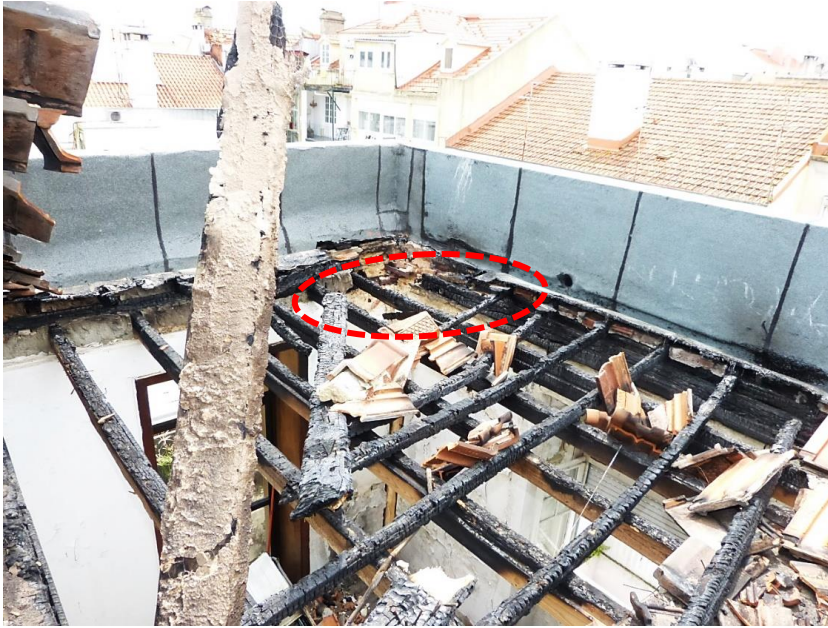
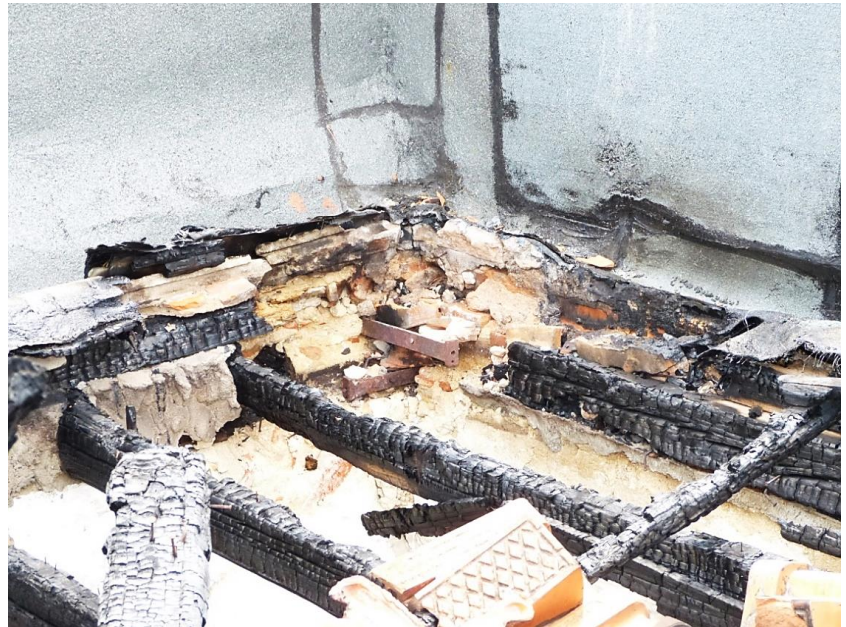
Thus, it is concluded that in this area a combustion must have started with the pouring and ignition of a liquid product with high calorific value and easy volatilization used as a fire accelerant (Picture 20).

**Picture 20** – Detailed view of the corner-area, where a heterogeneous damage in depth and downwards from the floor with a rounded shape is observed. This type of damage results from the combustion of fire accelerant in the initial phase, which was poured on the floor, allowing it to seep into the floor to develop a combustion at low level, in addition to allowing a spread in the initial phase of considerable intensity due to the evaporation capacity of the material used. It can also be observed that the combustion started in an area above the floor and below the roof structure, since a reduced damage of the sealing material of the curbs can be seen. The total combustion of the pavement in a circumscribed area downwards would lead to the partial destruction of the ceiling of the dining room in the lower floor, located right below the ignition point (see pictures 07 and 08).
